Virginia State University
MS-4 Permit: VAR040119
July 1, 2020 - June 30, 2021 Annual Report

Prepared for
Virginia State University
Capital Outlay & Facilities Management
PO Box 9414
Virginia State University, VA 23806

October 1, 2021

Prepared by: Timmons Group
1001 Boulders Parkway, Suite 300
Richmond, VA 23225
(804) 200-6500

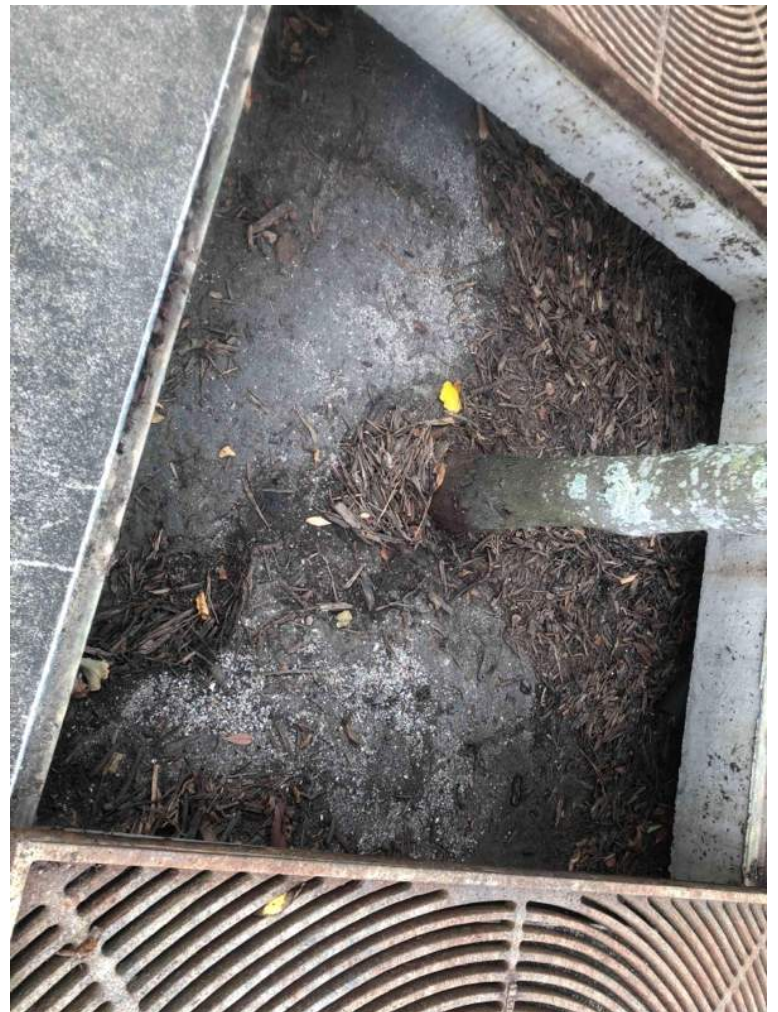
Unit 9: Before

Unit 9: after 2 rows inlet stones installed.

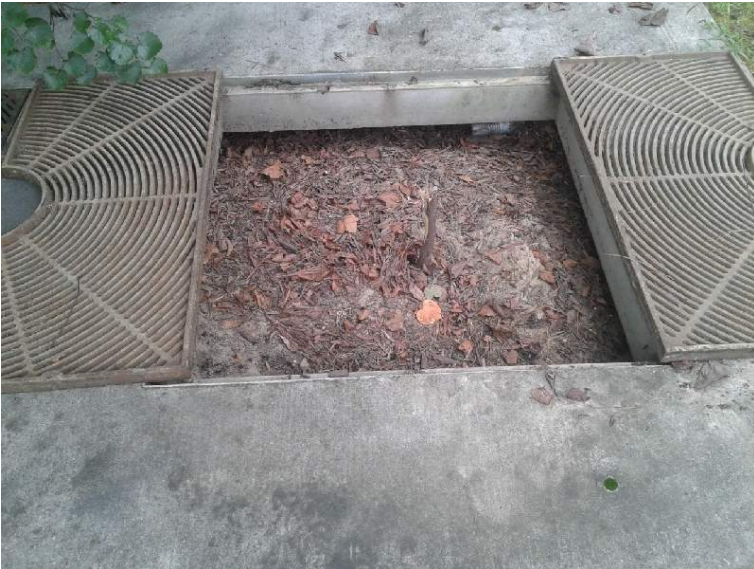
Unit 10: before Tree is dead and broken. Customer would like price to replace both trees with red buds or dogwoods.

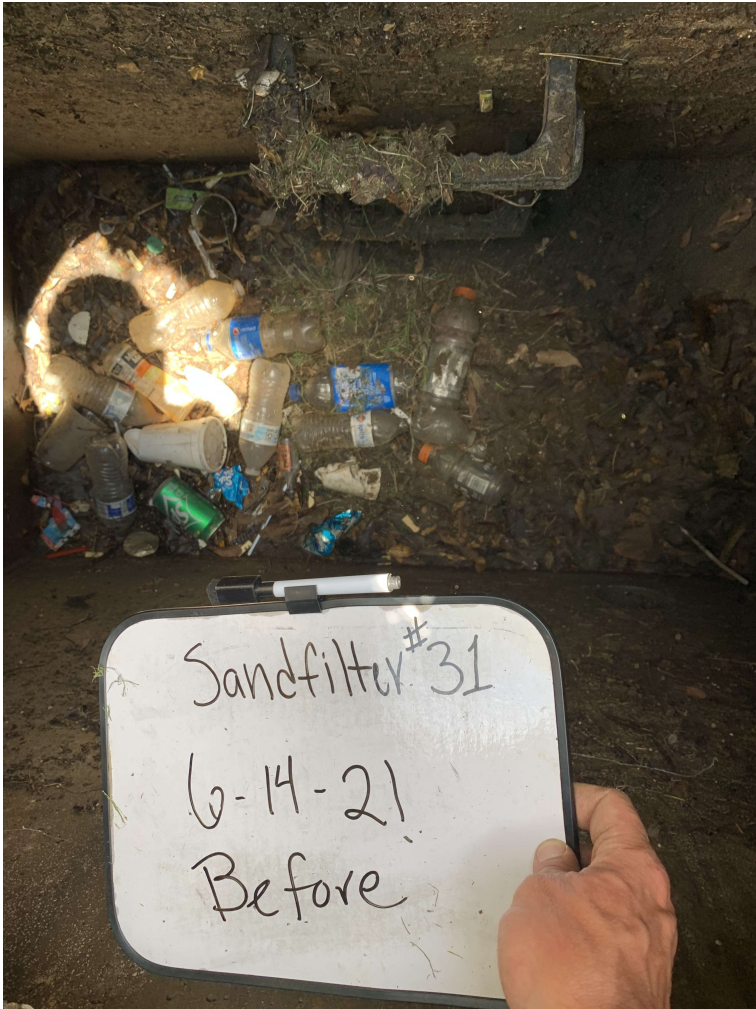
BMP 31 Sandfilter Before

BMP 31 - removed sediment and trash
BMP 40 - removed trash and floatables from system, removed blockage
BMP 42 - replaced broken grate
BMP 46 - cut back cattails
BMP 47 - removed sediment, trash, and debris
BMP 48 - removed sediment, trash, and debris
BMP 49 - removed sediment, trash, and debris

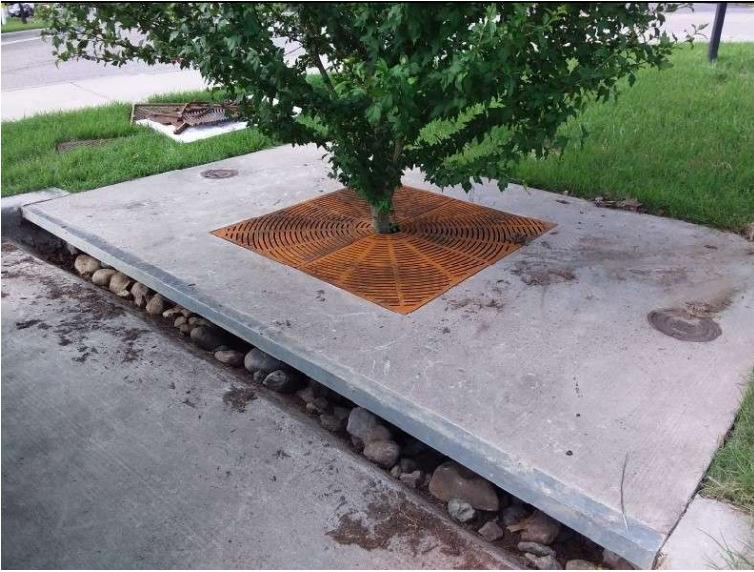
BMP 42 Grate replaced

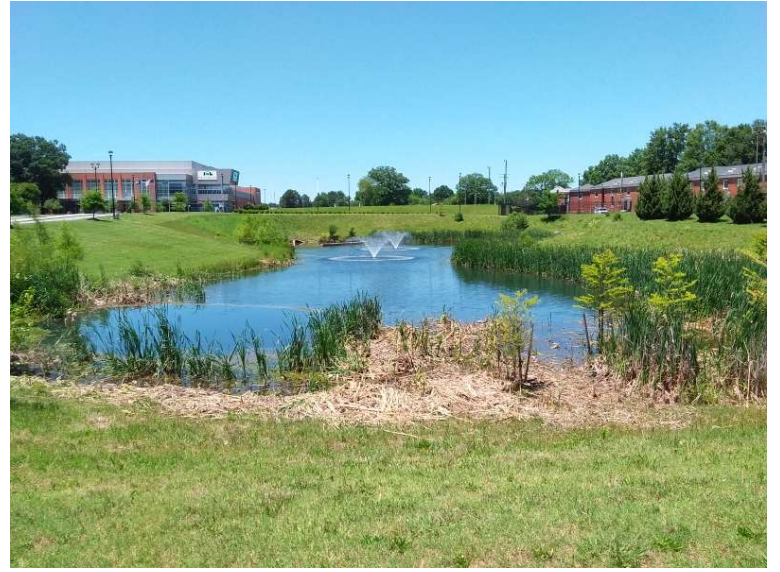
BMP 46 cut back cattails

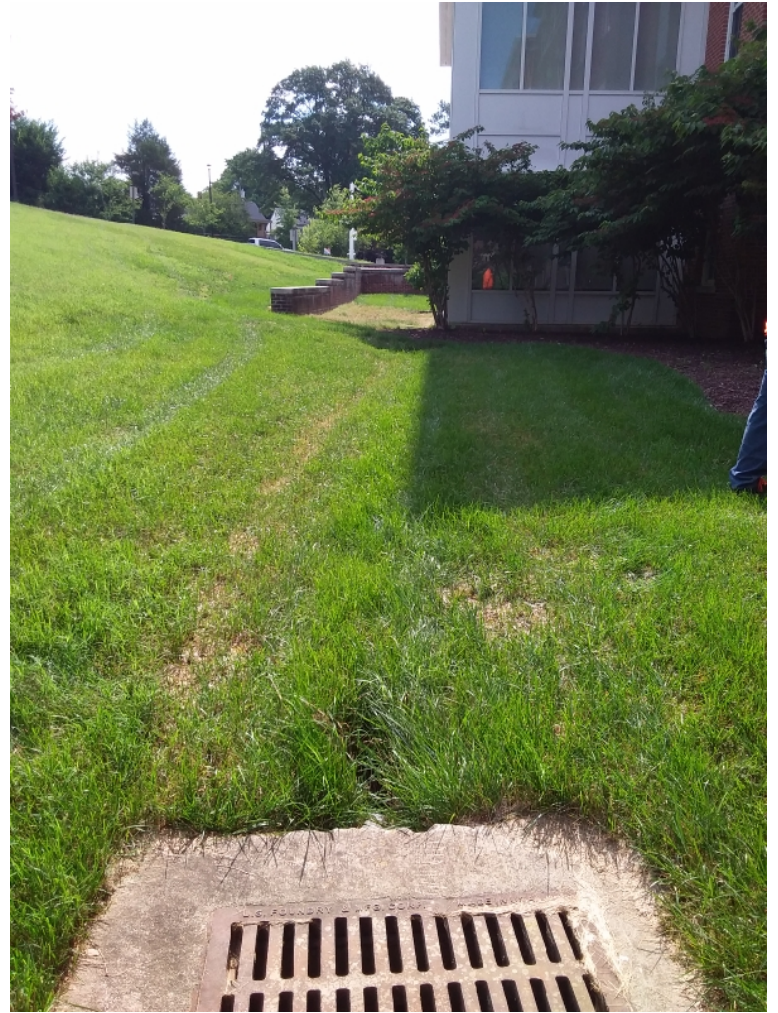
Noticed erosion and washout located SW of BMP 43

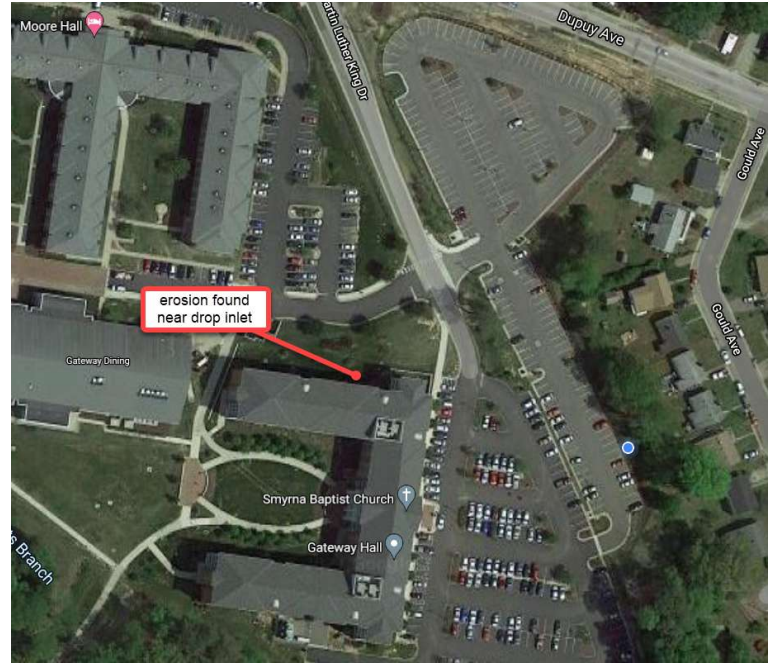
Site Map: showing area where erosion was noted

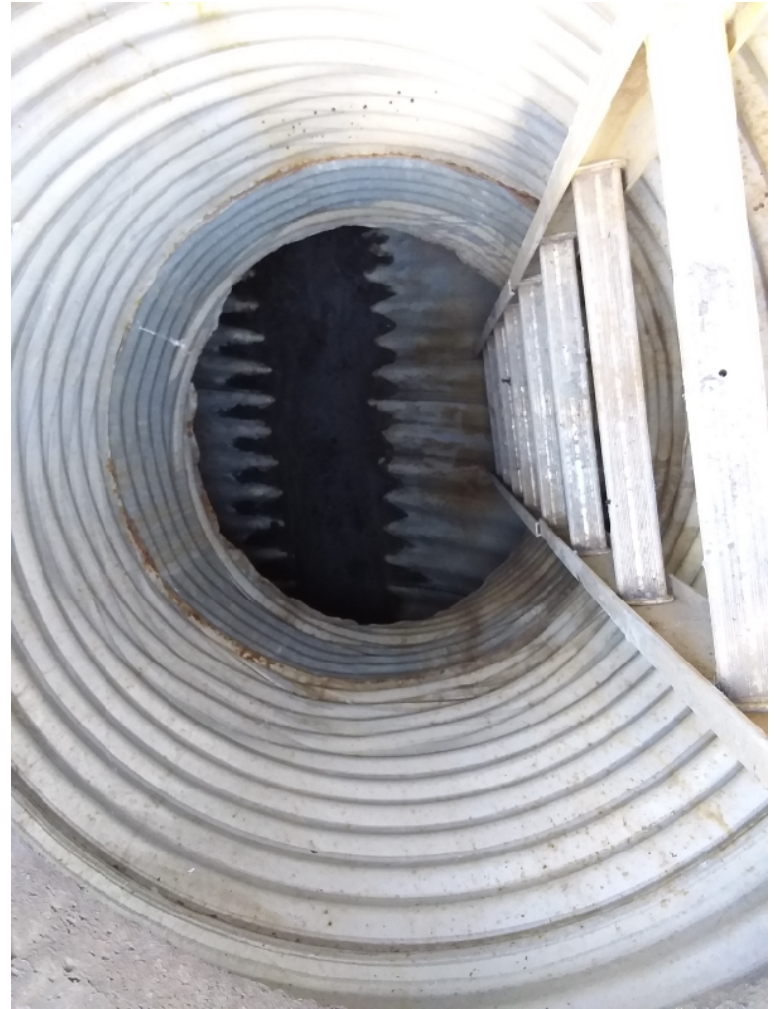
BMP 15- minimal sediment found

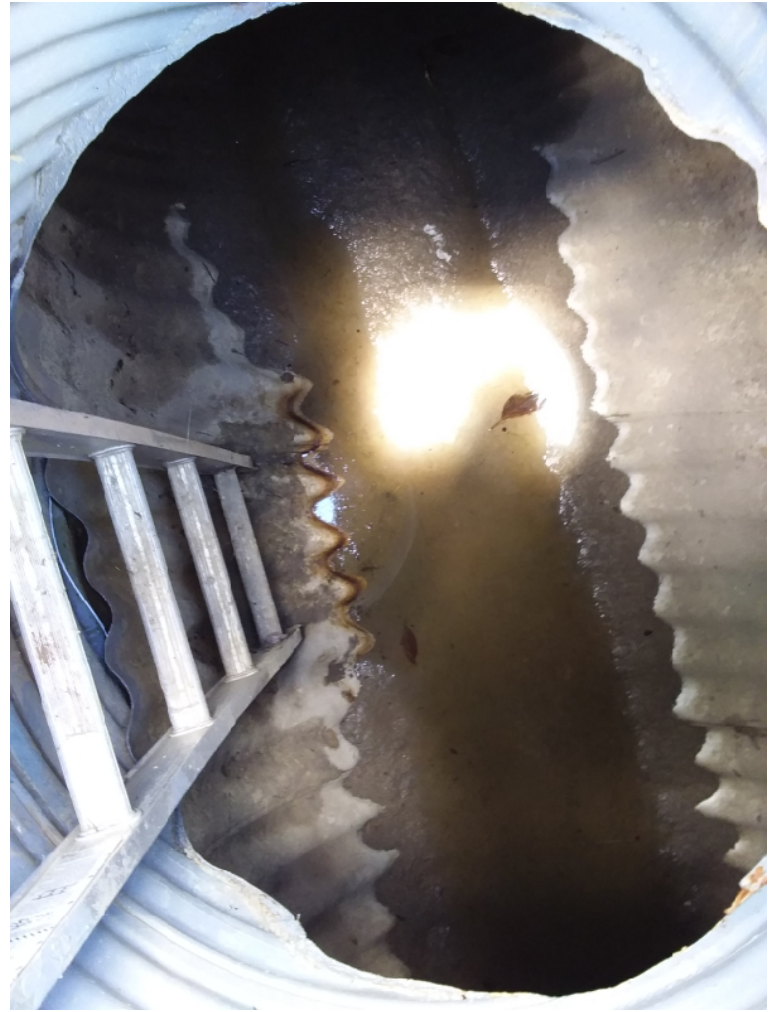
BMP 25: 1-2" sediment

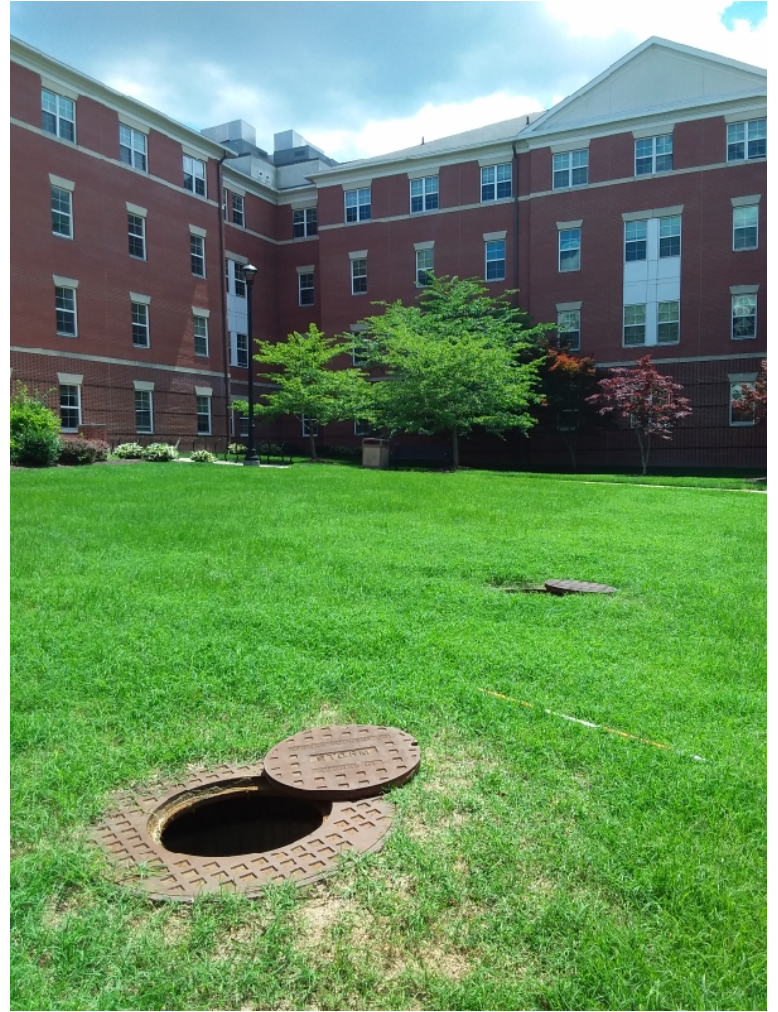
BMP 26: no significant sediment, trash or debris

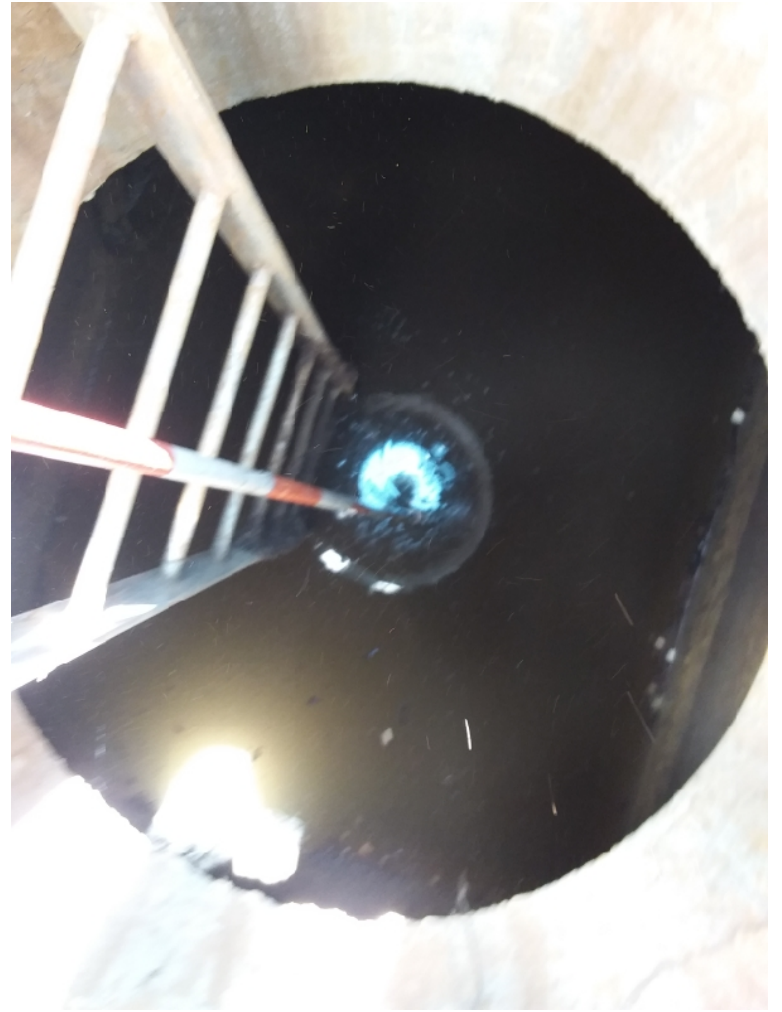
BMP 28- dewater and remove sediment accumulation (approximately 12")

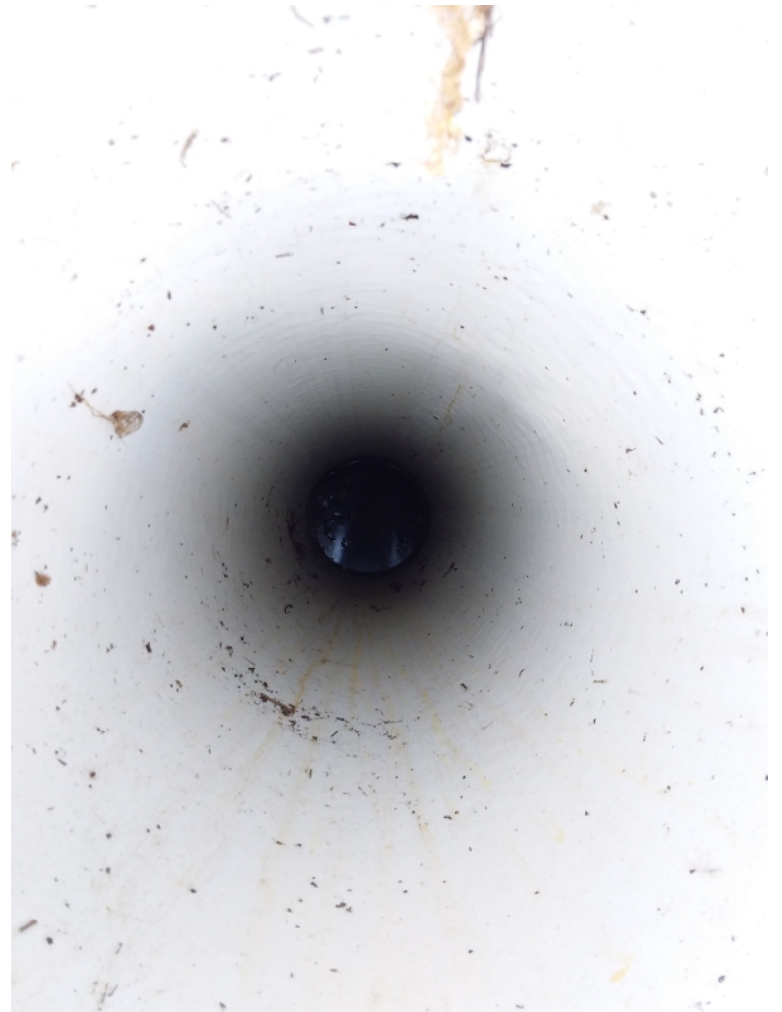
BMP 36: 16" of water standing in maintenance port

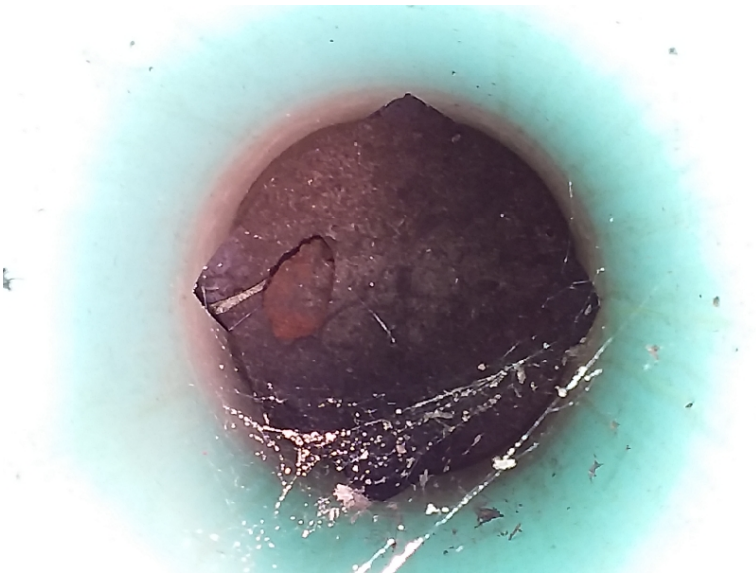
BMP 37- minimal sediment found inside maintenance port

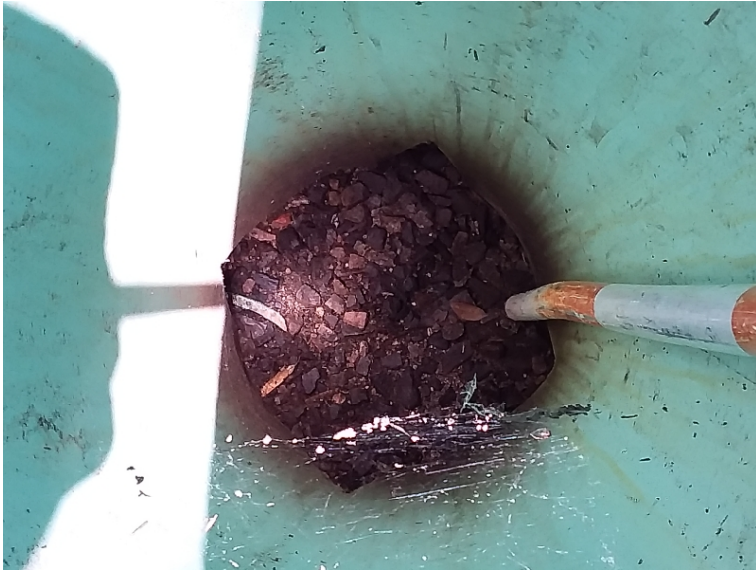
BMP 38- minimal sediment and gravel found in maintenance port

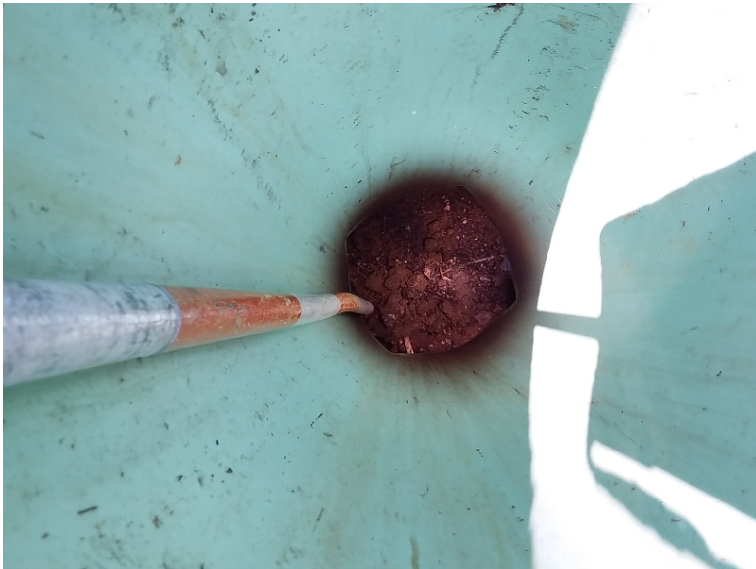
BMP 39- minimal sediment and gravel found in maintenance port

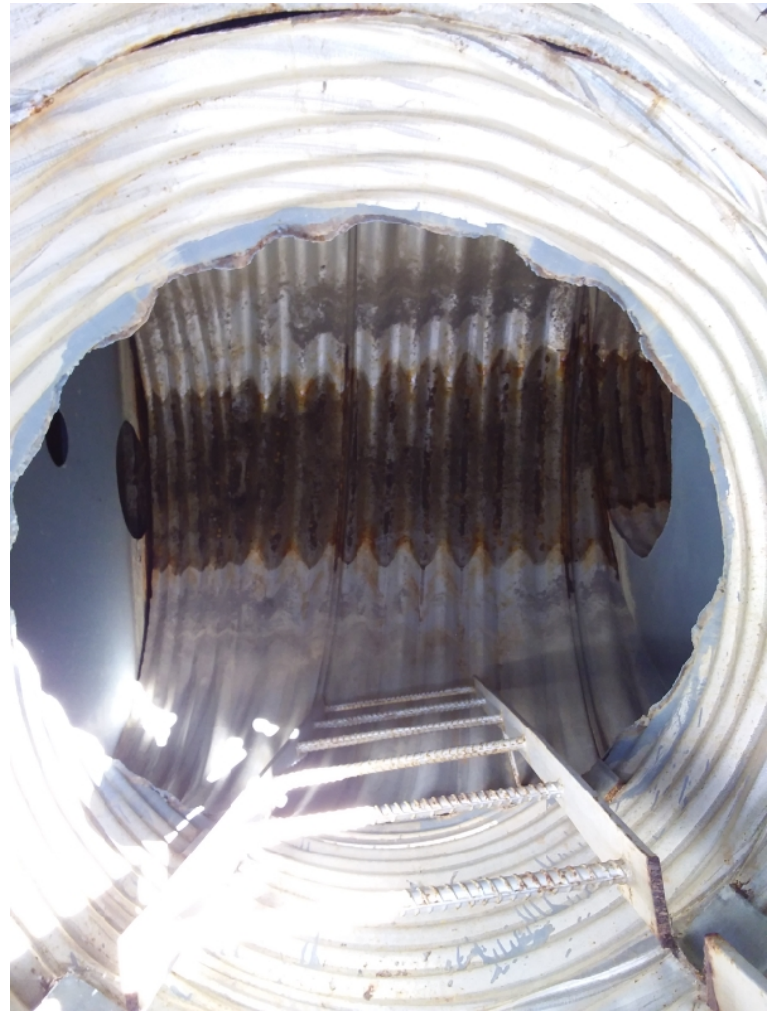
BMP 50- low flow orifice is clear

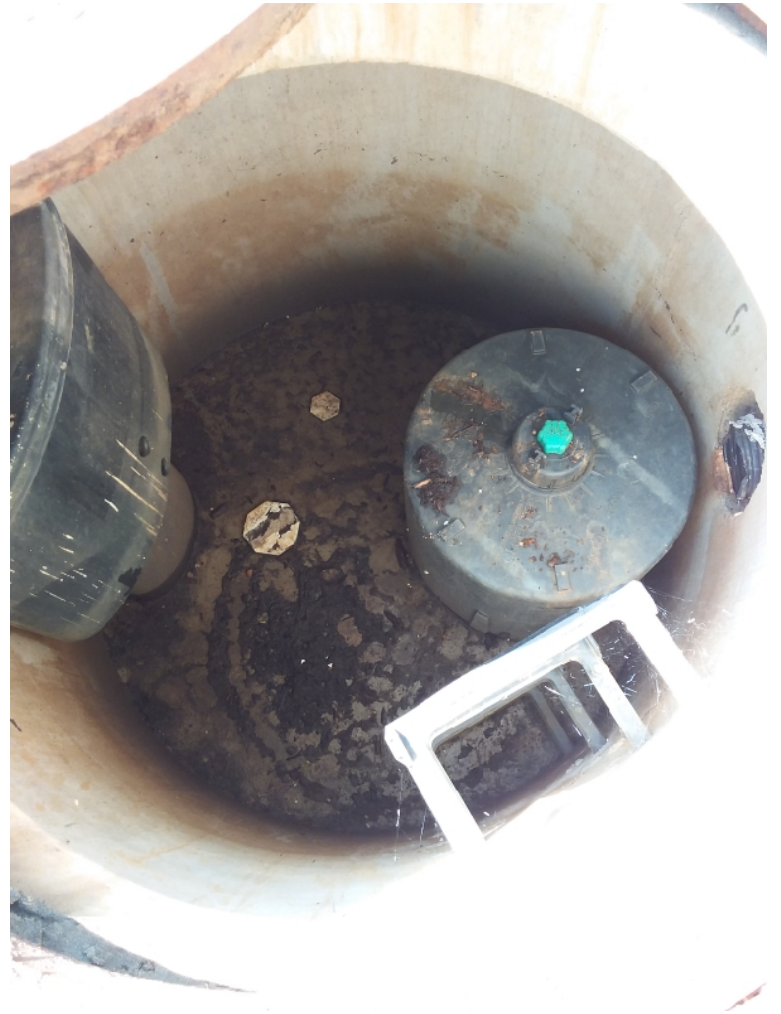
BMP 35: minimal sediment

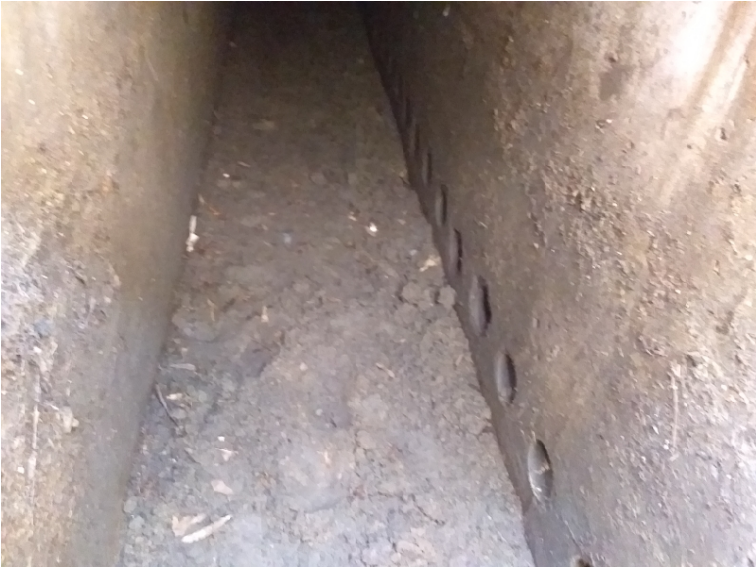
BMP 31: sand filter side- no sediment noted

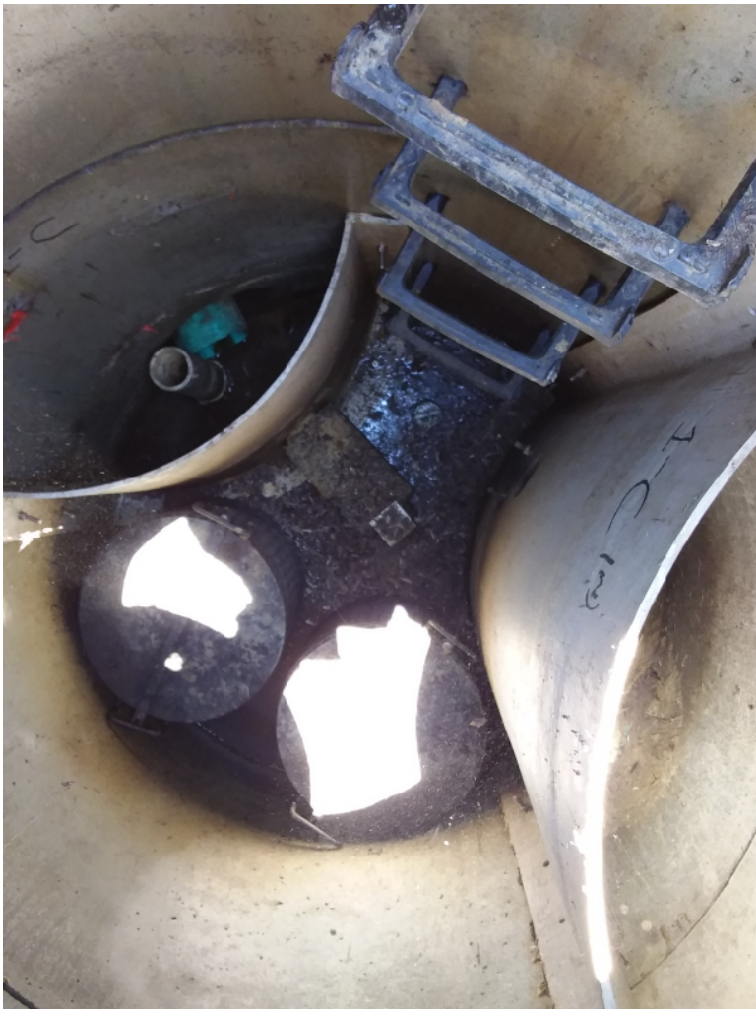
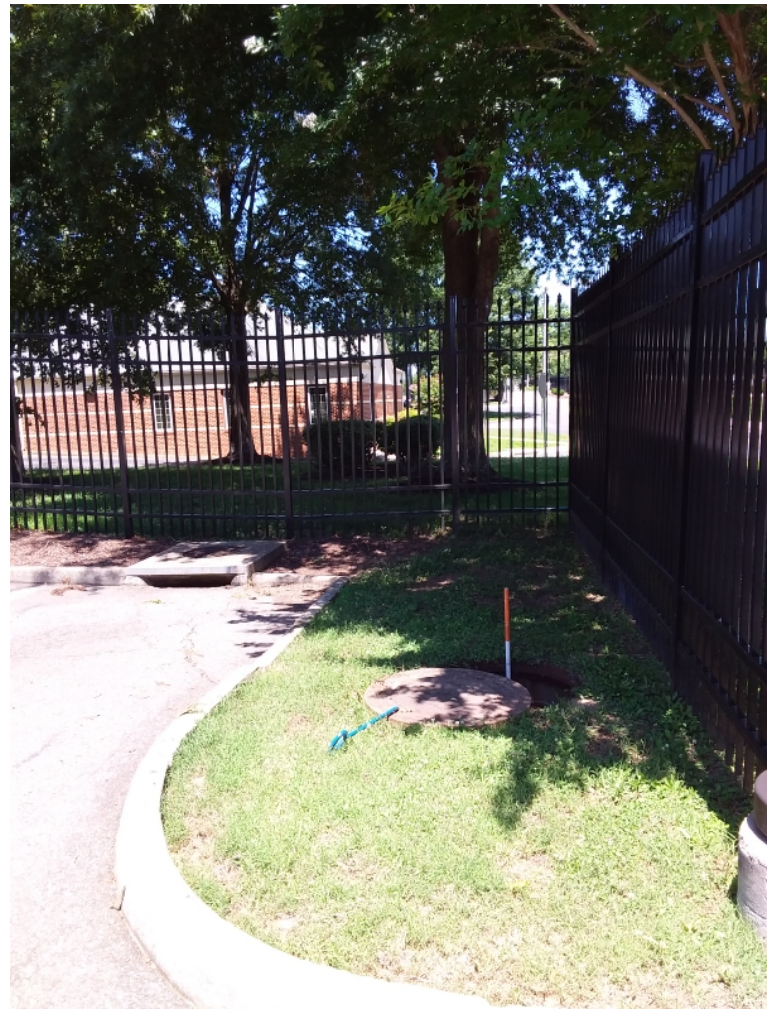
BMP 33- recycle trash can was sitting on top of lid and had to be uncovered with 2" of mulch on top of entire manhole lid

BMP 33- some mulch and other debris found
