Virginia State University
MS-4 Permit: VAR040119
July 1, 2023 - June 30, 2024 Annual Report

Prepared for
Virginia State University
Capital Outlay & Facilities Management
PO Box 9414
Virginia State University, VA 23806

October 1, 2024

Prepared by: Timmons Group
1001 Boulders Parkway, Suite 300
Richmond, VA 23225
(804) 200-6500

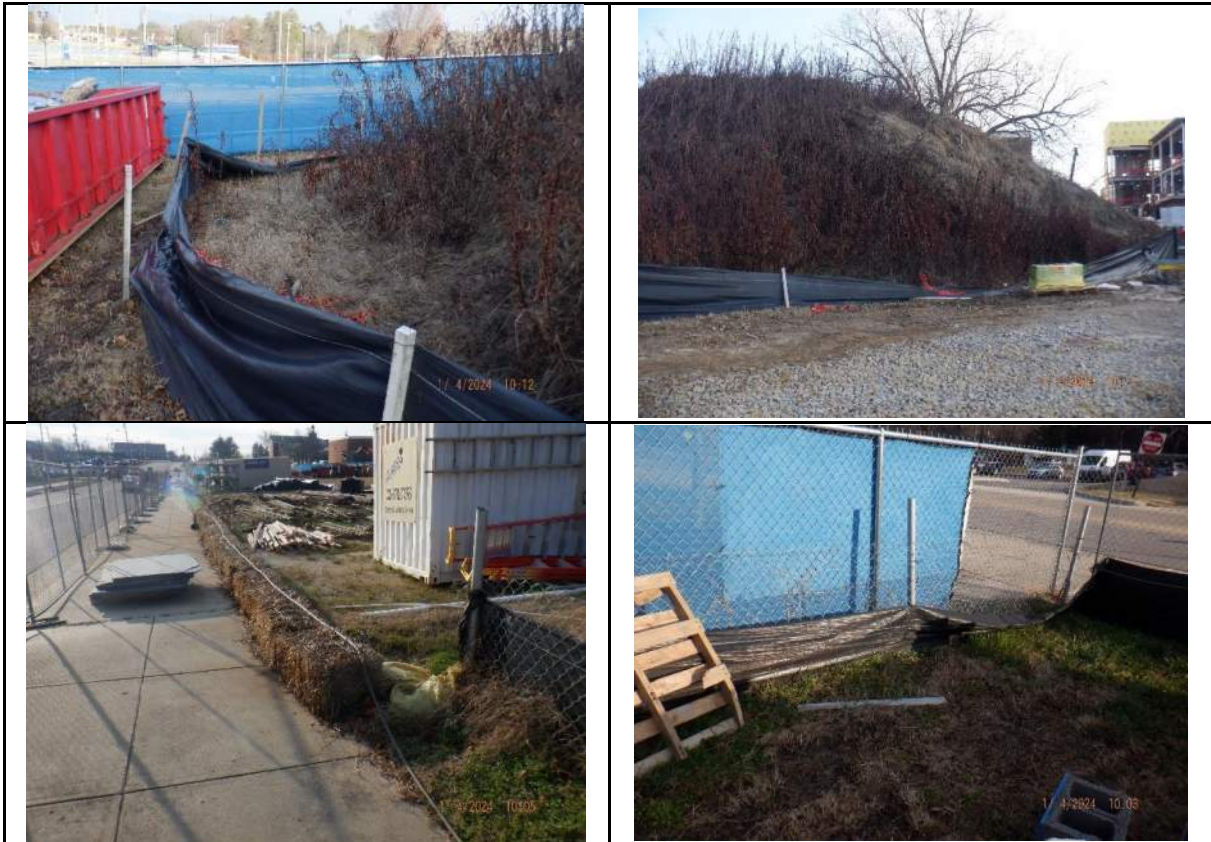
Soil stockpile referenced in item #3 is located east of the northern site entrance, along College Avenue. Stability has improved due to vegetative growth, but replacement of silt fence fabric is recommended.

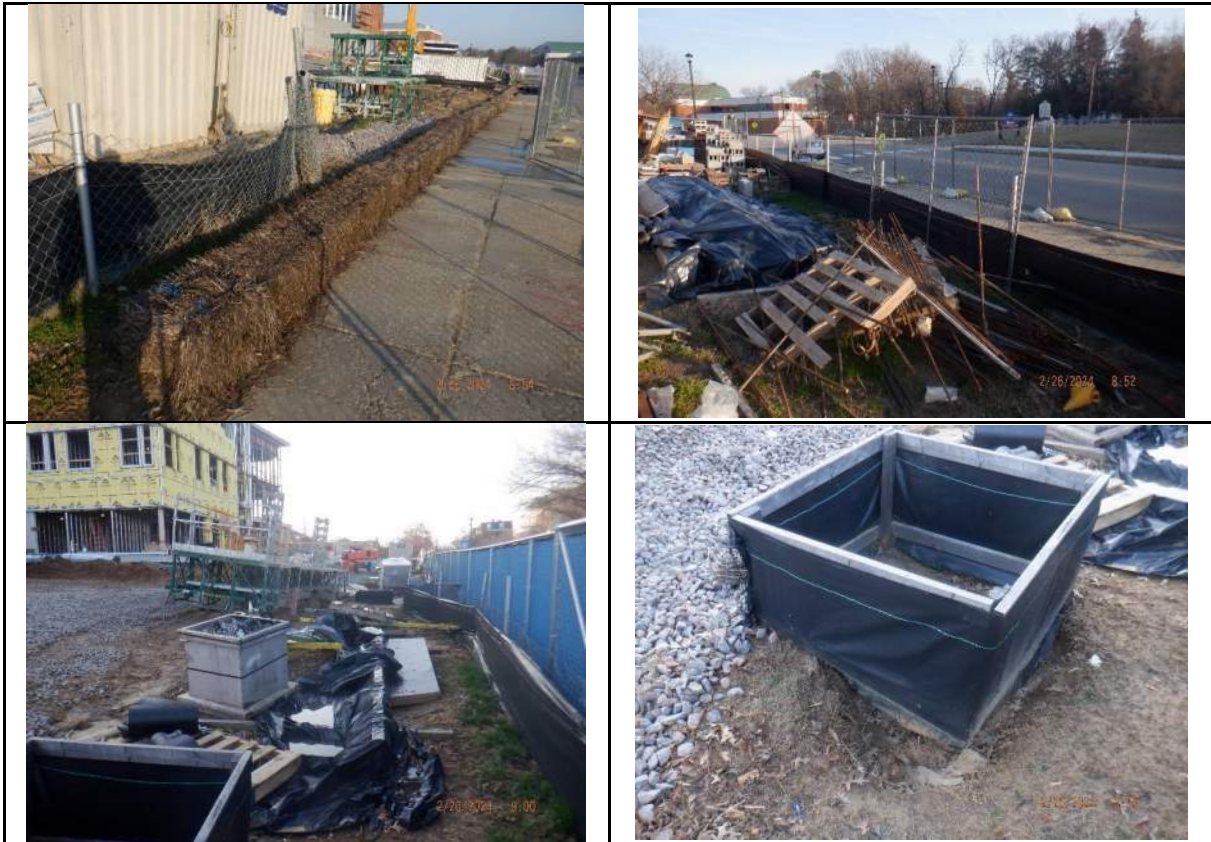
Inlet protection undercut near College Avenue north site entrance, stabilization and retrenching of silt fence fabric required. A picture is included above.

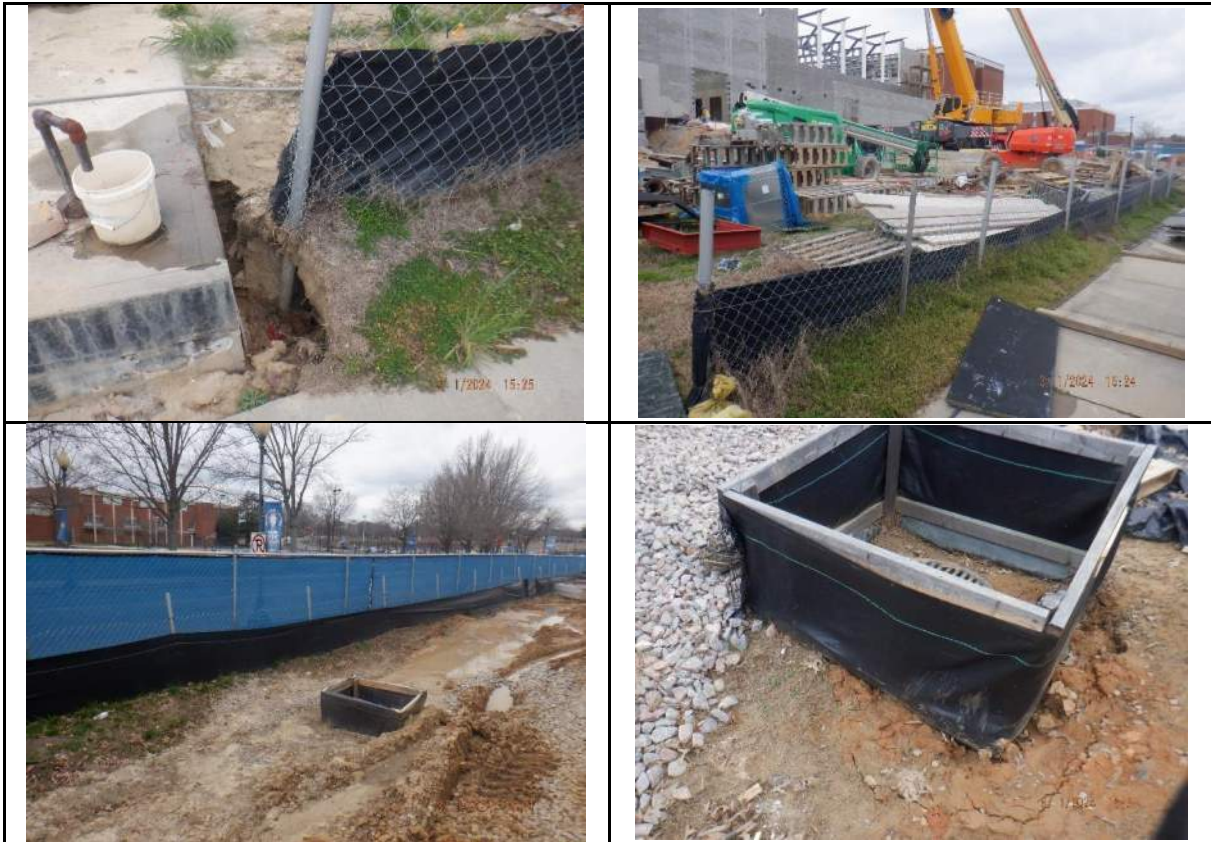
Erosion present north of a steam manhole along Carter G Woodson Avenue, undercutting nearby silt fence. Restabilization of the affected area required, a picture is included above.

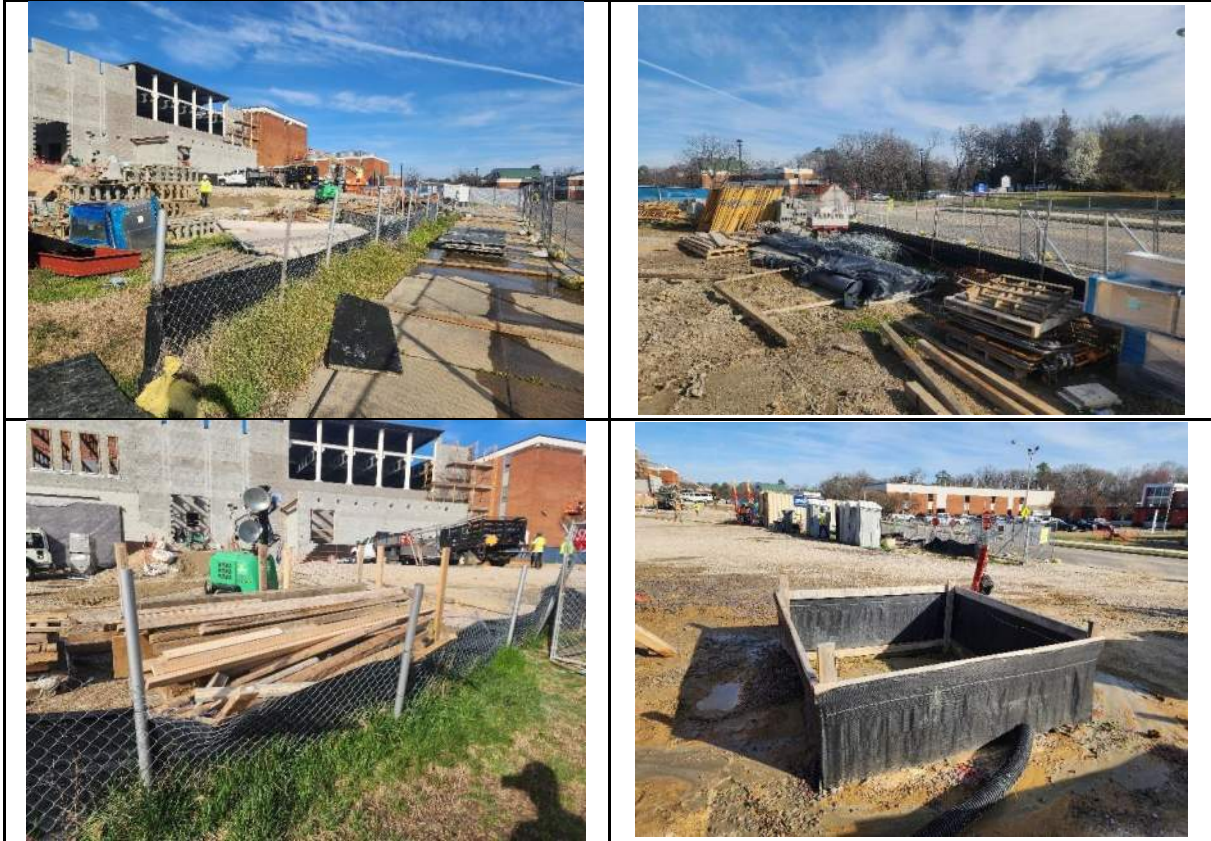
Silt fence along Carter G Woodson Avenue has been damaged by displaced wooden planks, bowing the fence outward and tearing fabric. Recommendations are to pull building materials away from perimeter controls and repair the affected segment of silt fence.

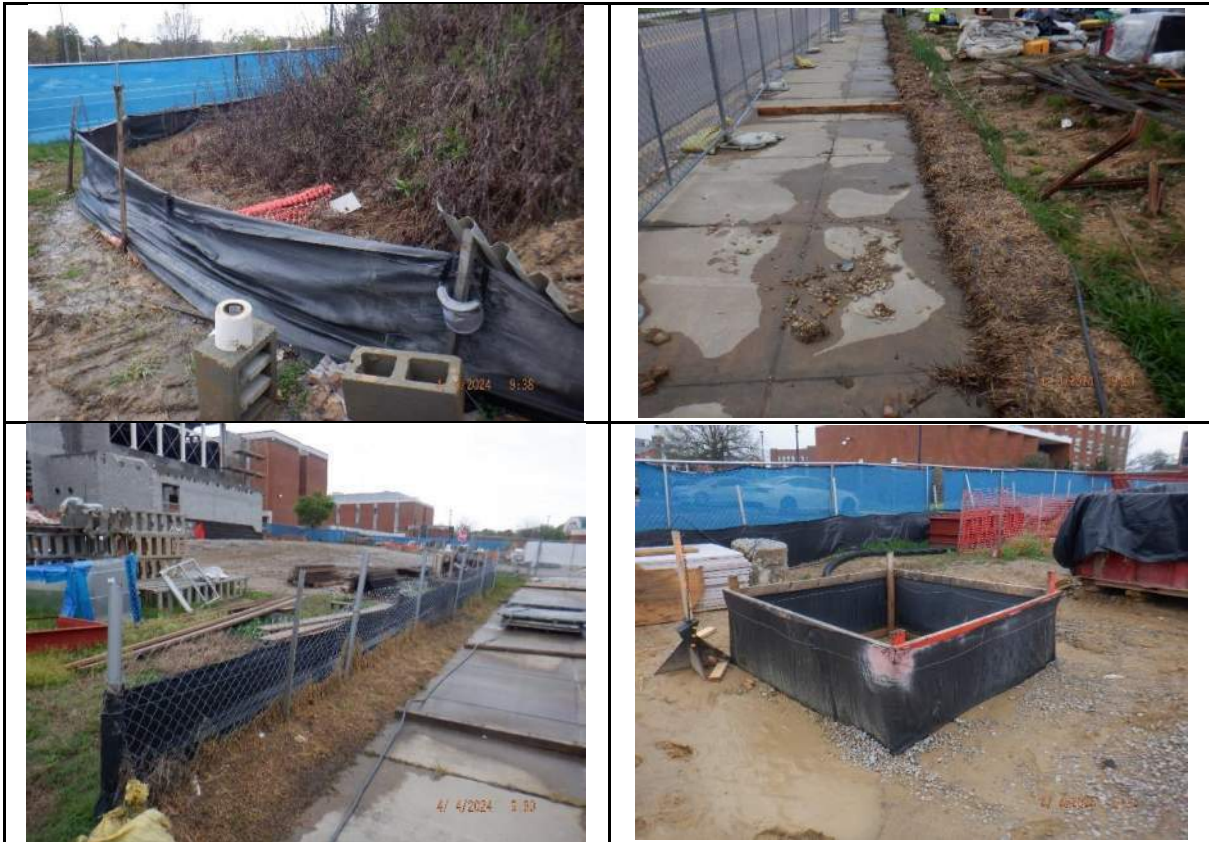
Silt fence fabric detached from stakes at northwest site entrance, along College Avenue. Fabric replacement required.

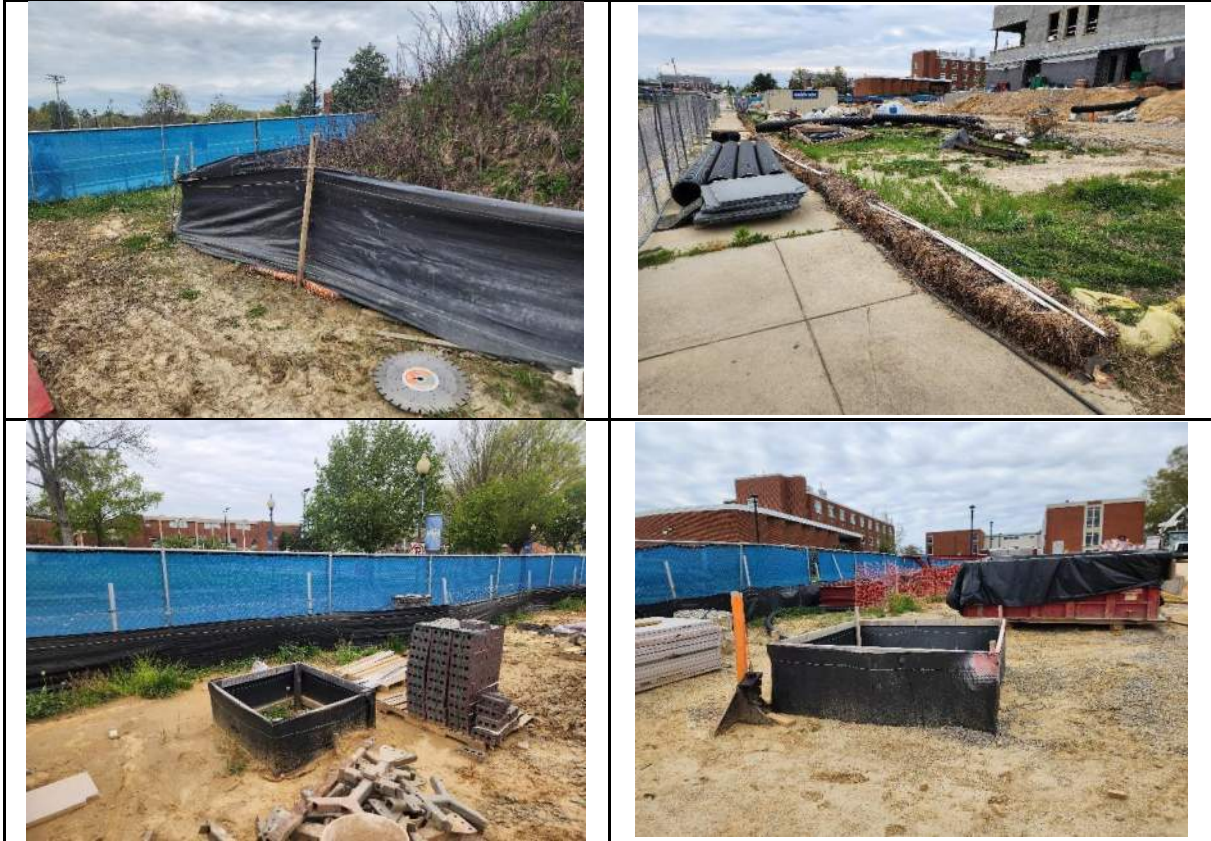
Silt fence fabric undercut around soil stockpile at northwest site entrance, along College Avenue. Retrenching of fabric required, removal of debris recommended.

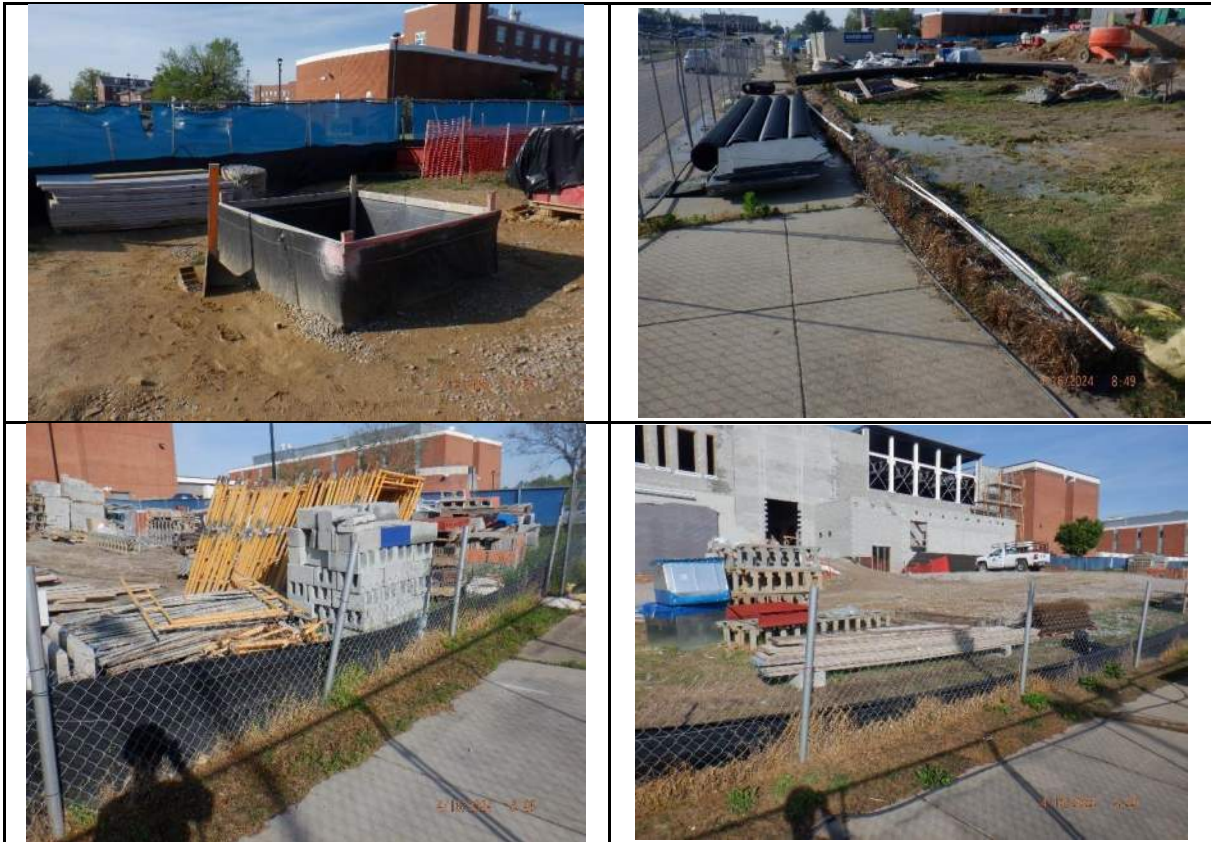
Item# 1: Straw bales flattened along Carter G Woodson Avenue, recommend avoiding placement of materials on top of bales. Replacement required to improve perimeter control effectiveness.
