Virginia State University
MS-4 Permit: VAR040119
July 1, 2019 - June 30, 2020 Annual Report

Prepared for
Virginia State University
Capital Outlay & Facilities Management
PO Box 9414
Virginia State University, VA 23806

September 21, 2020

Prepared by: Timmons Group
1001 Boulders Parkway, Suite 300
Richmond, VA 23225
(804) 200-6500

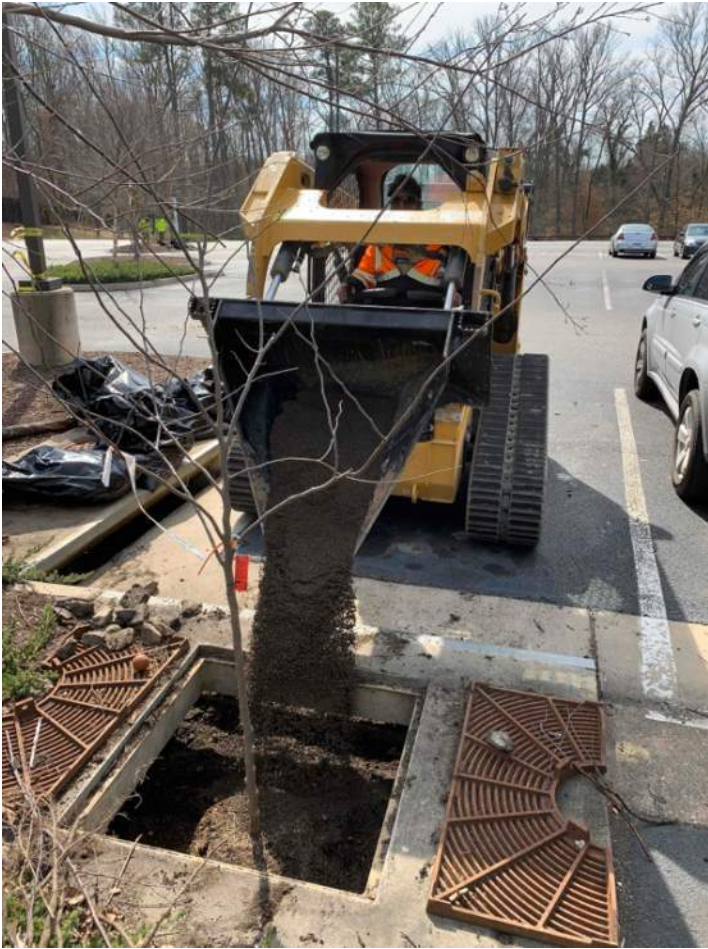
Unit 7 tree removal

Unit 7 media replacement

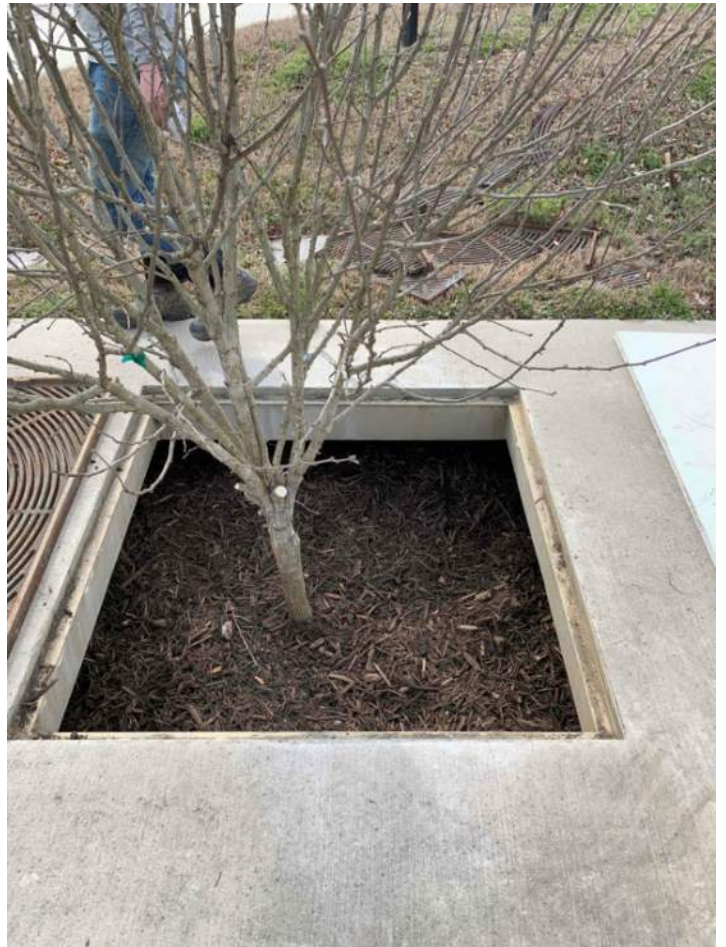
Unit 42 after - one side of grate is missing and has a board as a temporary replacement

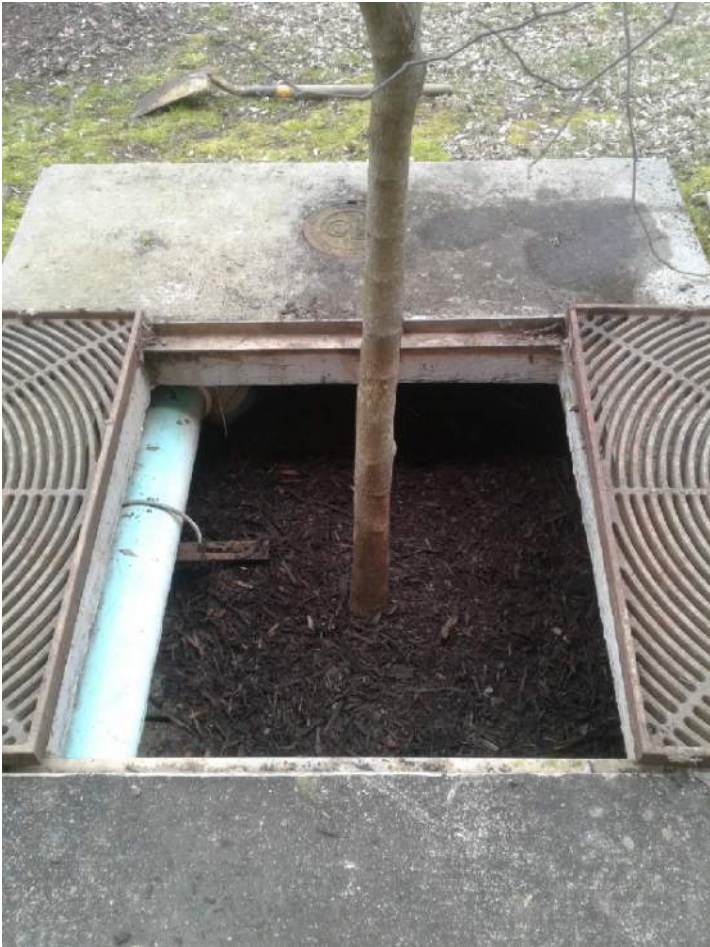
Unit 19 tree replaced and unit maintenance complete. Added media to replace lost during tree replacement.

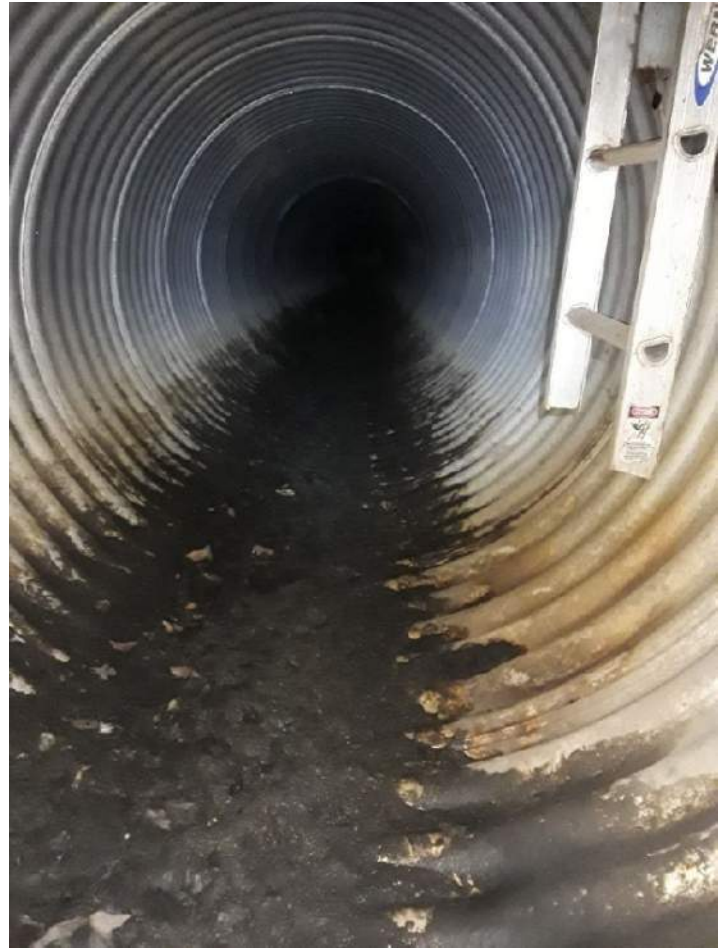
CMP 15 before

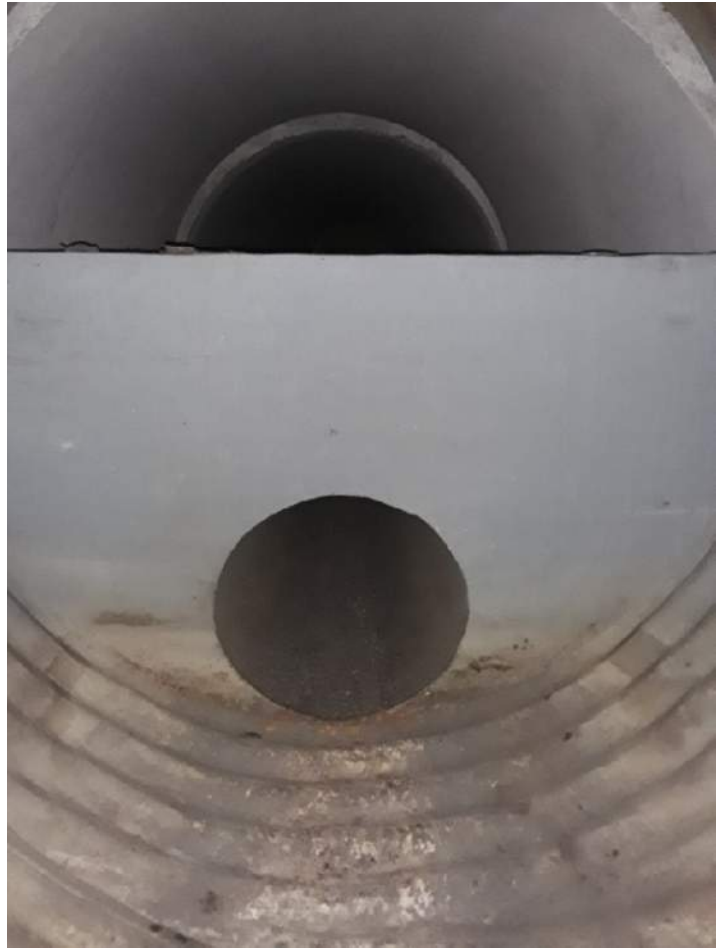
CMP 15 after. Removed 800 gal

CMP 15 low flow is clear.

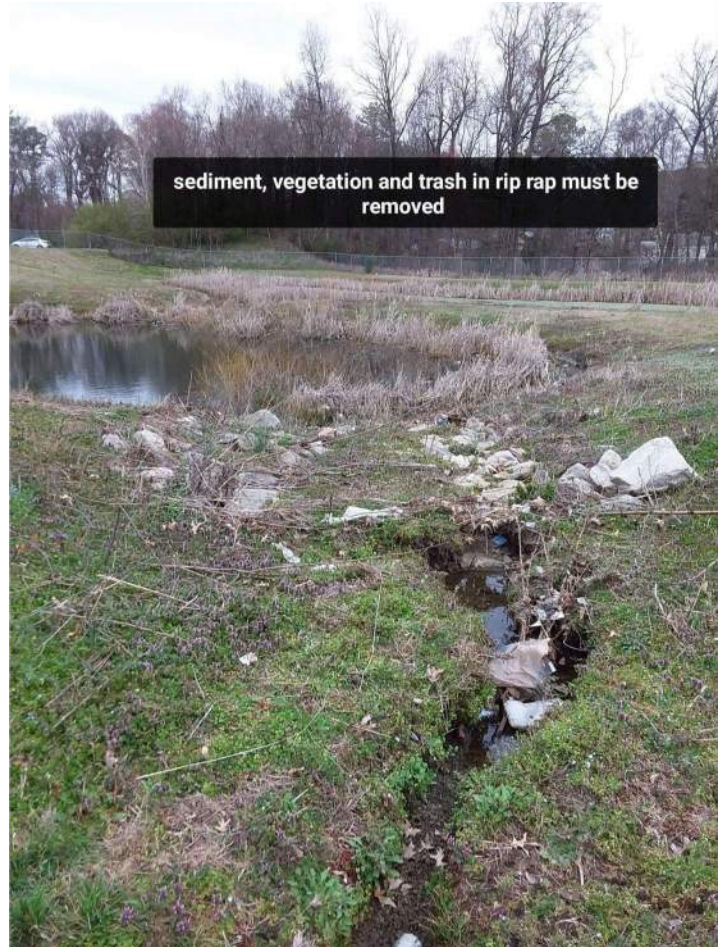
BMP 30

close up of erosion before rip rap channel inlet

sediment, vegetation and trash in rip rap must be removed

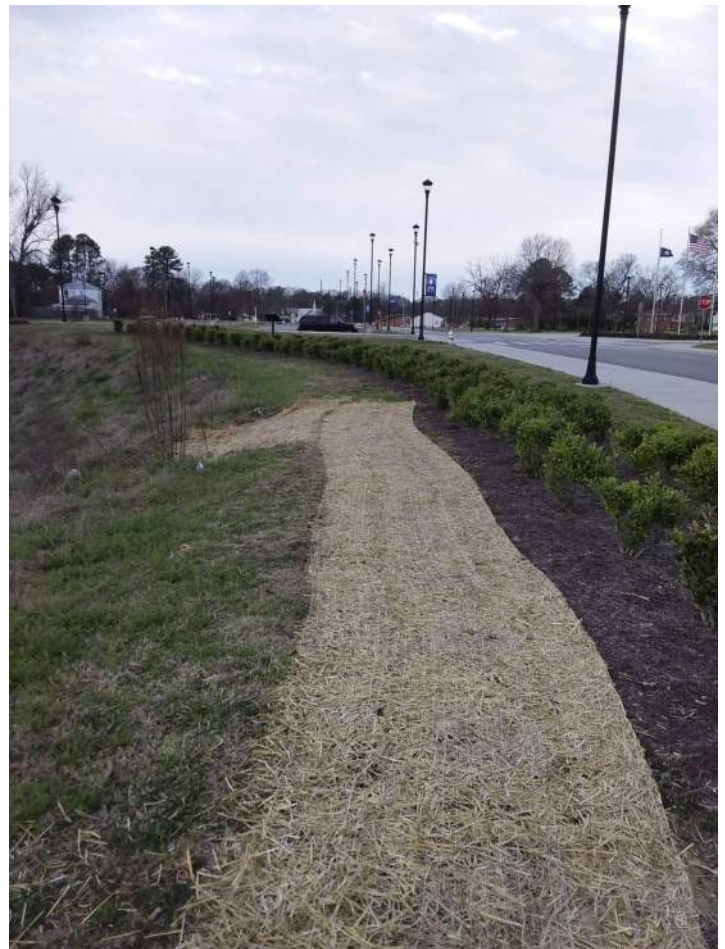
BMP 46: Erosion on the top of embankment repaired and then seed and straw matting was installed.

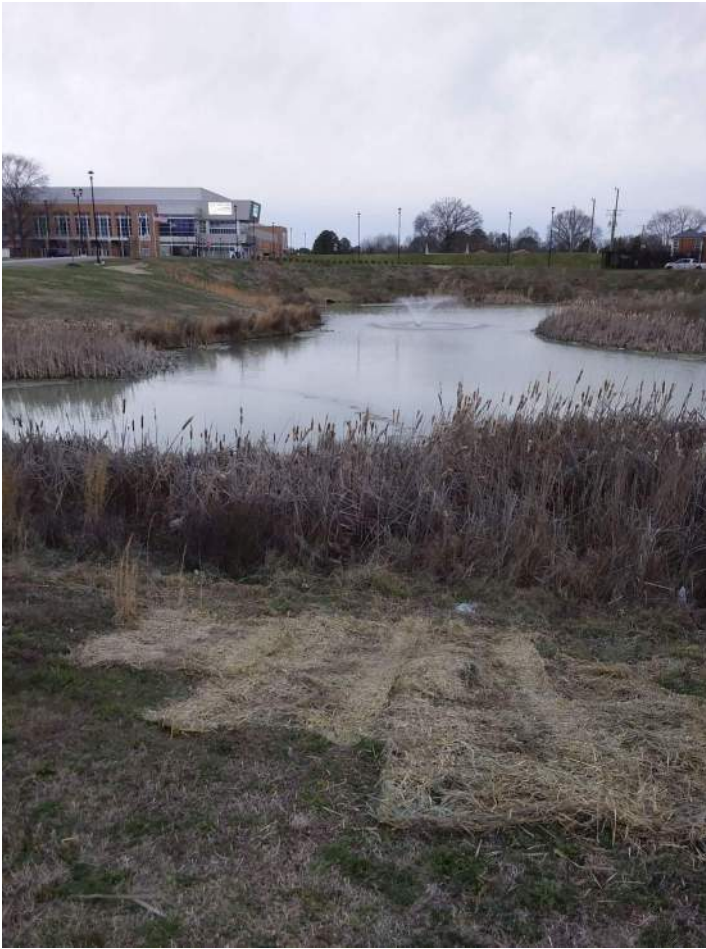
BMP 46: Bank erosion repaired with topsoil and seed and straw matting

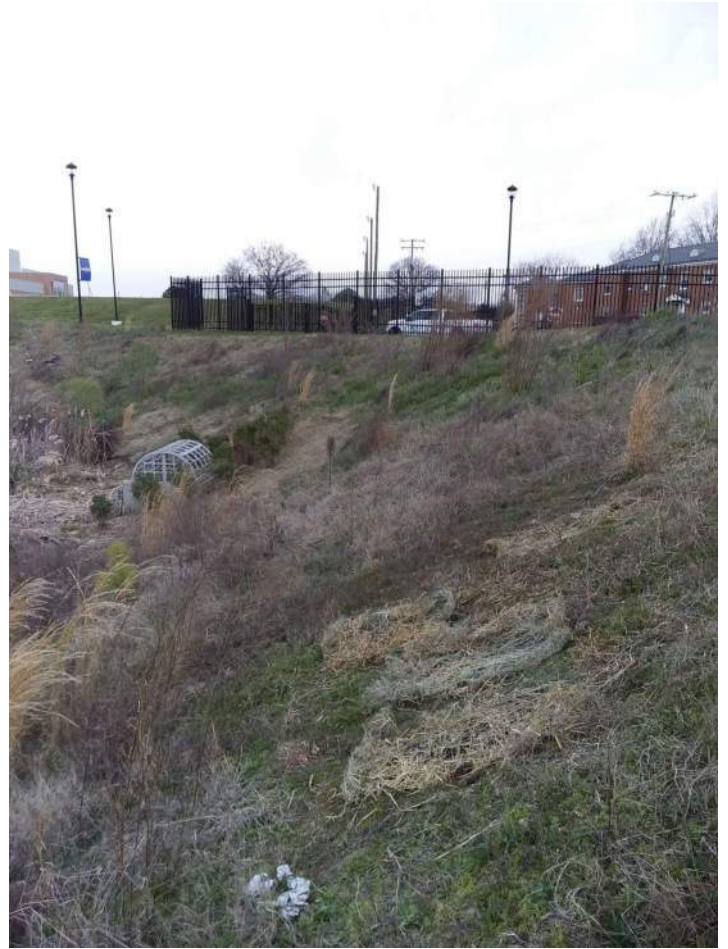
BMP 46: Small spots of erosion on side slopes near outfall structure were repaired with topsoil and then seed and straw matting was installed.

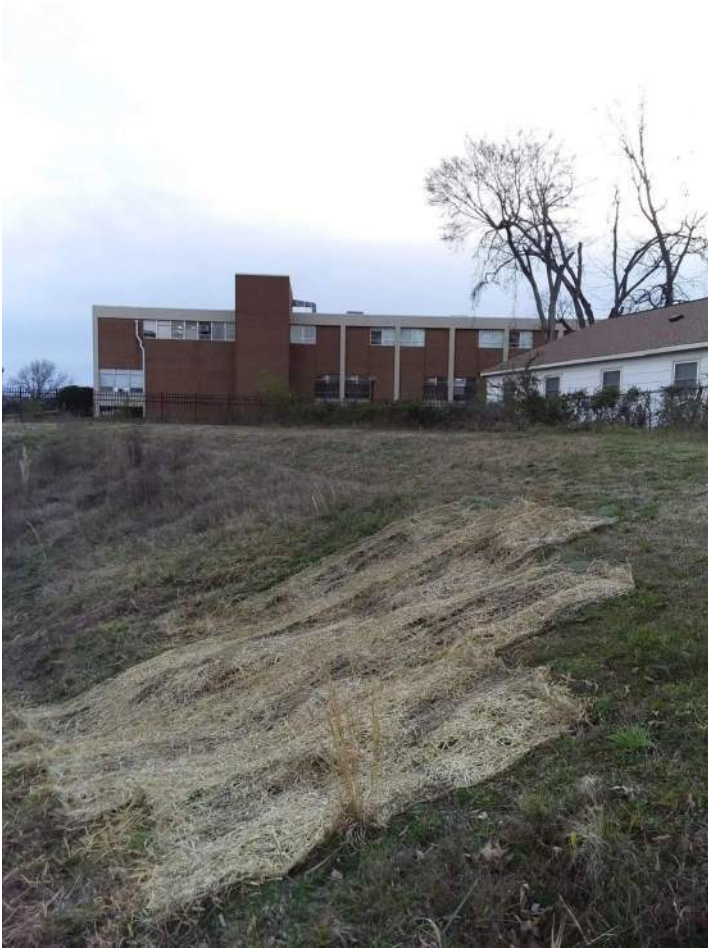
BMP 46: Different angle of the same repaired section.

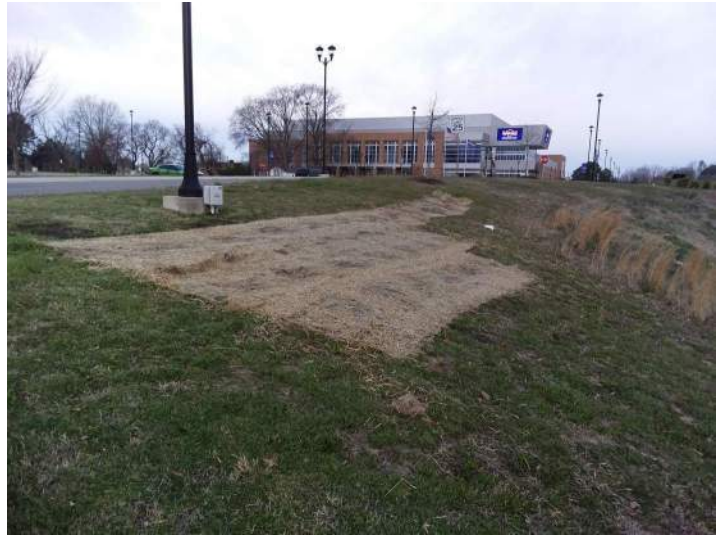
BMP 46: Side slope and top of embankment eroded area was repaired and stabilized properly.

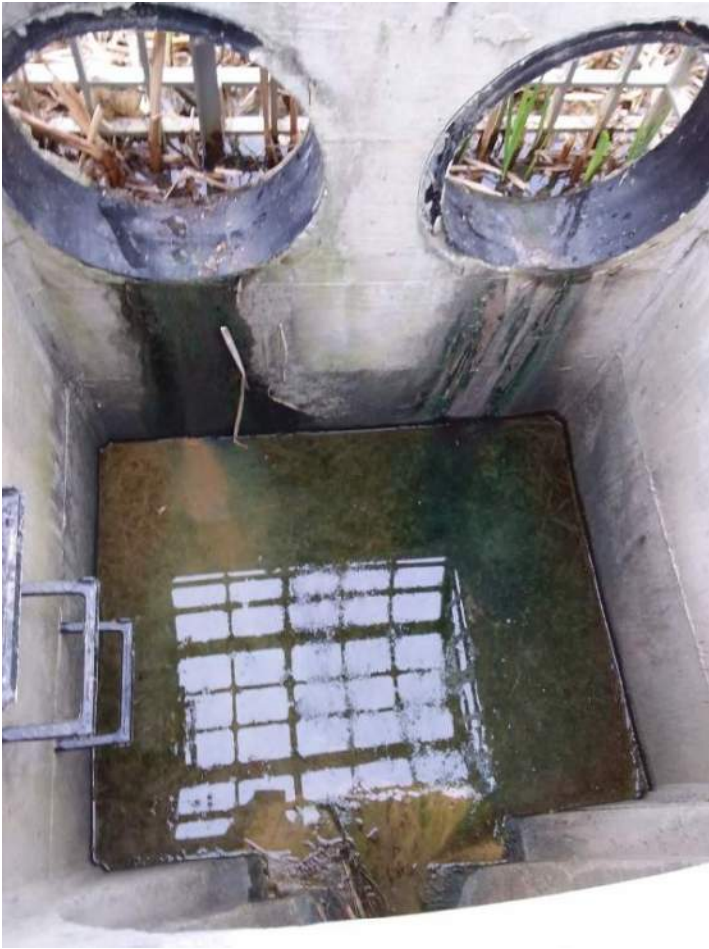
BMP 46: outfall structure with trash rack
