Virginia State University
MS-4 Permit: VAR040119
July 1, 2020 - June 30, 2021 Annual Report

Prepared for
Virginia State University
Capital Outlay & Facilities Management
PO Box 9414
Virginia State University, VA 23806

October 1, 2021

Prepared by: Timmons Group
1001 Boulders Parkway, Suite 300
Richmond, VA 23225
(804) 200-6500

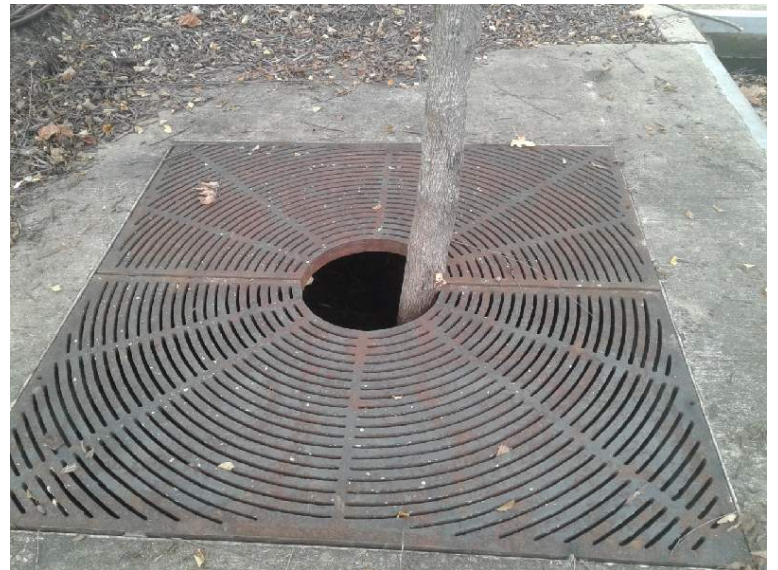
8: tree is growing over grate

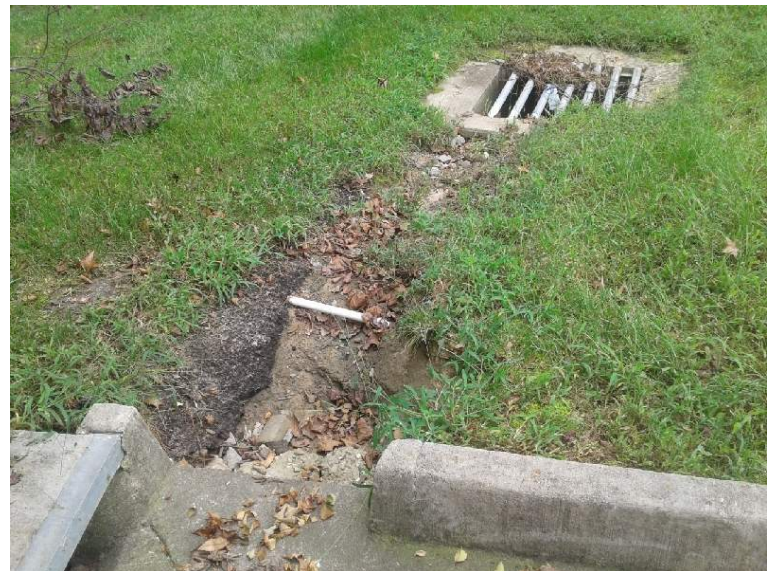
Unit 10: Major erosion to right of unit 10

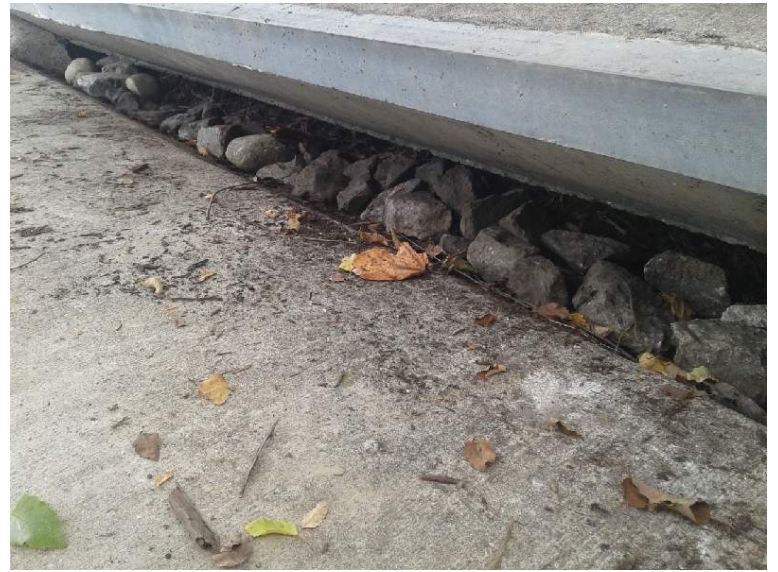
Unit 12: After, 2 rows of inlet stones installed

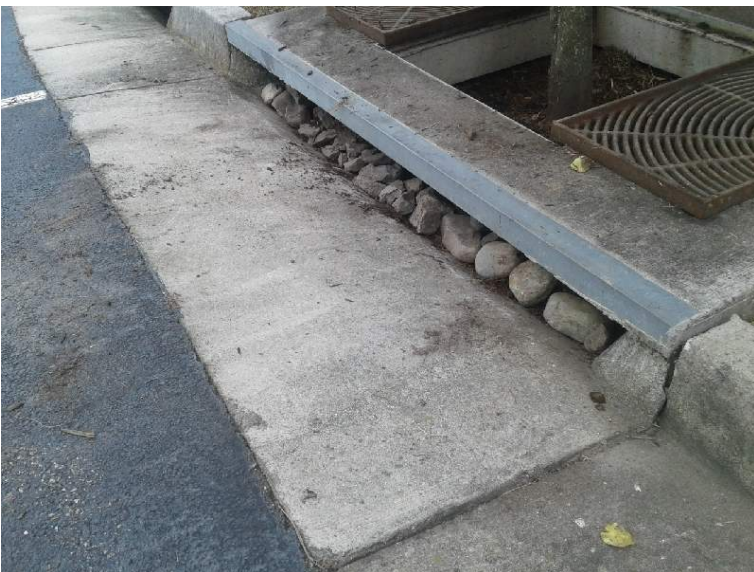
Unit 13: After 2 rows of inlet stones installed.

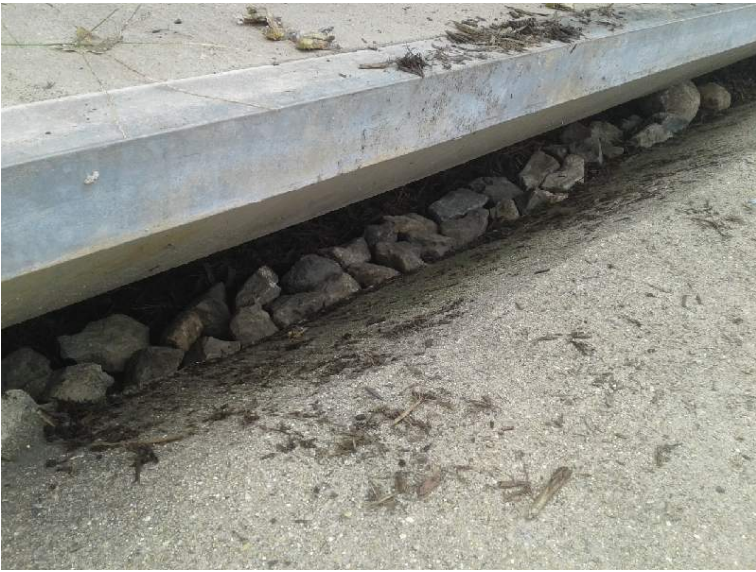
Unit 41: after 2 rows of inlet stones installed

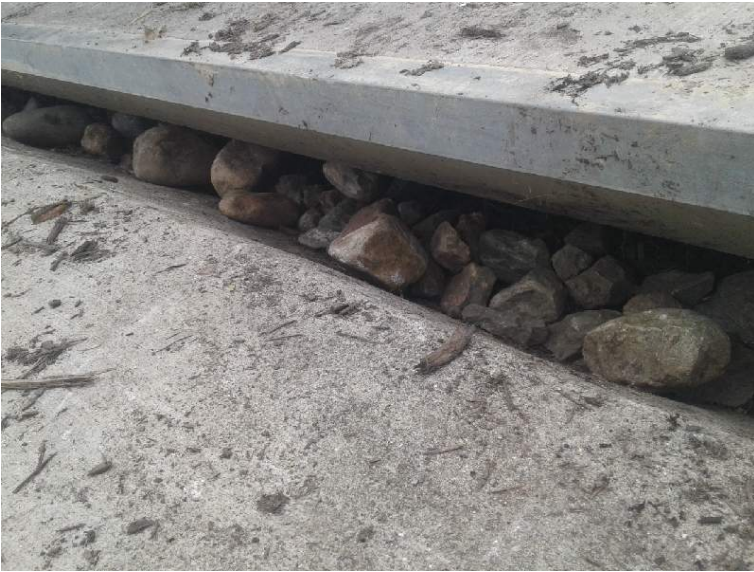
Unit 42: after 2 rows of inlet stones installed

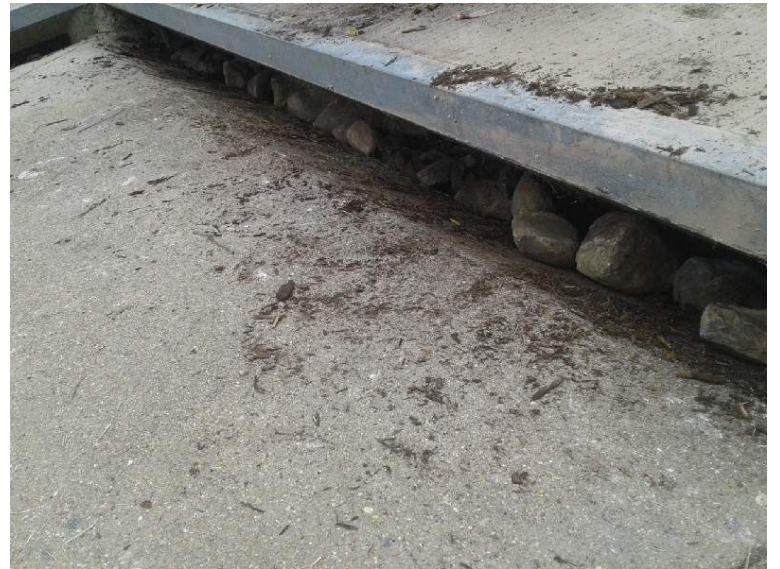
Unit 43: After 2 rows inlet stones installed

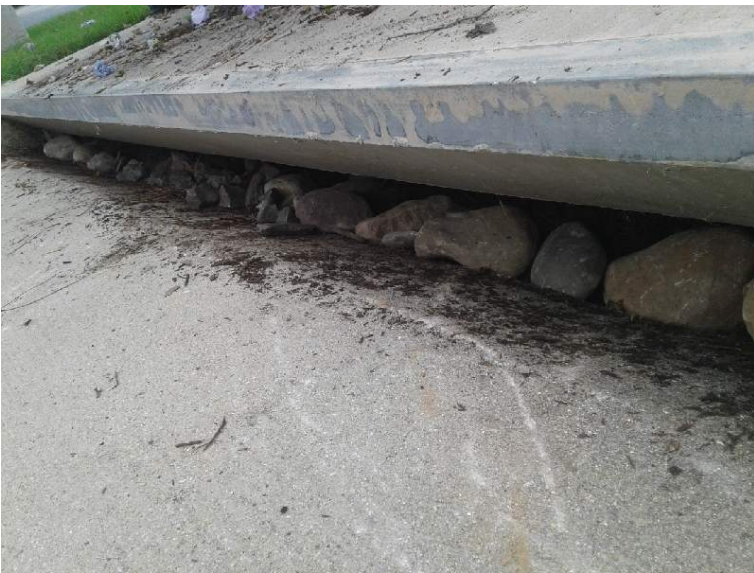
Unit 44: after 2 rows inlet stones installed

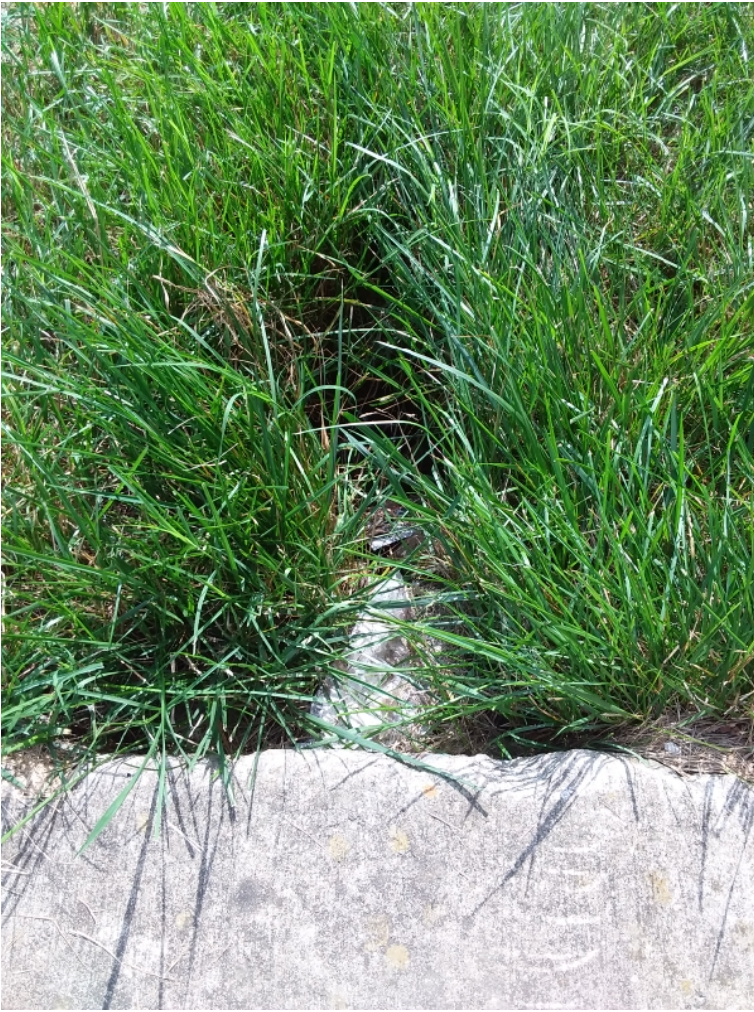
Noticed erosion and washout located SW of BMP 43

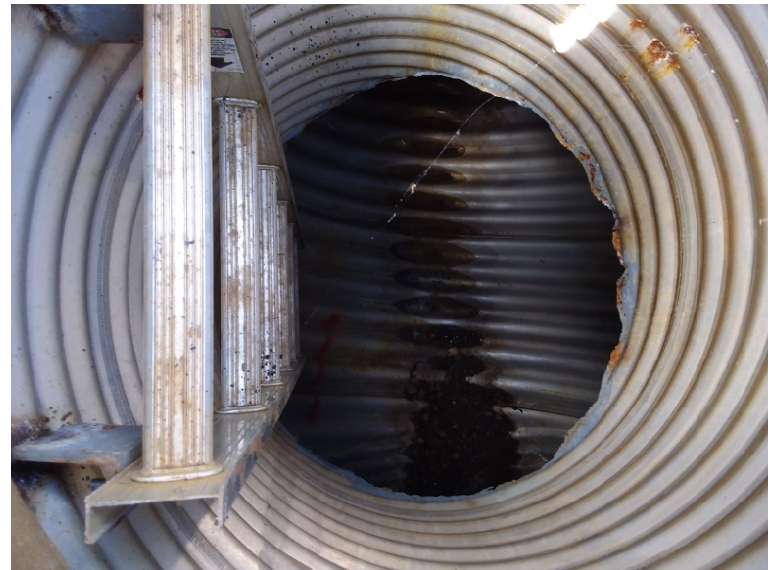
BMP 15: hardly any sediment at this access point

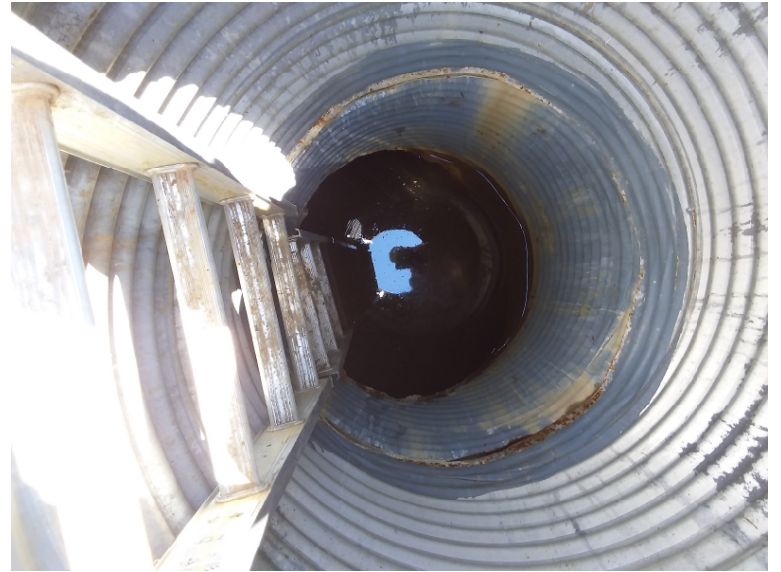
BMP 24: 7' of water standing inside- minimal sediment

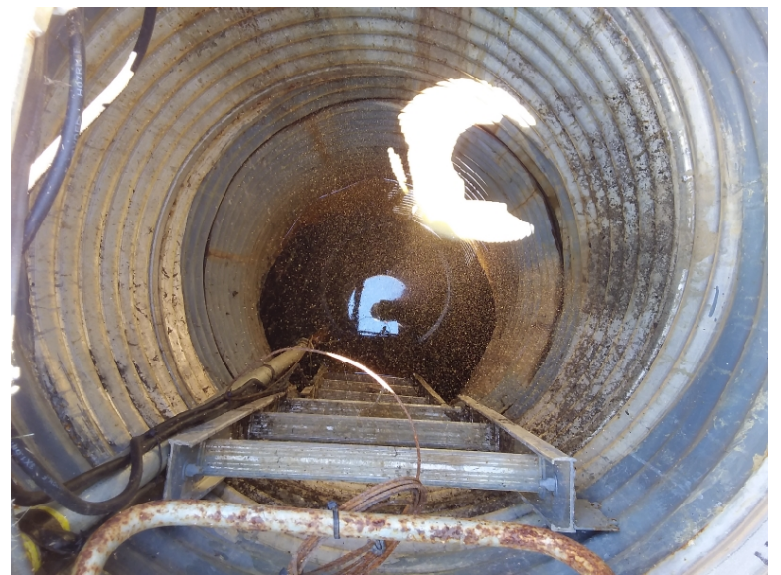
BMP 24: 7' of water and minimal sediment

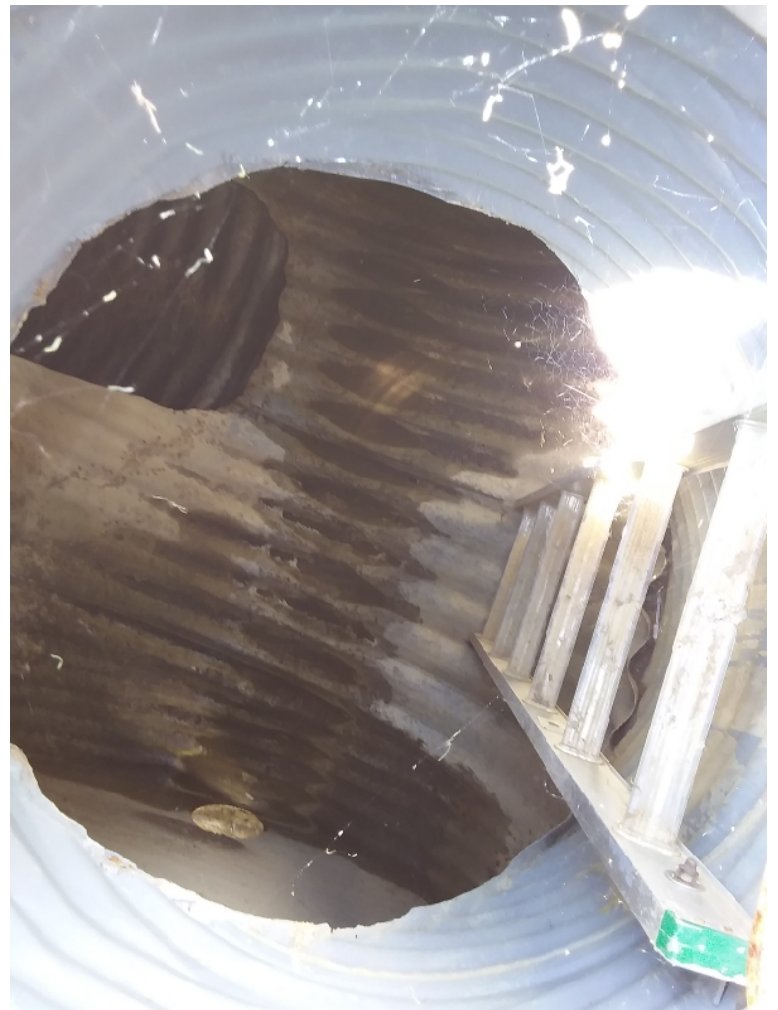
BMP 26: no significant sediment, trash or debris

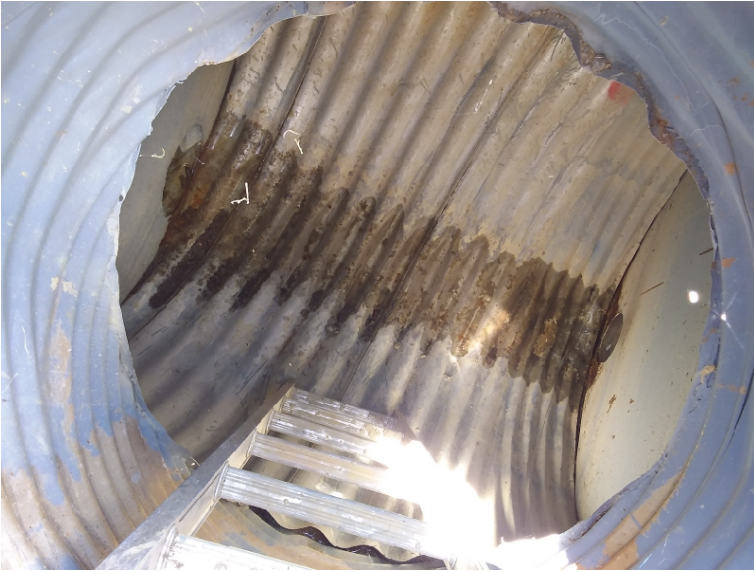
BMP 26: no significant sediment, trash or debris

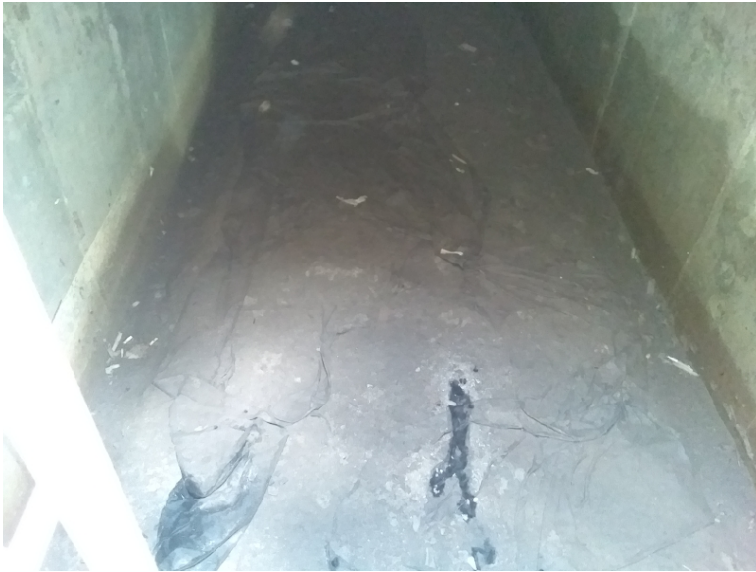
BMP 27- fabric needs to be re-positioned on sand filter side

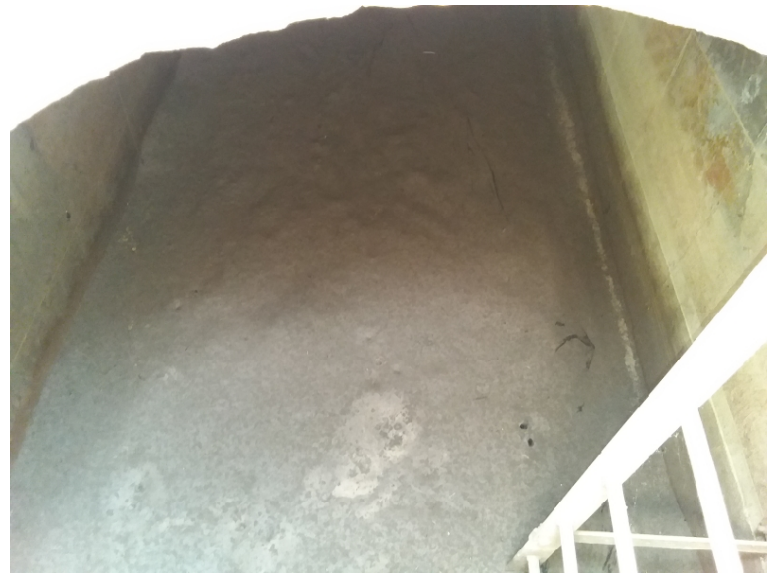
BMP 28- remove 3" of sediment accumulation from that is on top of fabric layer

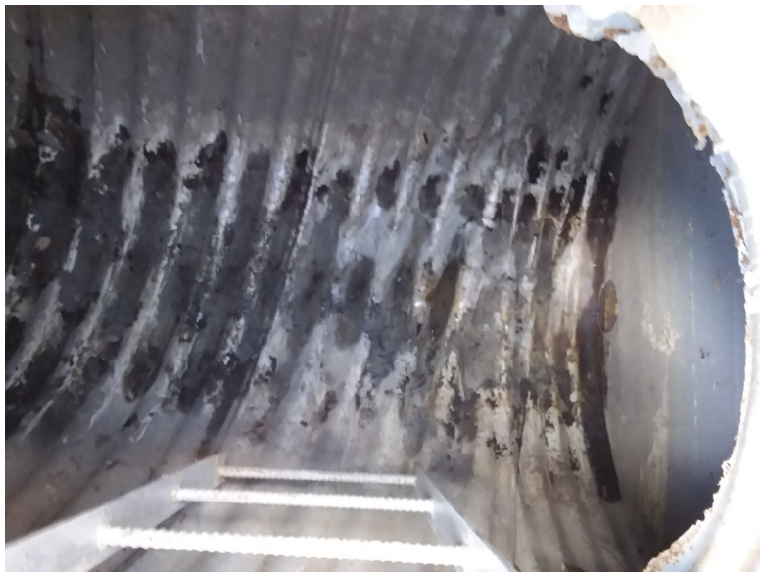
BMP 40- all floatables, debris, and sediment removed

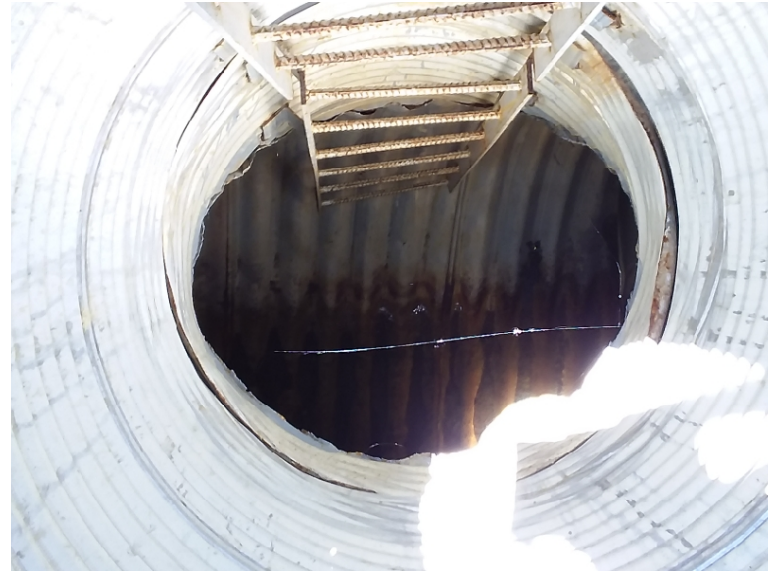
BMP 50- trace amounts of sediment

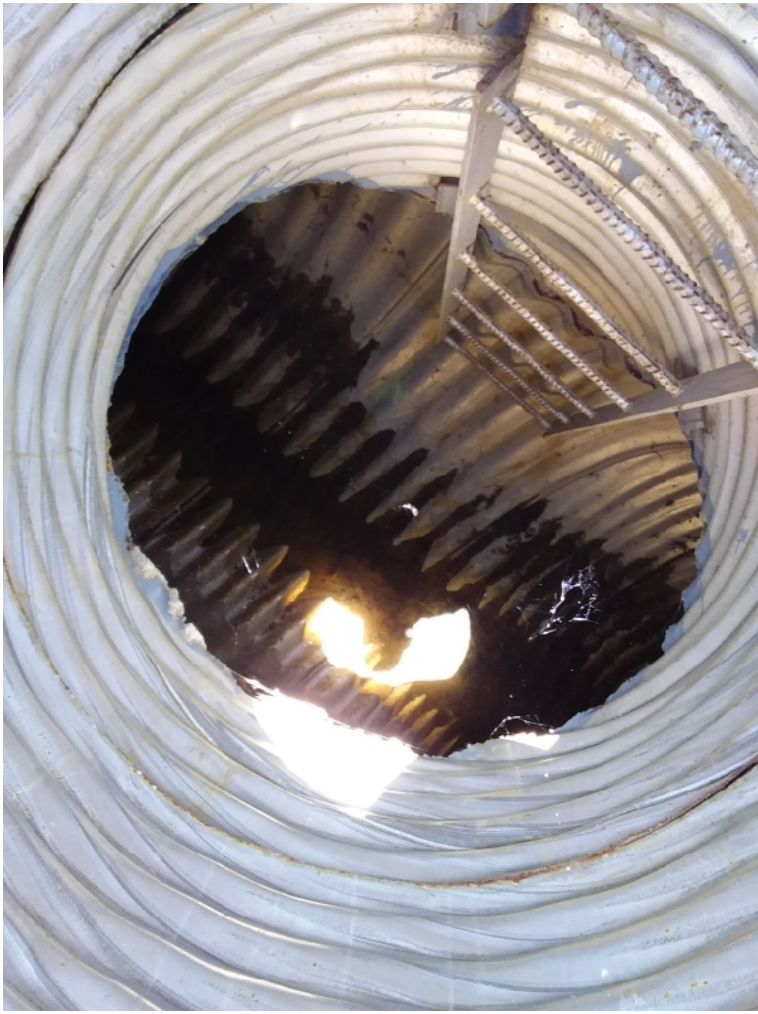
BMP 50- trace amounts of sediment

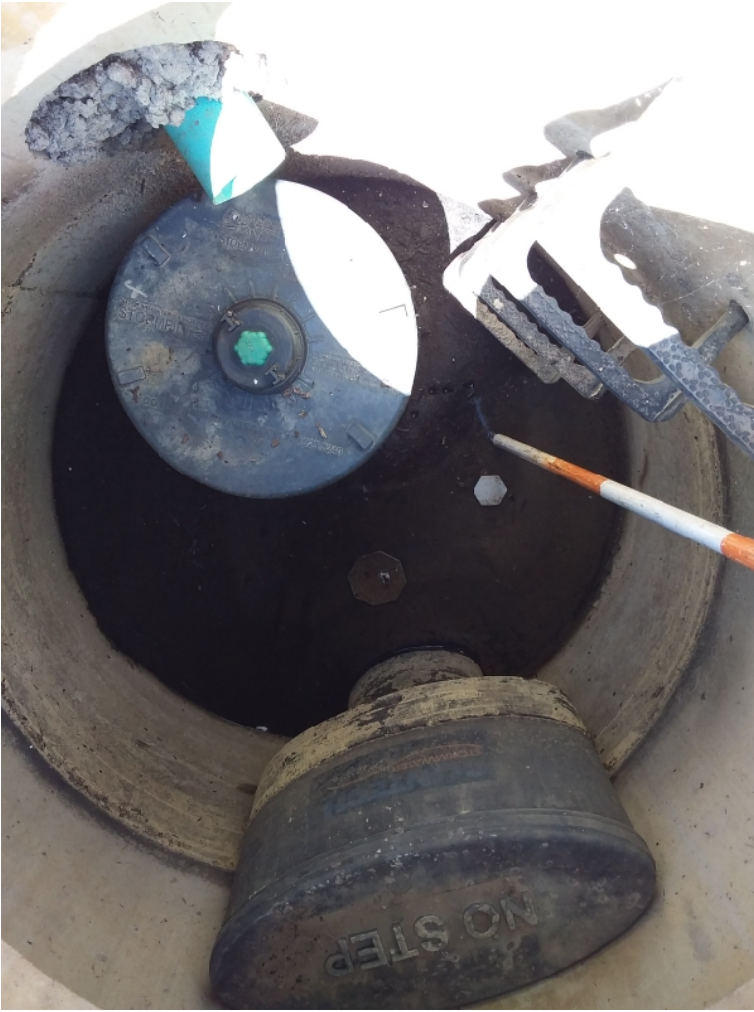
BMP 22- remove accumulated sediment for next maintenance visit

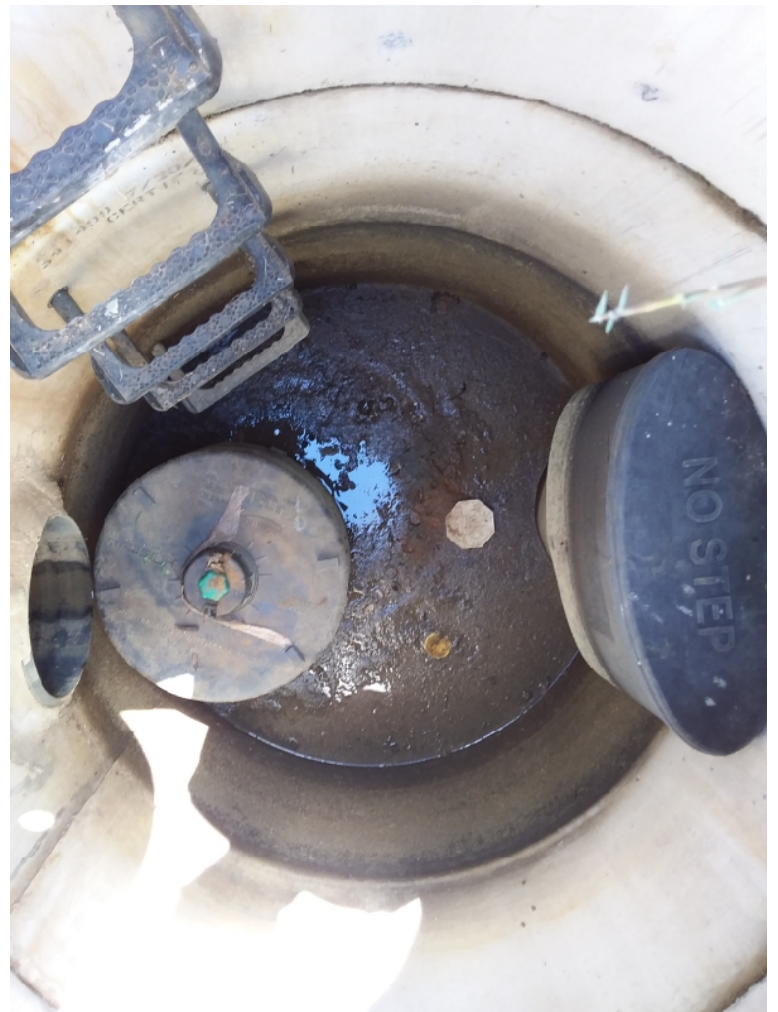
BMP 23: minimal sediment accumulation

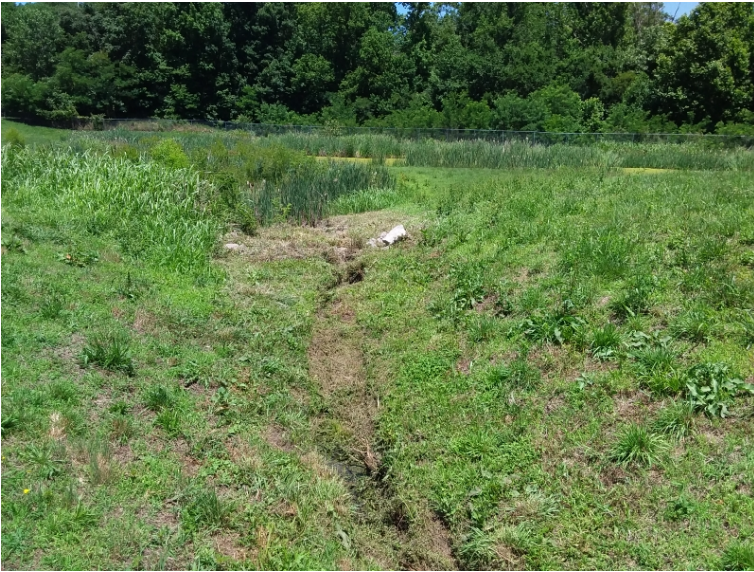
BMP 30- erosion occurring throughout inlet channel

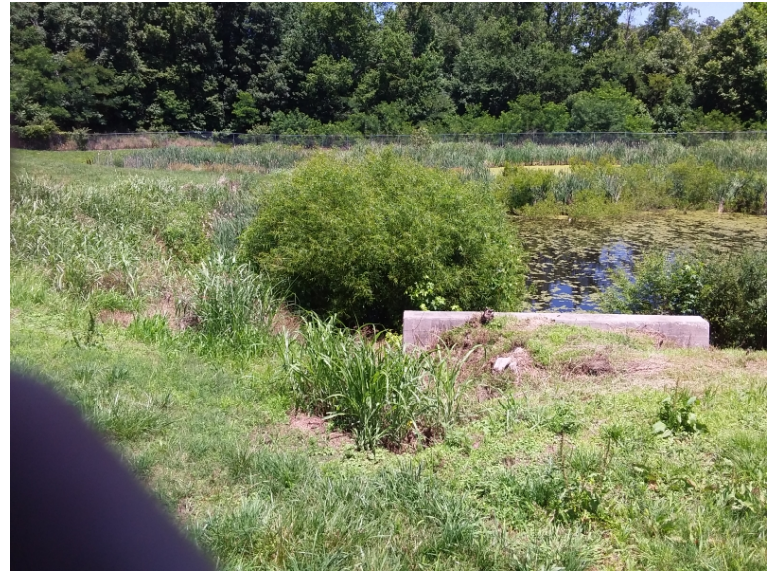
BMP 30- erosion occurring behind inlet structure and headwall that flows into forebay

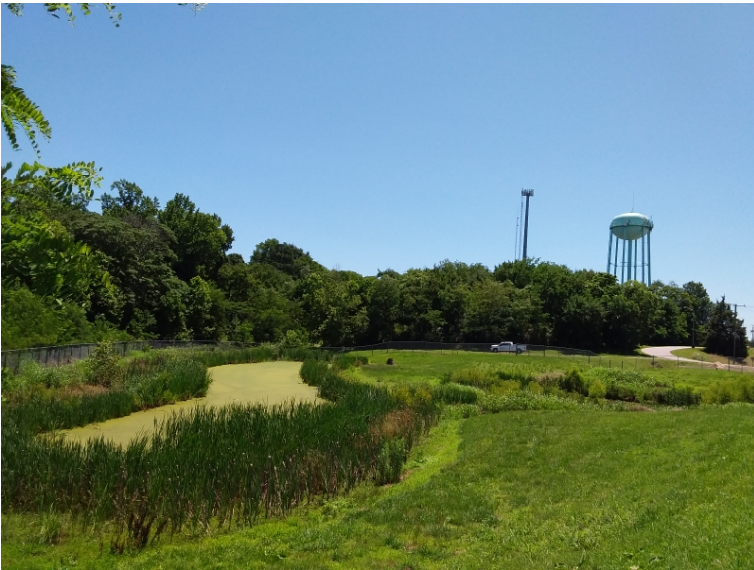
BMP 30- cattails along the aquatic bench surrounding the entire pond and duck weed has taken over the surface water

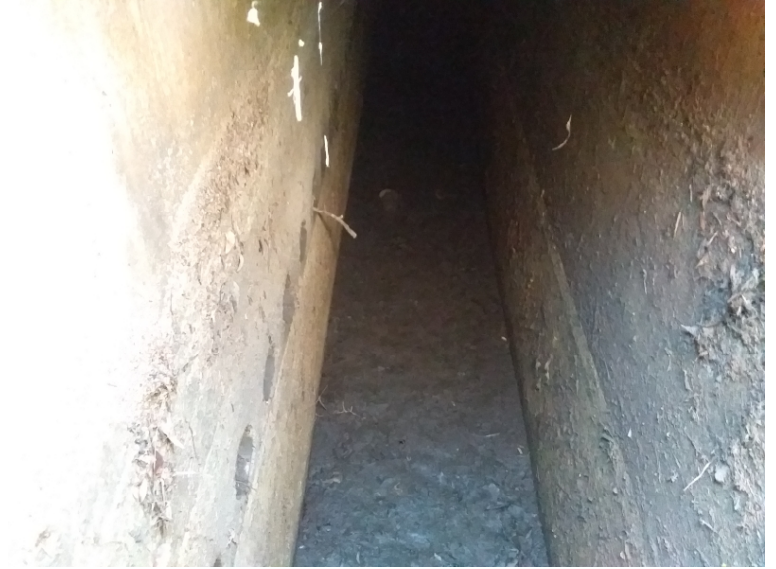
BMP 31: sediment chamber side- very little accumulation
