Virginia State University
MS-4 Permit: VAR040119
July 1, 2023 - June 30, 2024 Annual Report

Prepared for
Virginia State University
Capital Outlay & Facilities Management
PO Box 9414
Virginia State University, VA 23806

October 1, 2024

Prepared by: Timmons Group
1001 Boulders Parkway, Suite 300
Richmond, VA 23225
(804) 200-6500

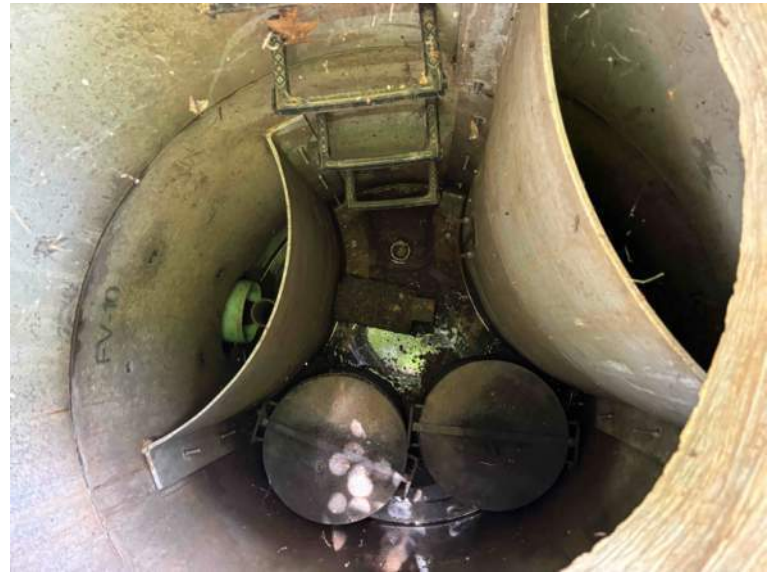
BMP 34- inside view

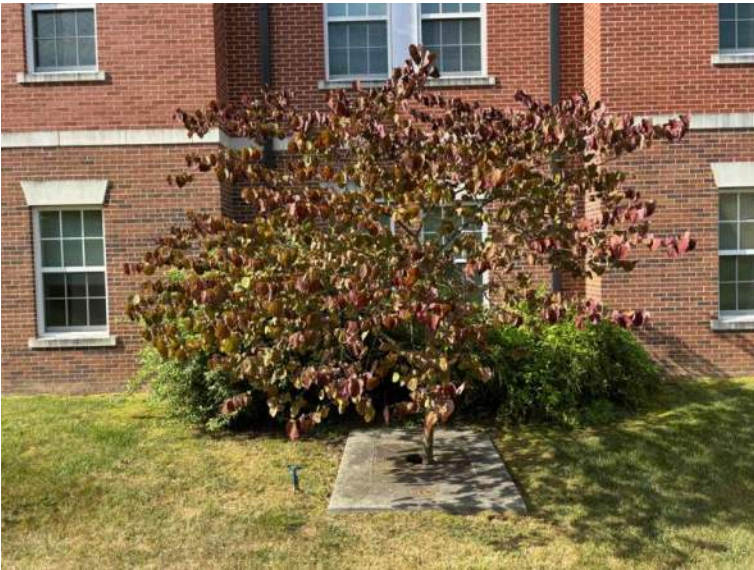
BMP 1- overall after maintenance

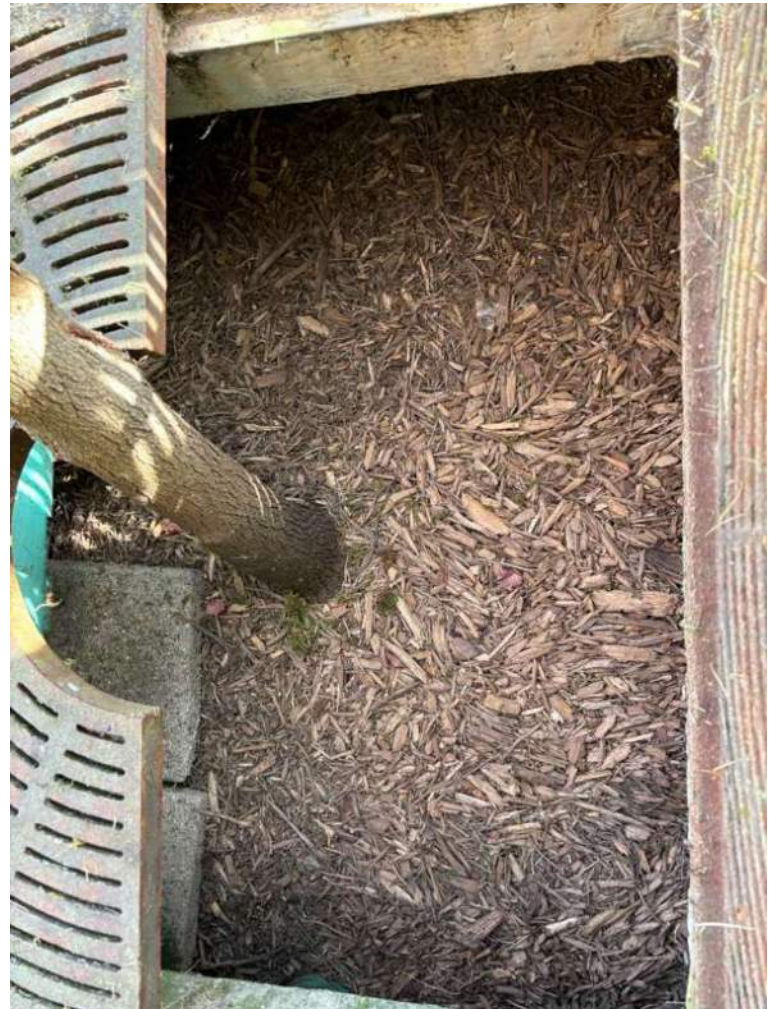
BMP 1- inside view after maintenance

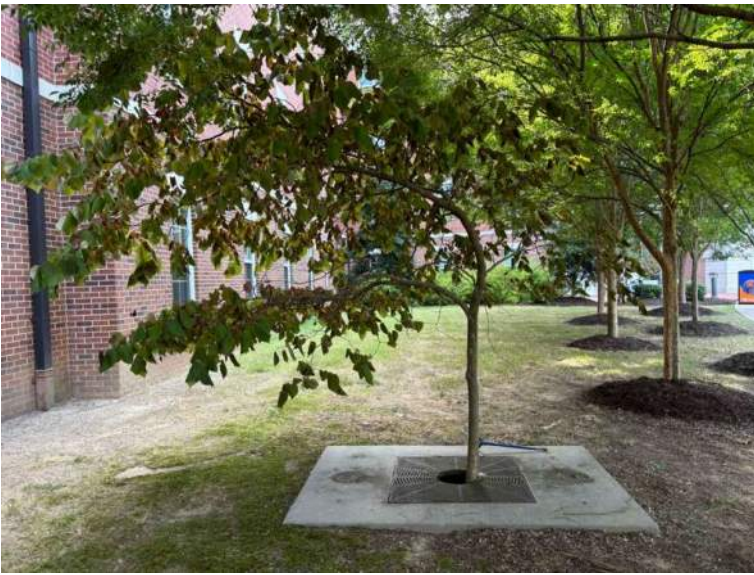
BMP 2- overall after maintenance

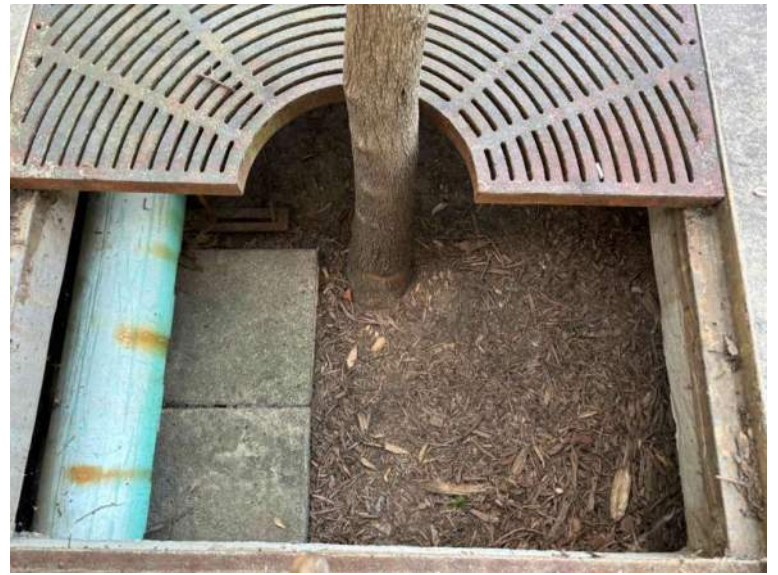
BMP 2- inside view after maintenance

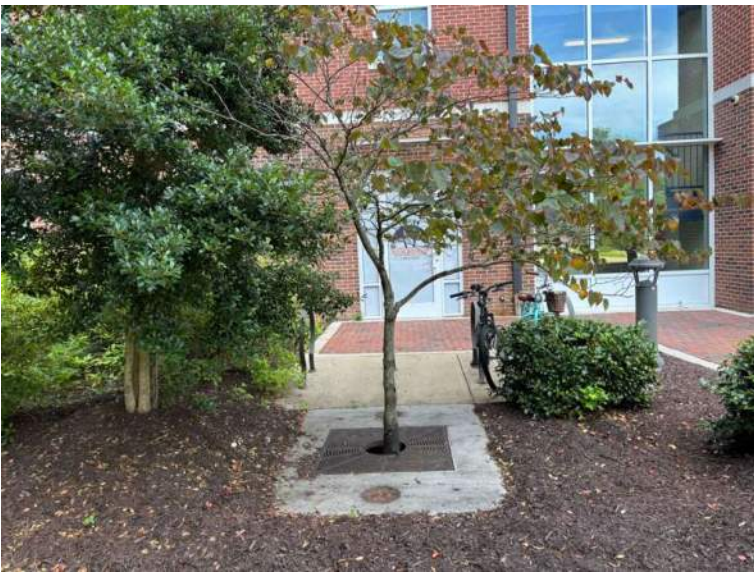
BMP 3- overall after maintenance

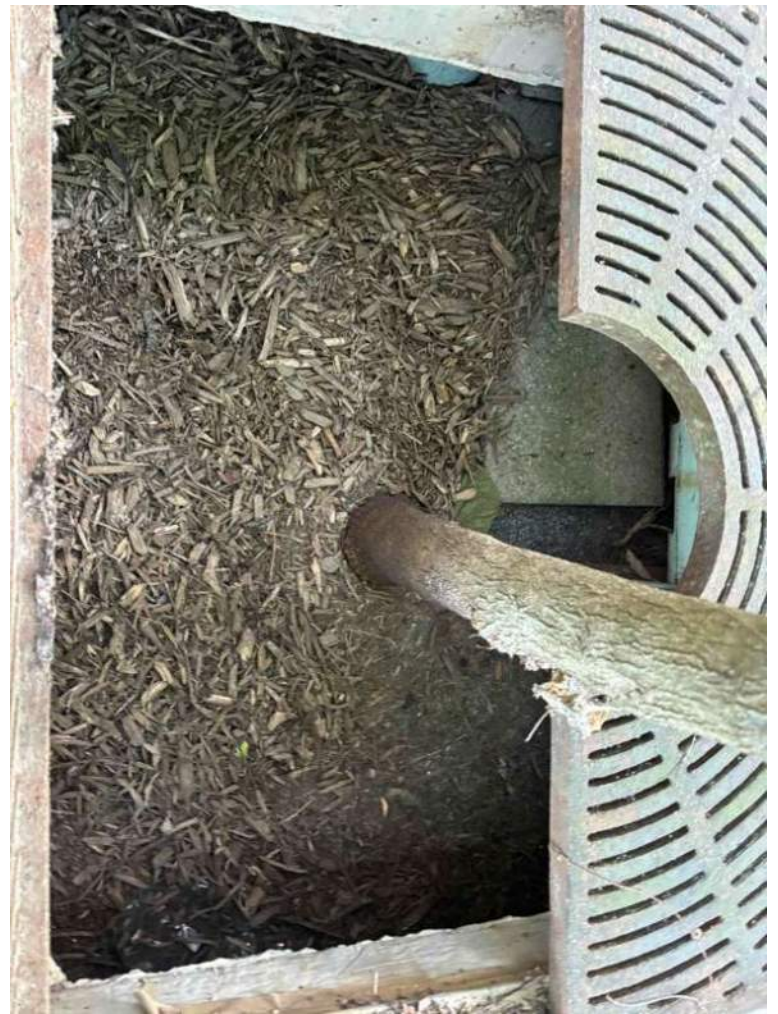
BMP 3- inside view after maintenance

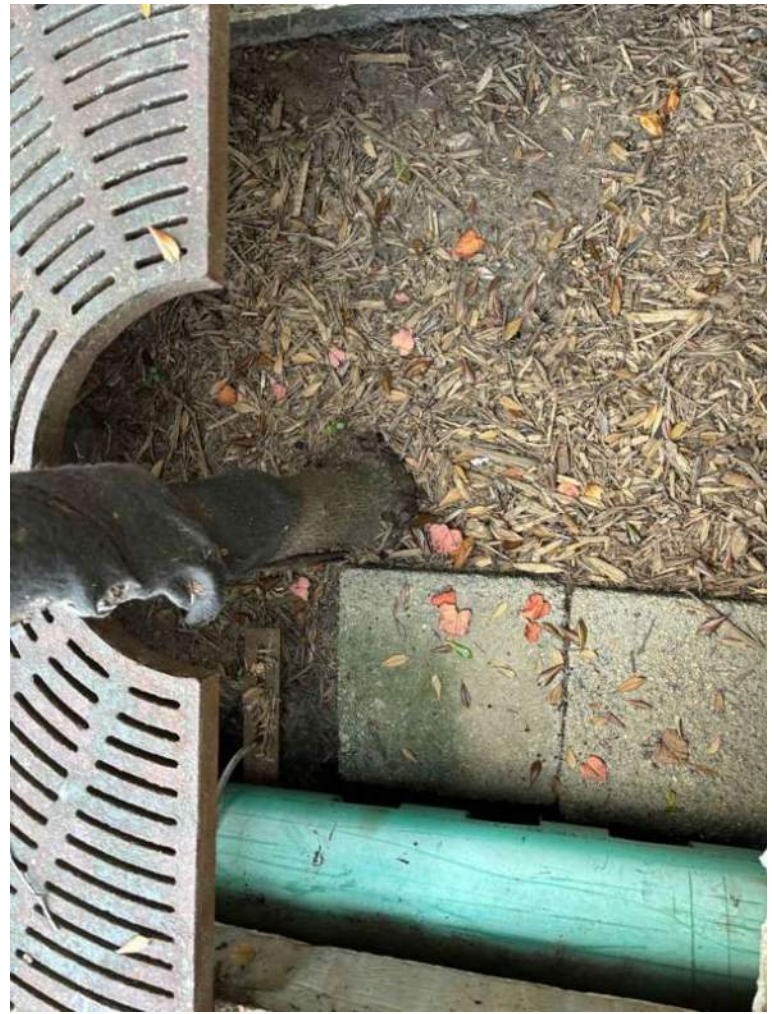
BMP 4- inside view after maintenance

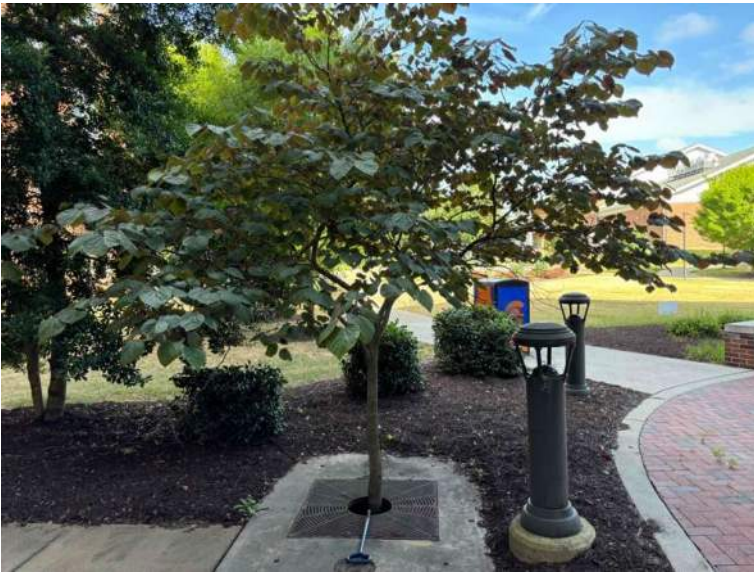
BMP 5- overall after maintenance

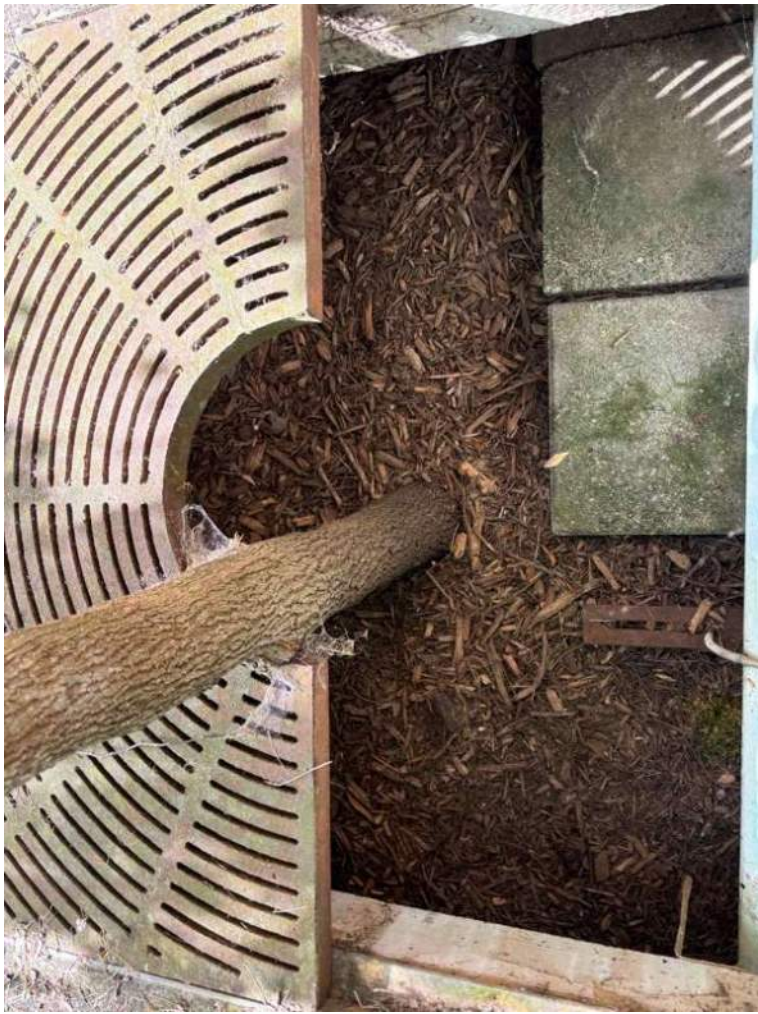
BMP 5- inside view after maintenance

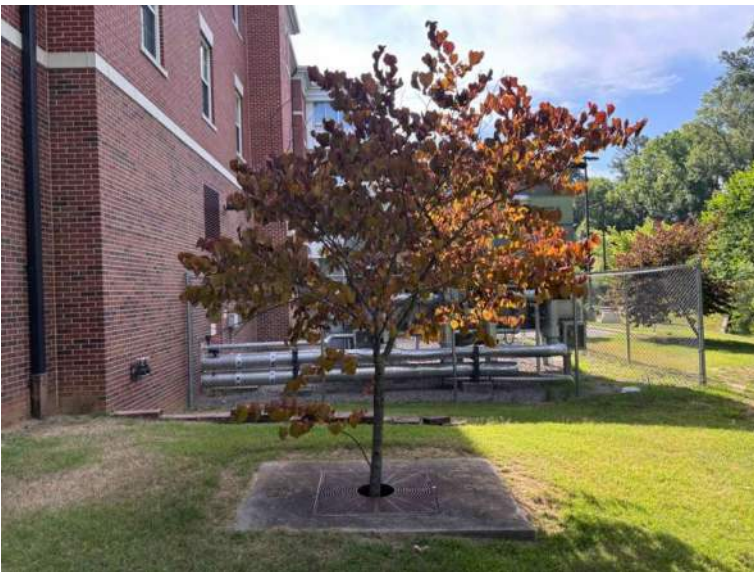
BMP 6- overall after maintenance

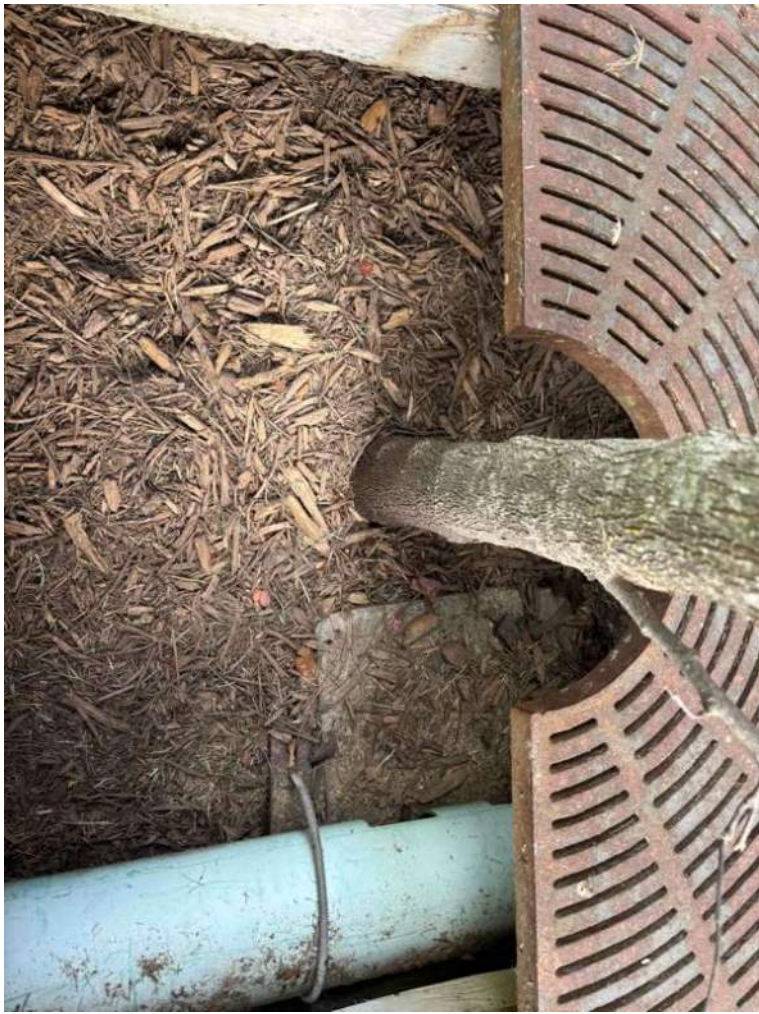
BMP 6- inside view after maintenance

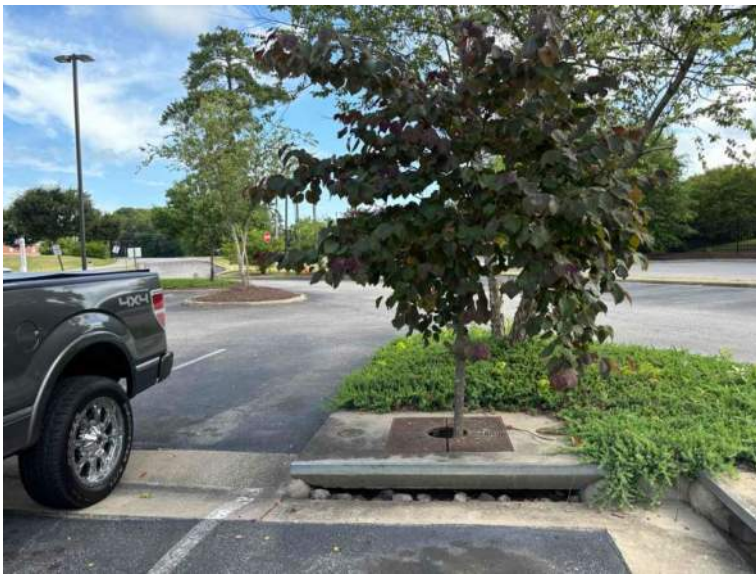
BMP 7- overall after maintenance

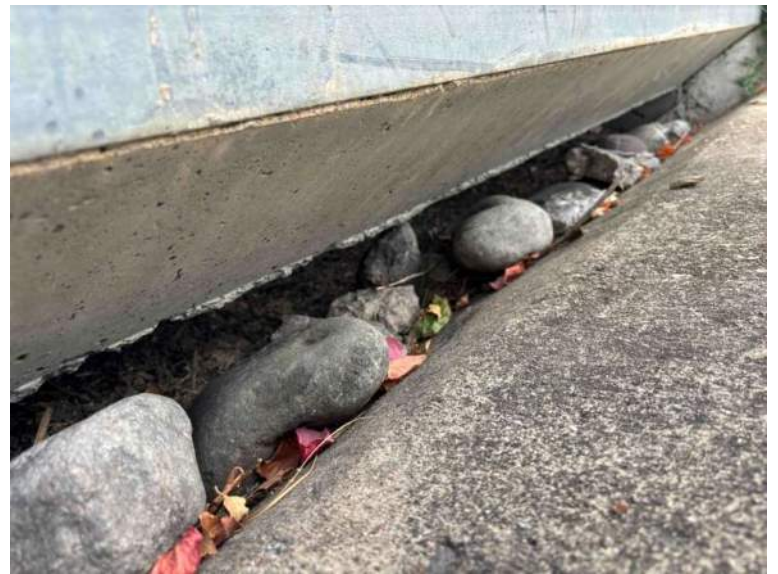
BMP 7- inlet throat after maintenance

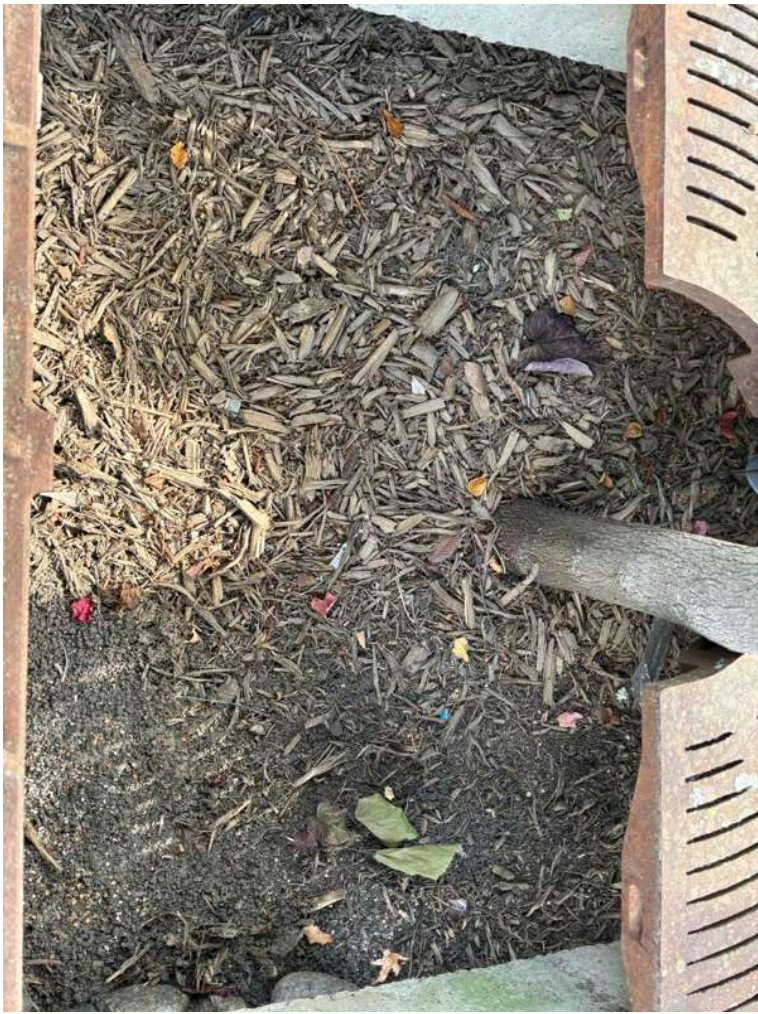
BMP 7- inside view after maintenance

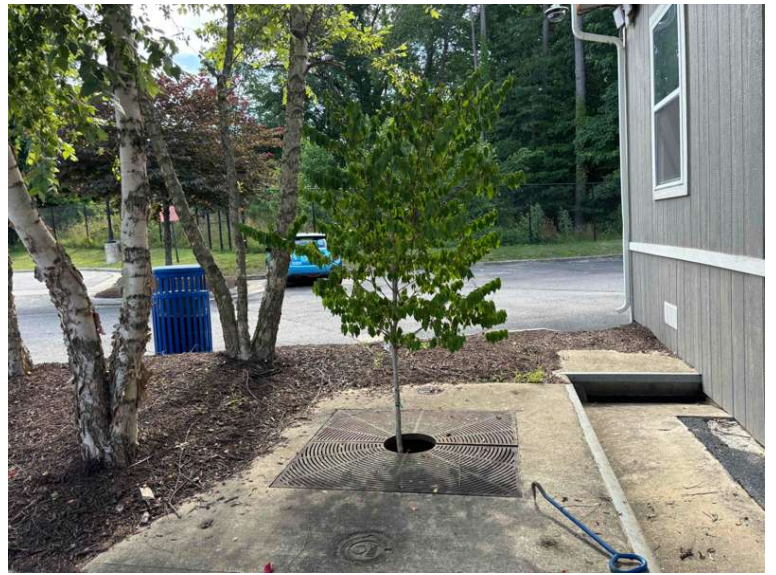
BMP 8- overall after maintenance

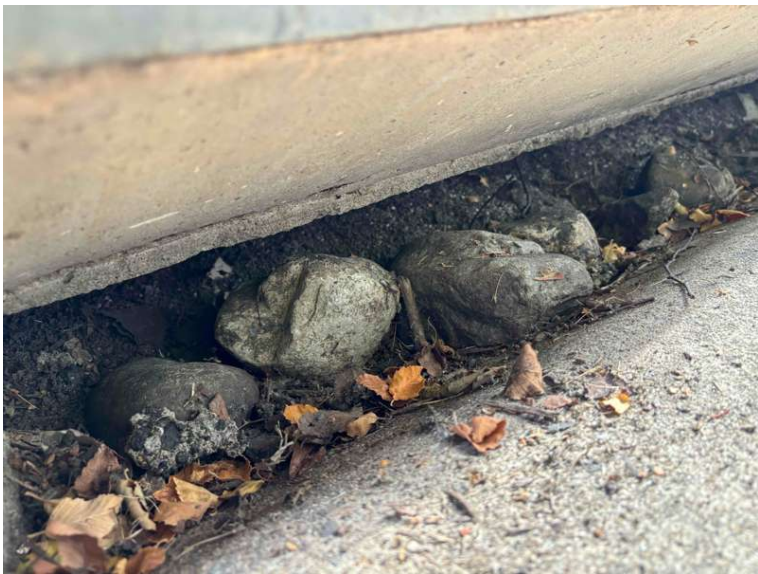
BMP 8- inlet throat after maintenance

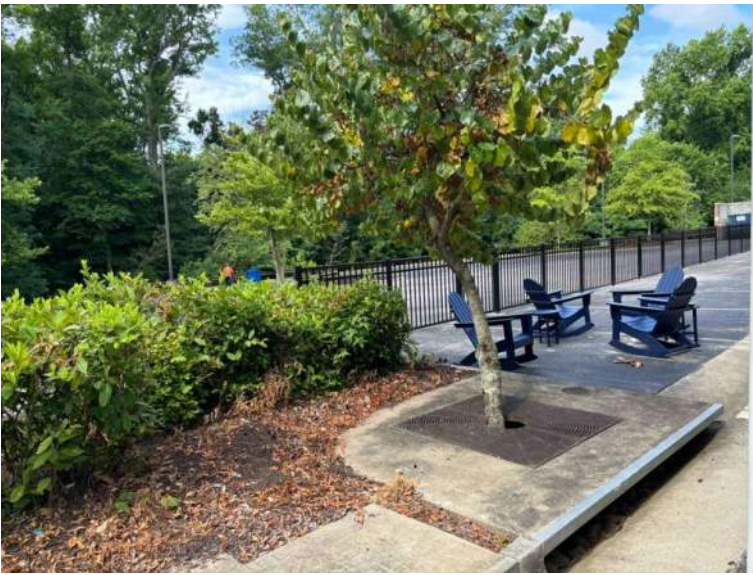
BMP 9- overall after maintenance

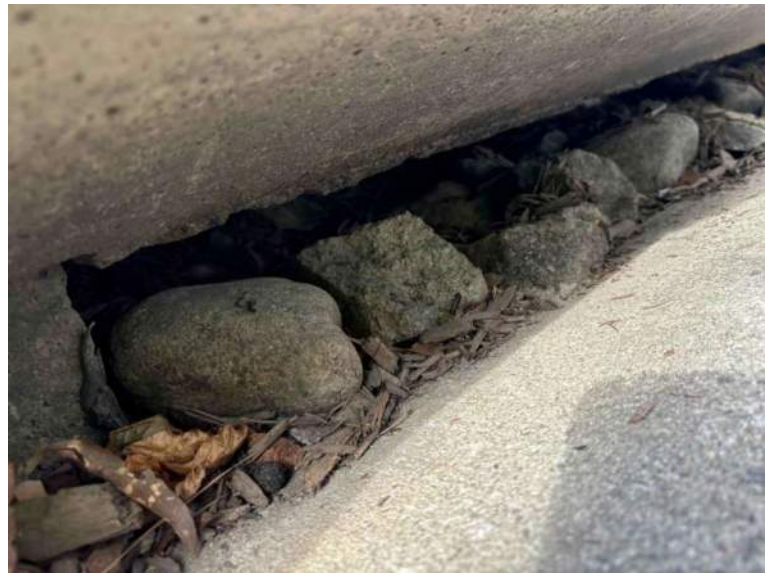
BMP 9- inlet throat after maintenance

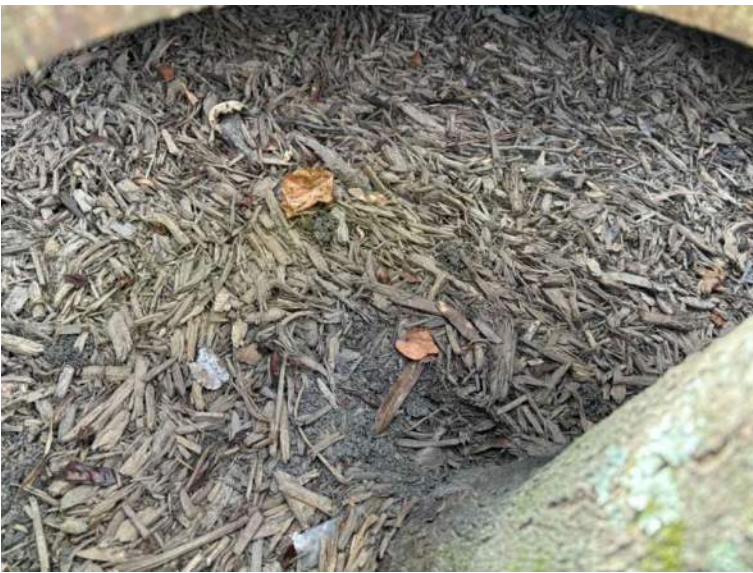
BMP 9- inside view after maintenance

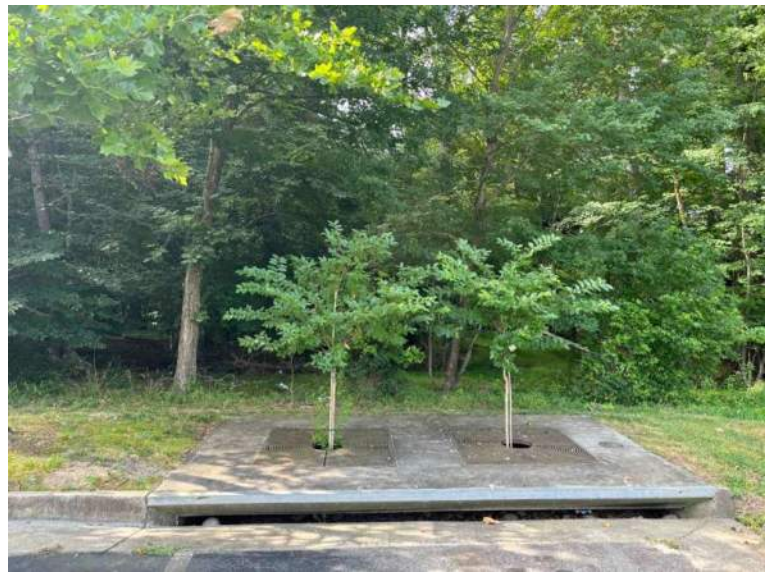
BMP 10- overall after maintenance

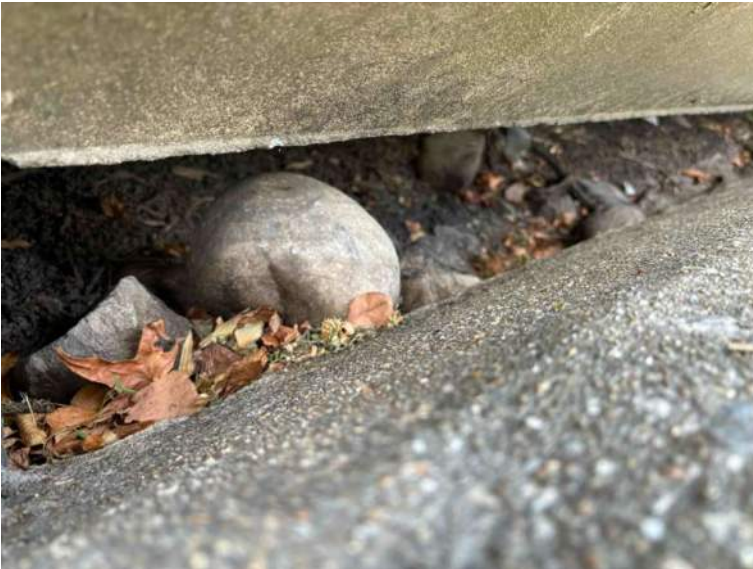
BMP 10- inlet throat after maintenance

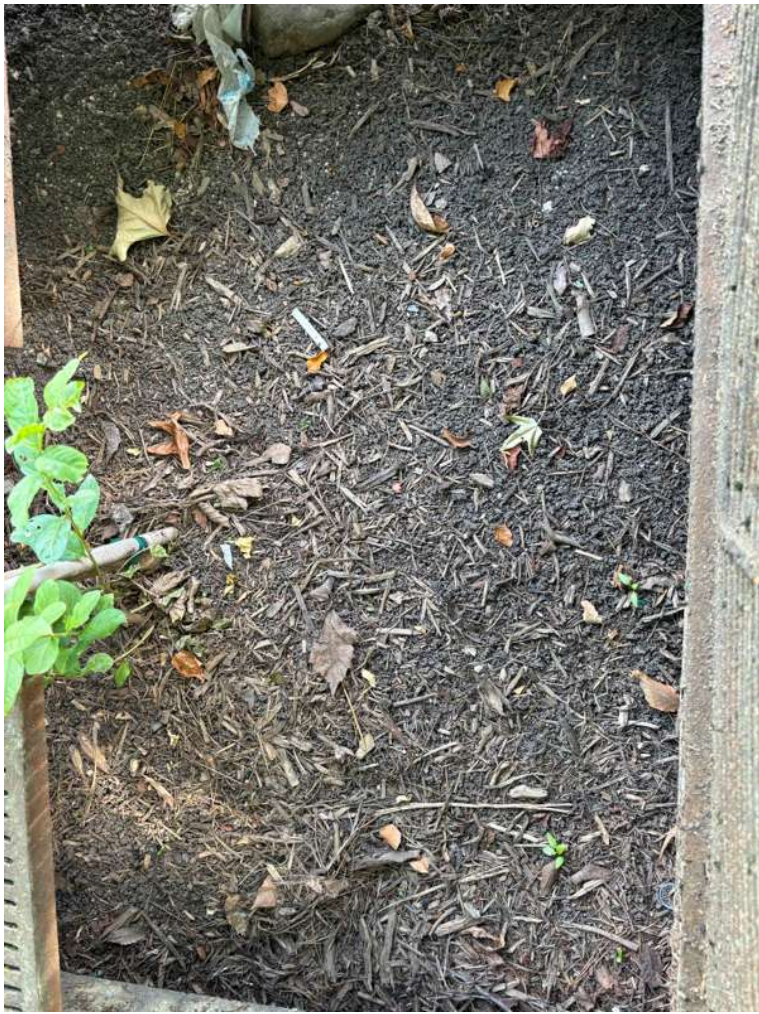
BMP 10- left inside view after maintenance

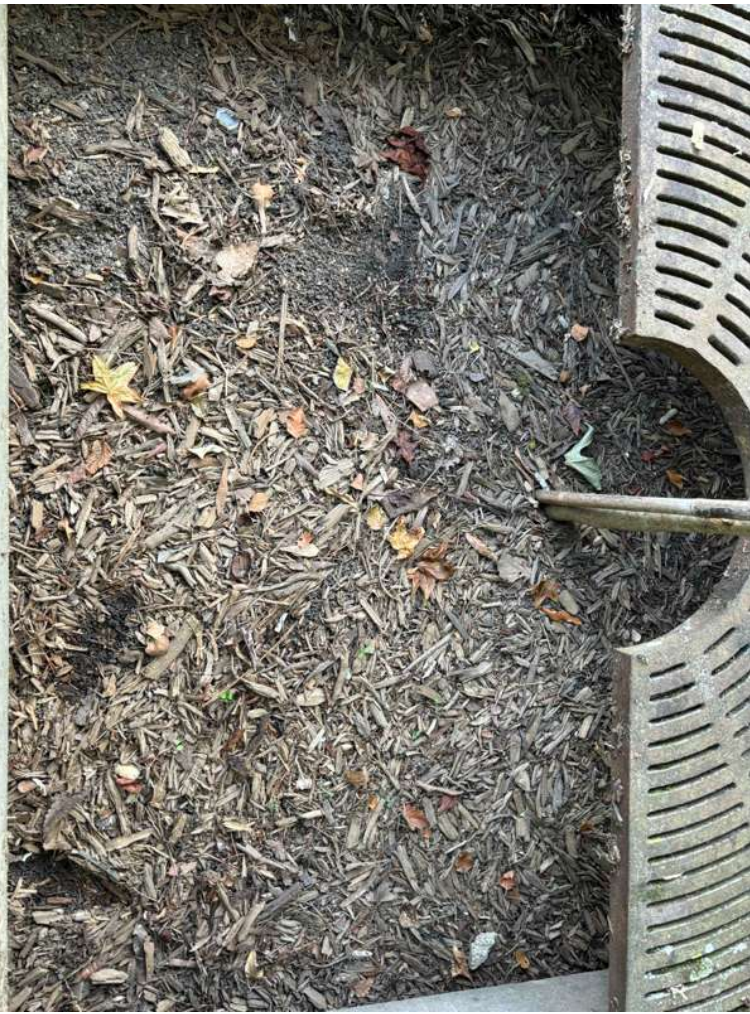
BMP 10- right inside view after maintenance

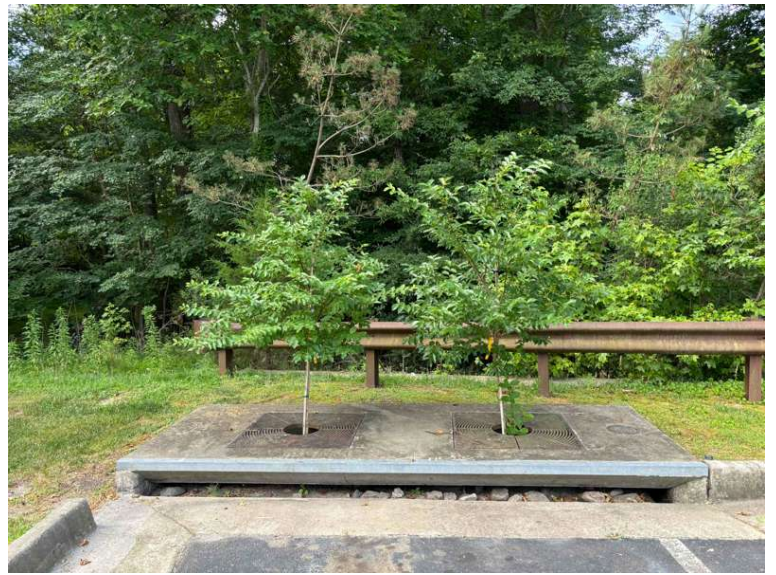
BMP 11- overall after maintenance

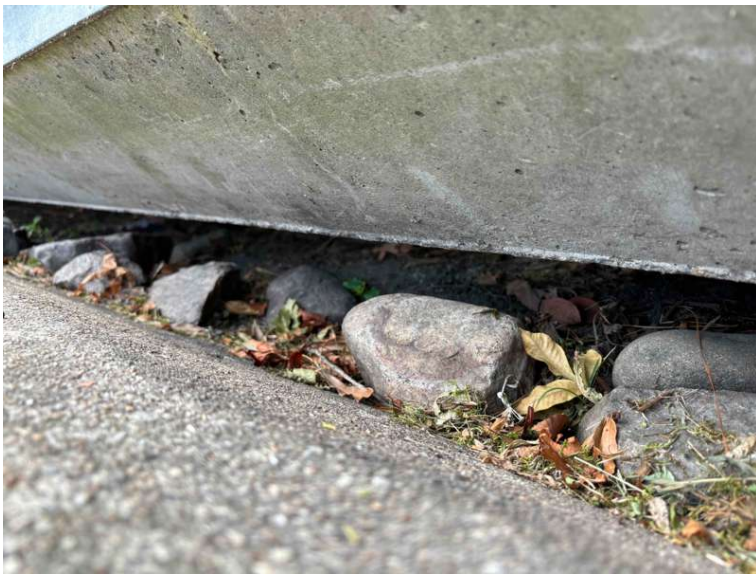
BMP 11- inlet throat after maintenance

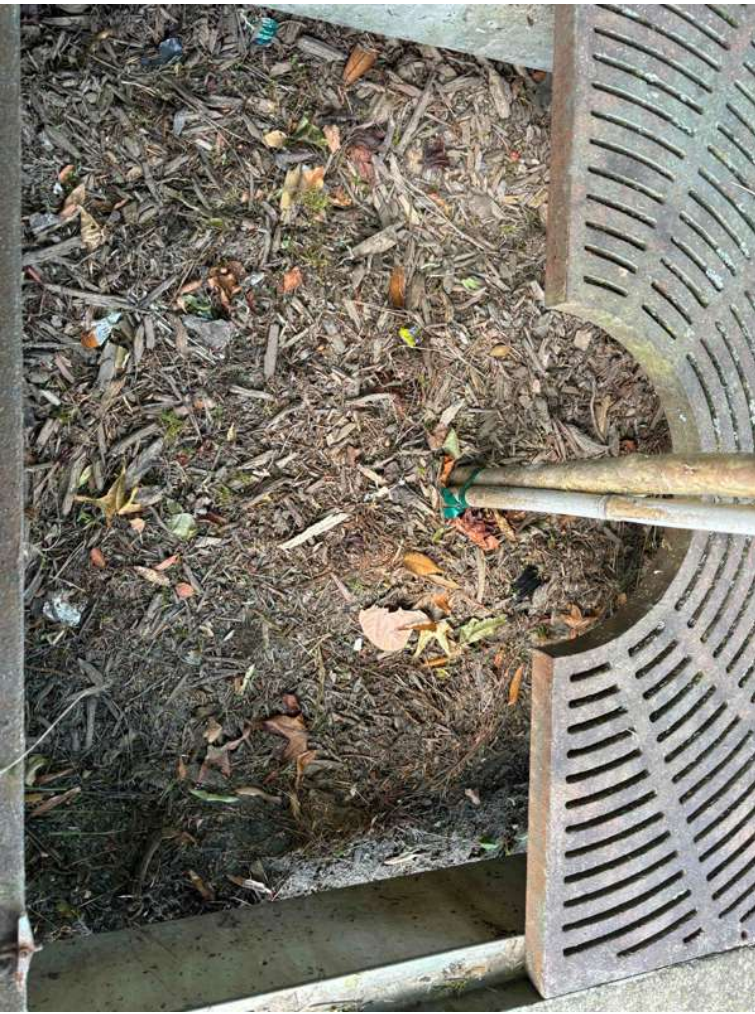
BMP 11- left inside view after maintenance

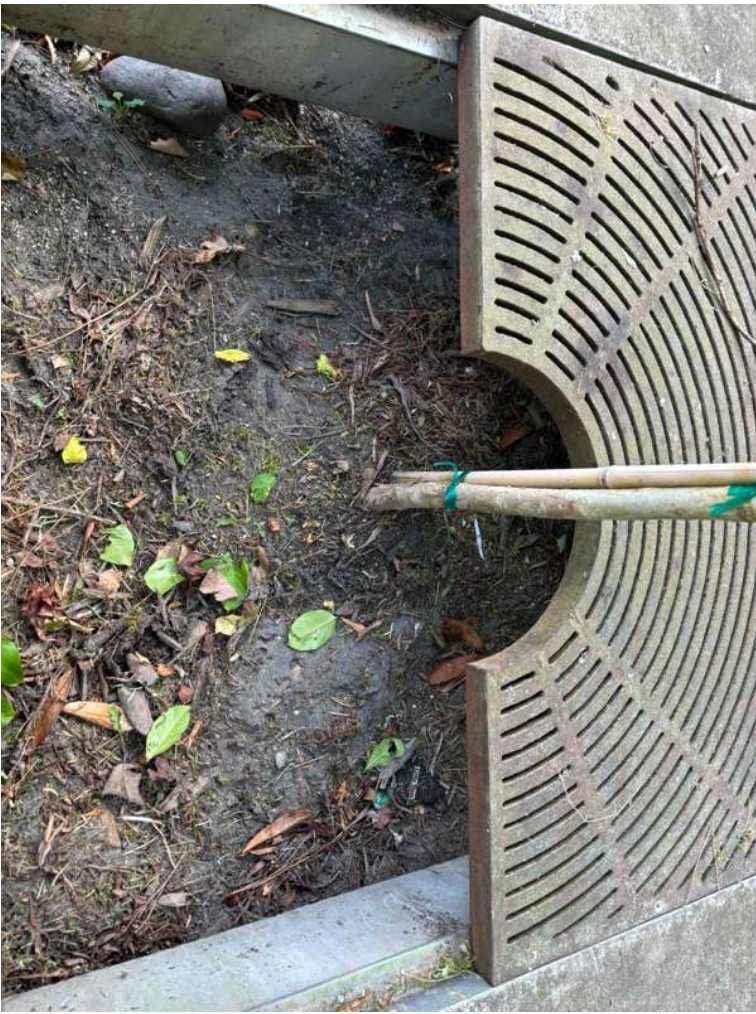
BMP 11- right inside view after maintenance

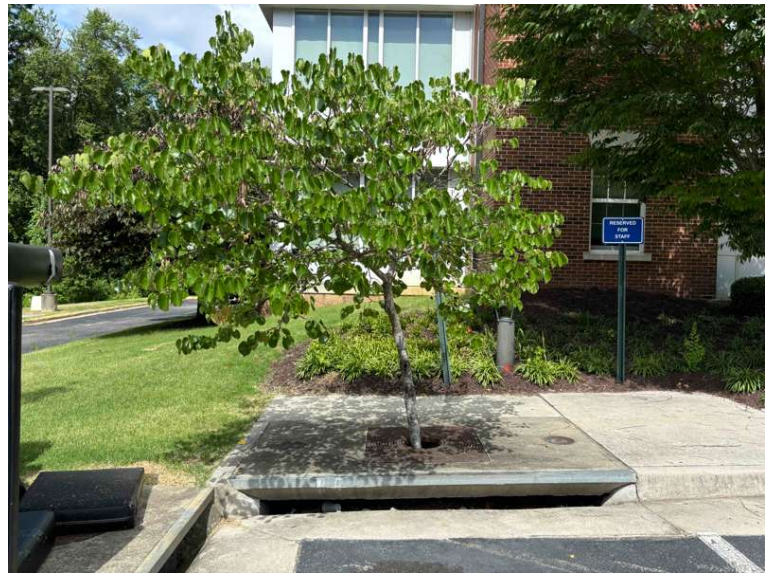
BMP 12- overall after maintenance

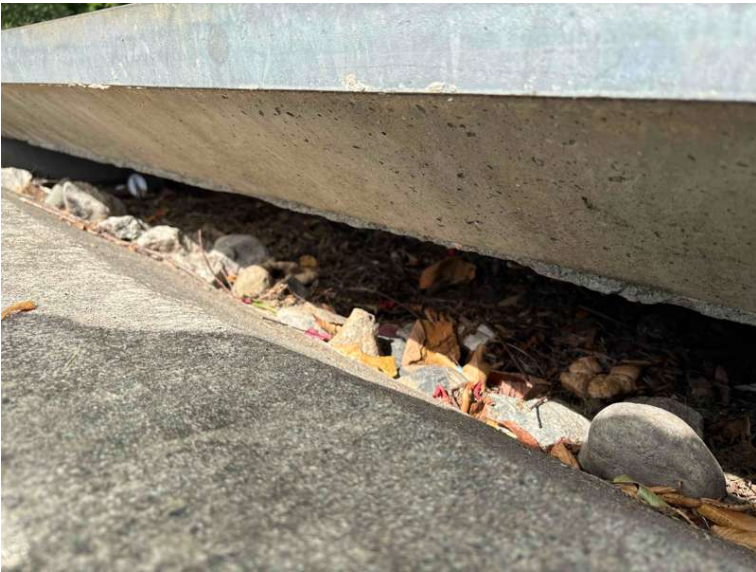
BMP 12- inlet throat after maintenance

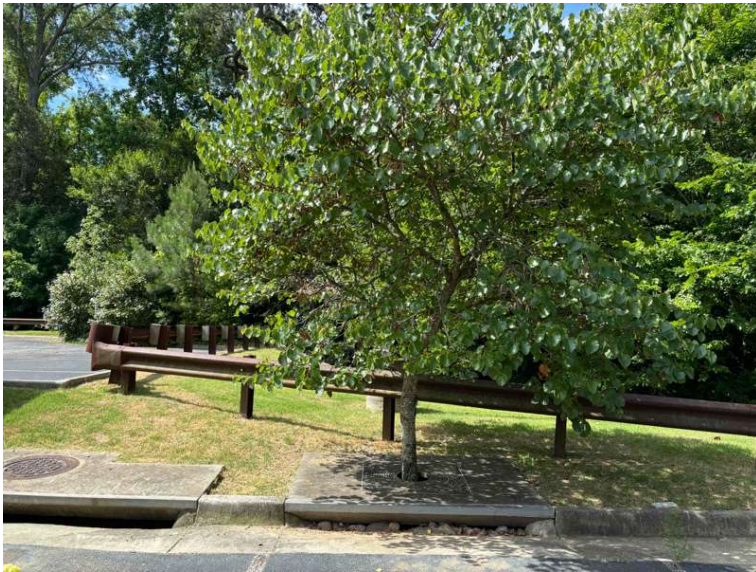
BMP 12- inside view after maintenance

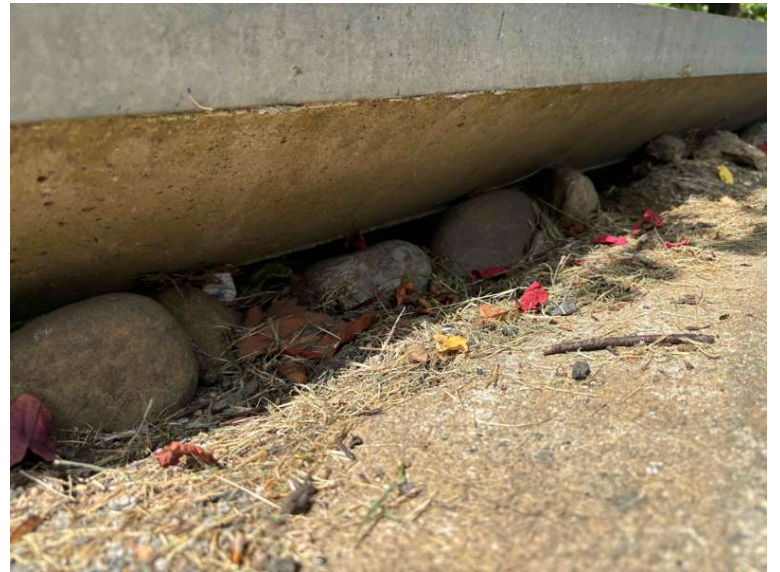
BMP 13- overall after maintenance

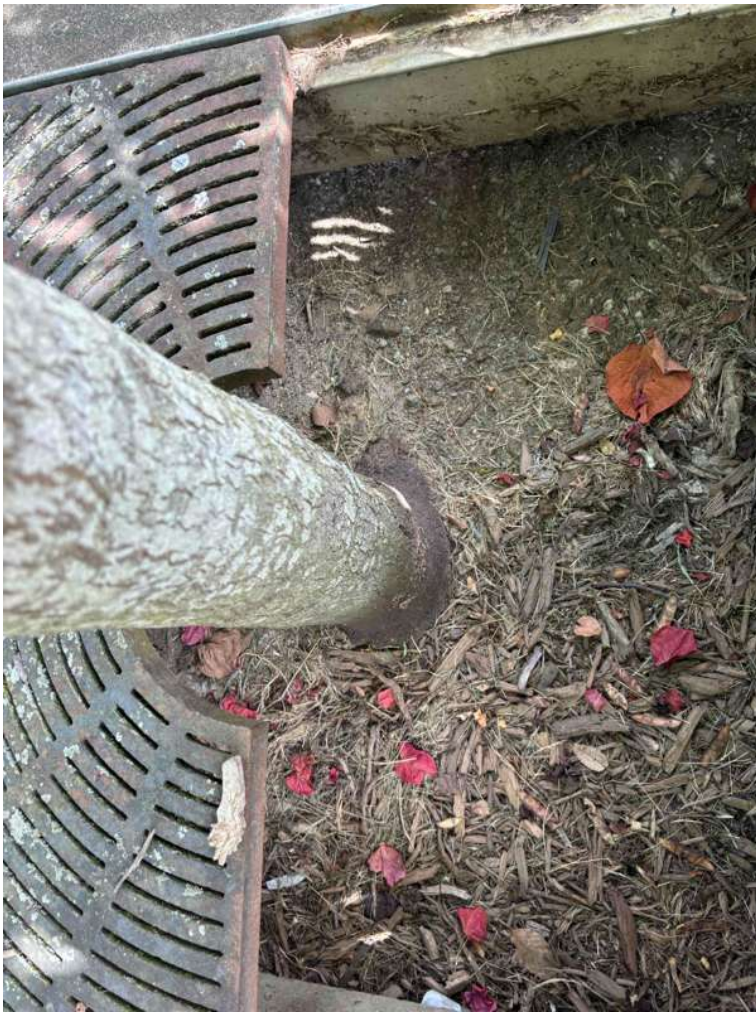
BMP 13- inlet throat after maintenance

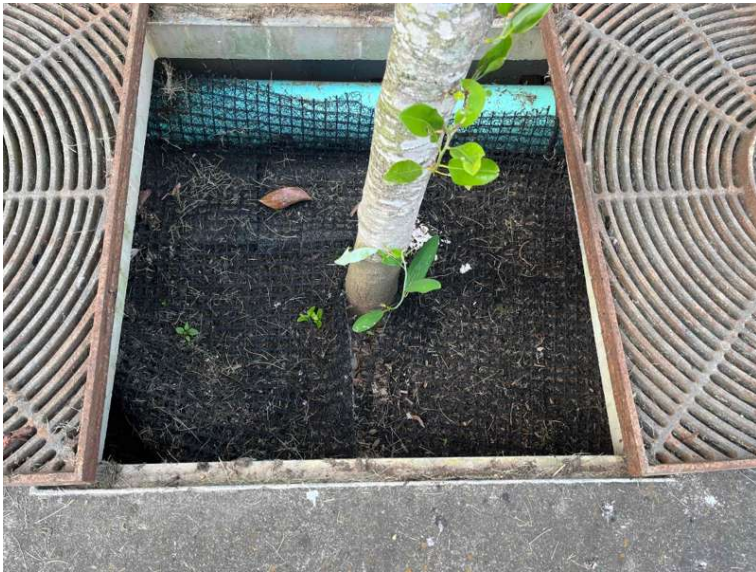
BMP 13- inside view after maintenance

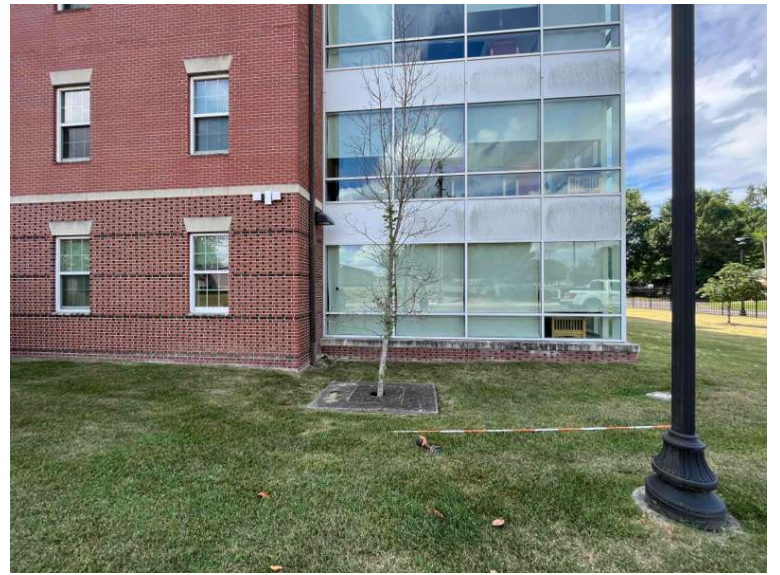
BMP 16- inside view after maintenance

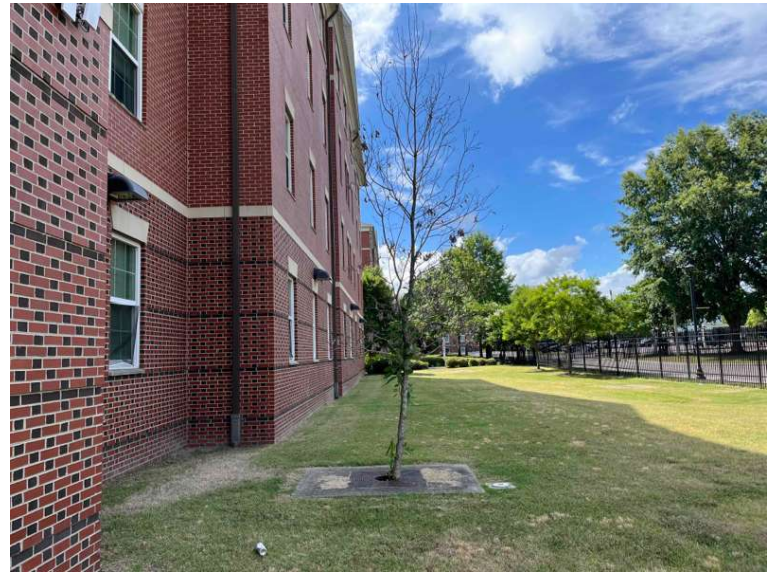
BMP 16- overall after maintenance

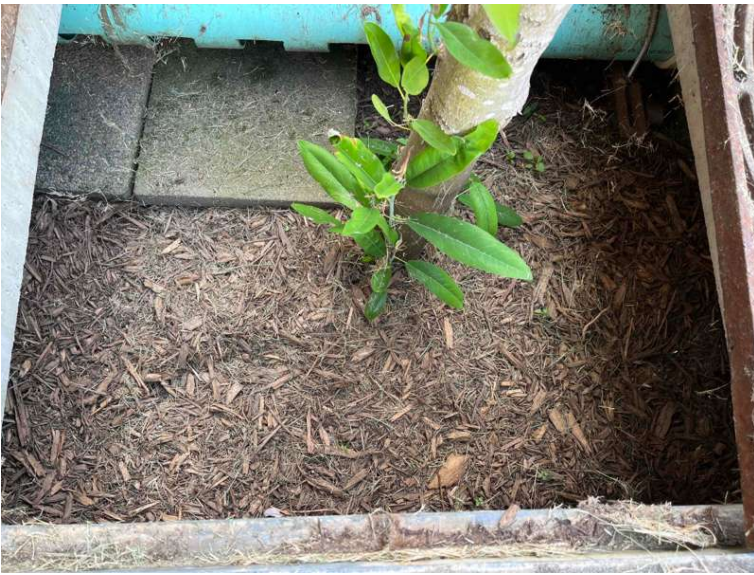
BMP 17- overall after maintenance

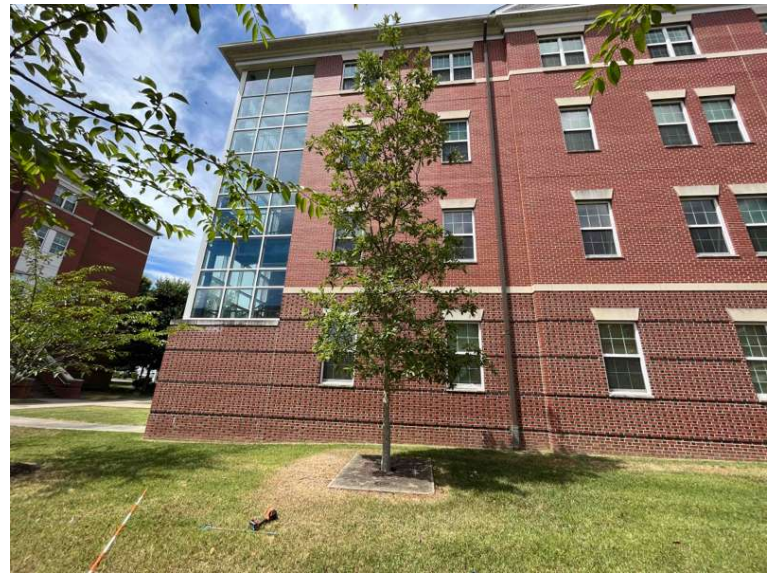
BMP 17- inside view after maintenance

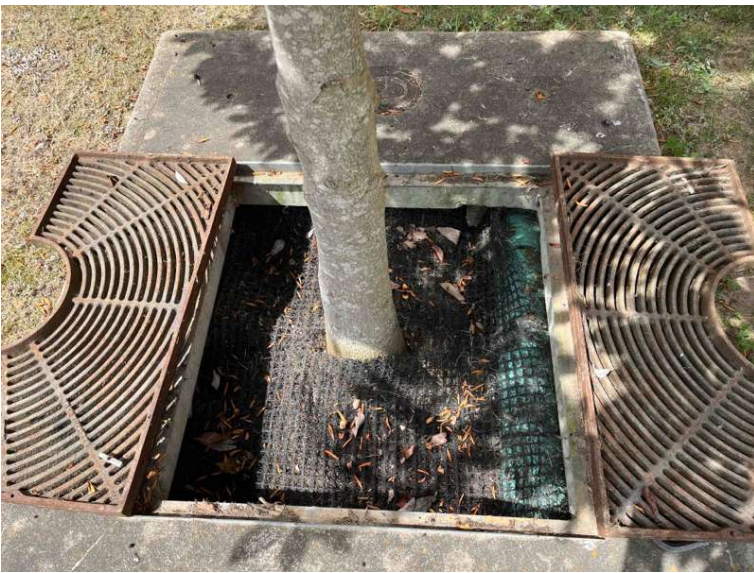
BMP 18- overall after maintenance

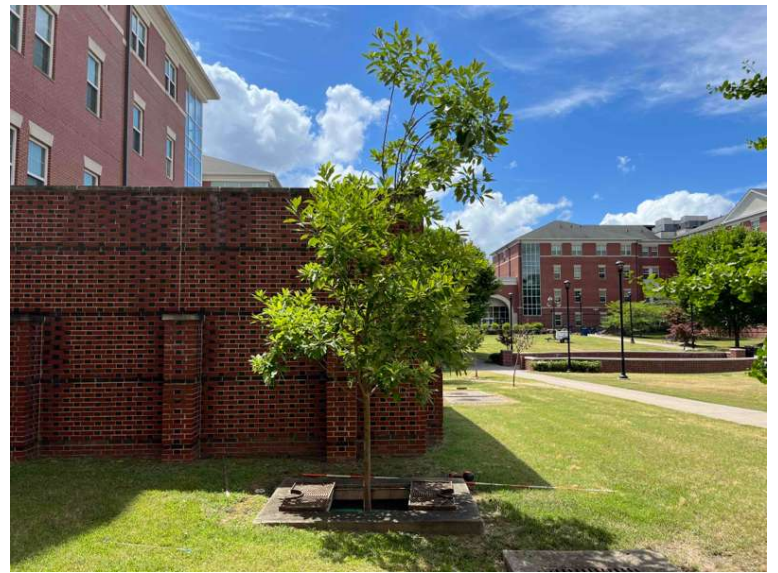
BMP 18- inside view after maintenance

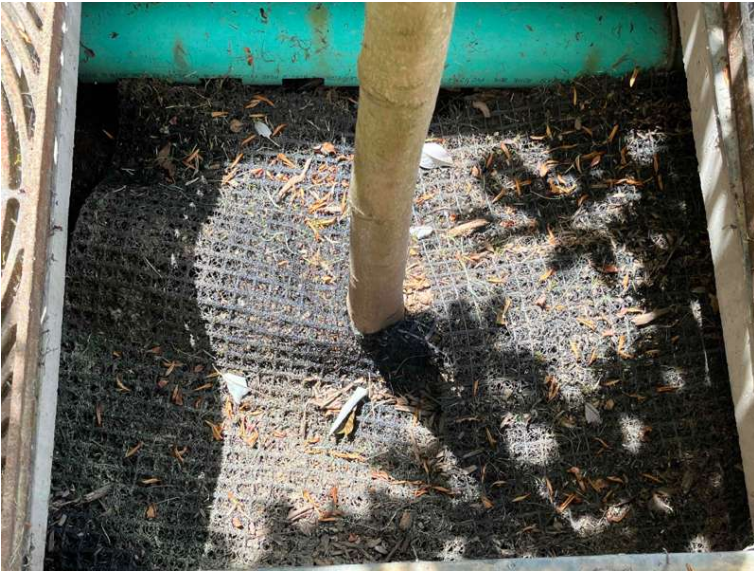
BMP 19- overall after maintenance

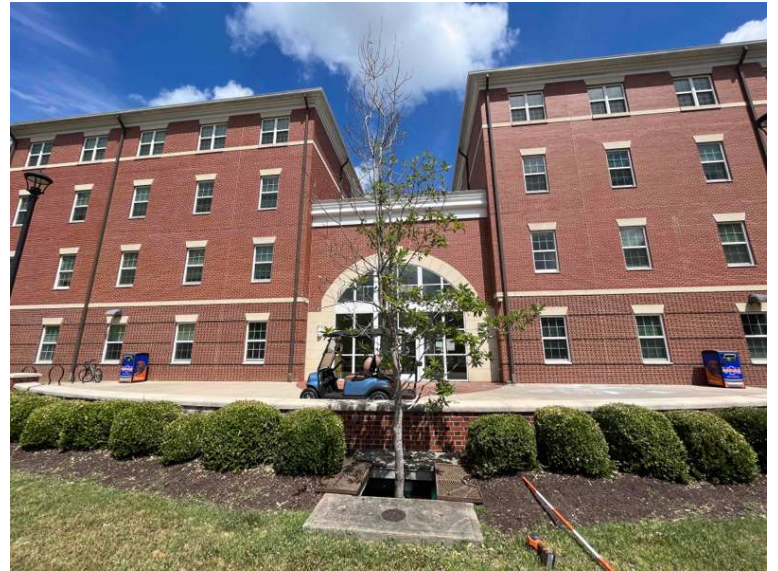
BMP 19- inside view after maintenance

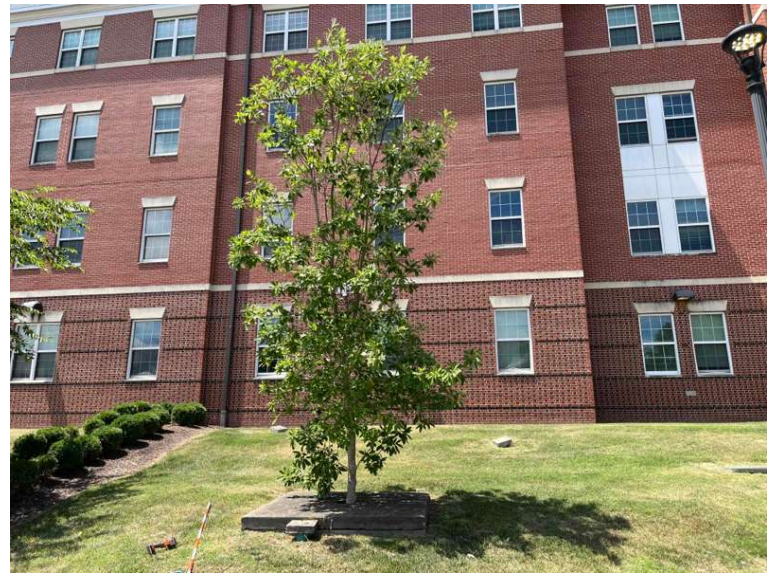
BMP 20- inside view after maintenance
