Virginia State University
MS-4 Permit: VAR040119
July 1, 2023 - June 30, 2024 Annual Report

Prepared for
Virginia State University
Capital Outlay & Facilities Management
PO Box 9414
Virginia State University, VA 23806

October 1, 2024

Prepared by: Timmons Group
1001 Boulders Parkway, Suite 300
Richmond, VA 23225
(804) 200-6500

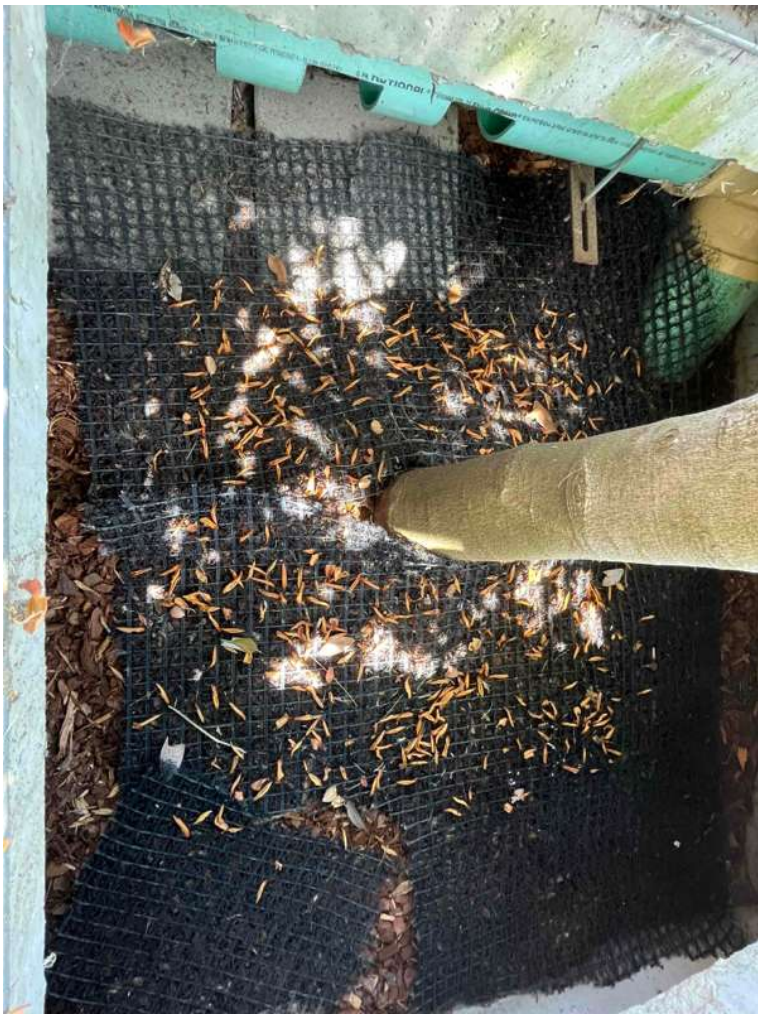
BMP 21- overall after maintenance

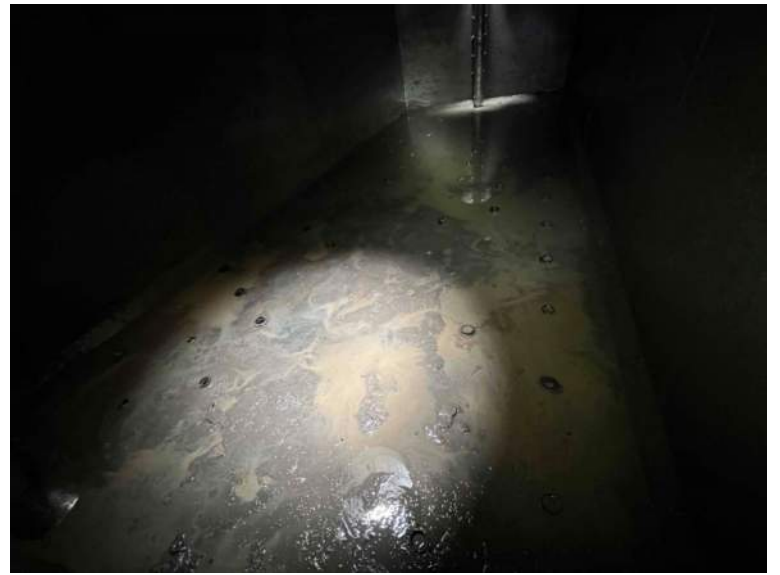
BMP 31- after

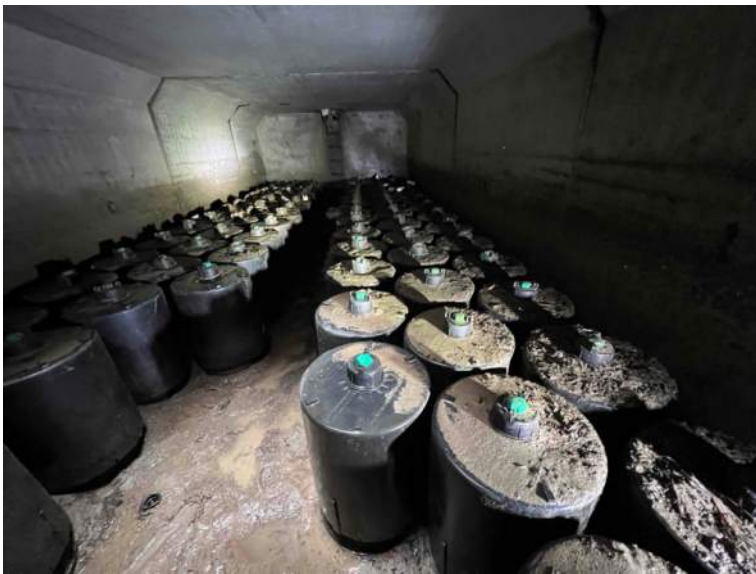
BMP 47 - after cleaning vault

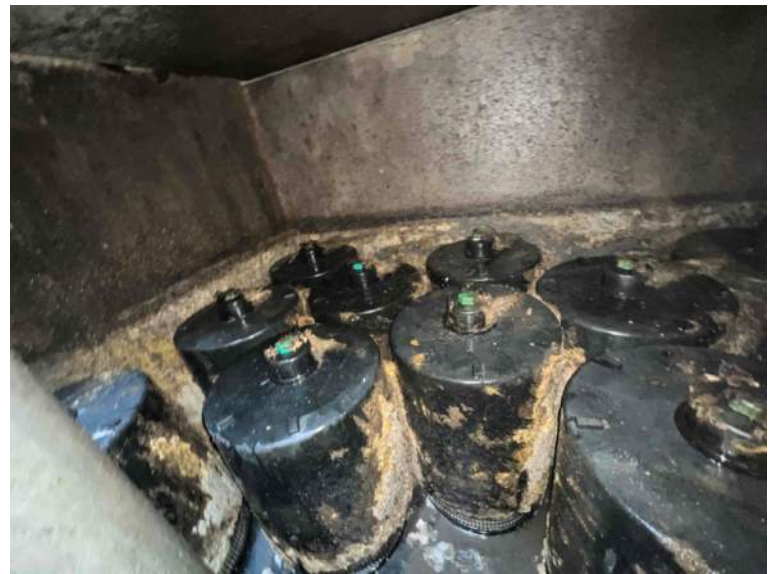
BMP 47 - after replacing cartridges

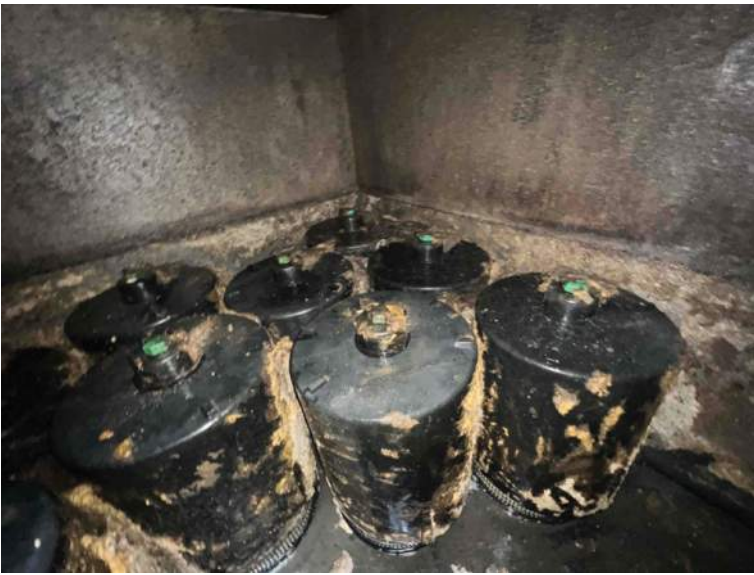
BMP 48- before replacing cartridges

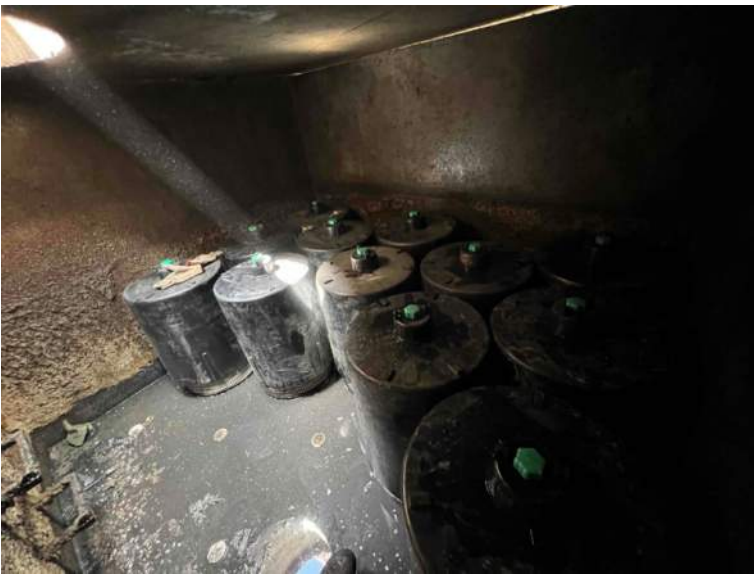
BMP 48- After cleaning vault

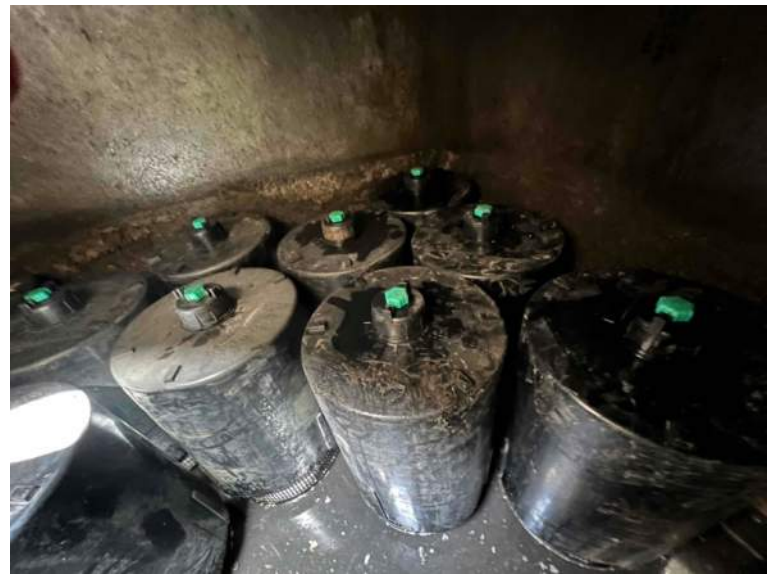
BMP 48- After replacing cartridges

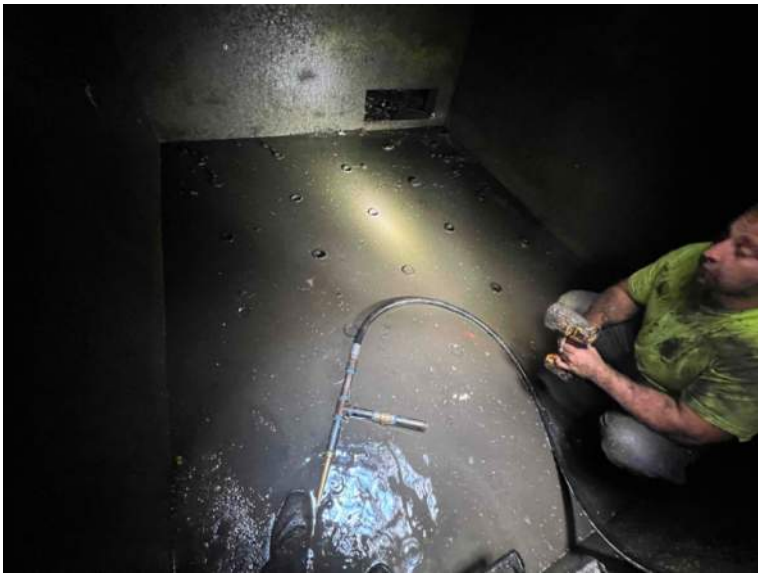
BMP 48- After replacing cartridges

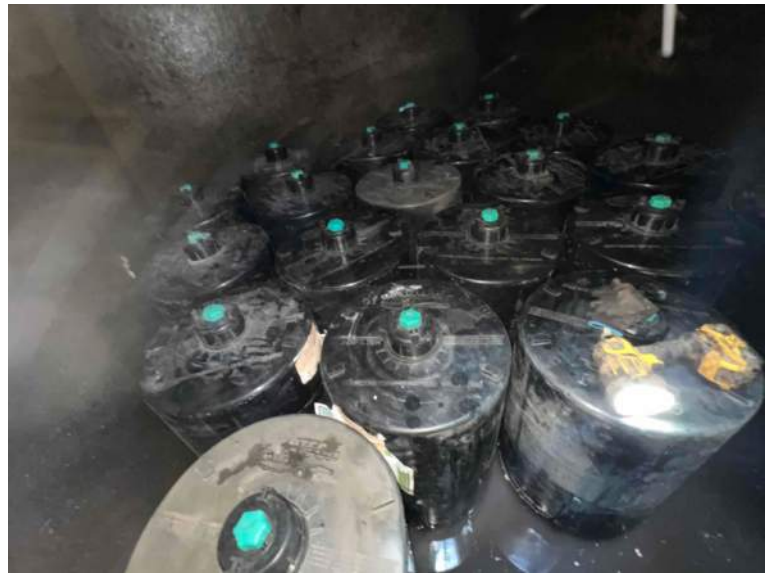
BMP 49 - after cleaning vault
