Virginia State University
MS-4 Permit: VAR040119
July 1, 2019 - June 30, 2020 Annual Report

Prepared for
Virginia State University
Capital Outlay & Facilities Management
PO Box 9414
Virginia State University, VA 23806

September 21, 2020

Prepared by: Timmons Group
1001 Boulders Parkway, Suite 300
Richmond, VA 23225
(804) 200-6500

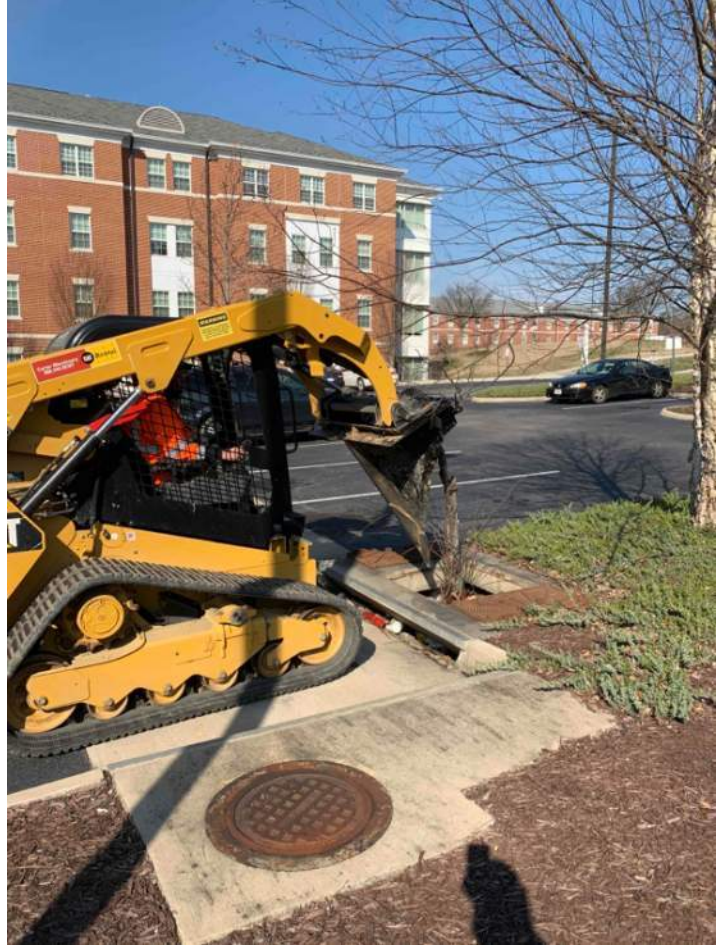
Unit 7 tree removal

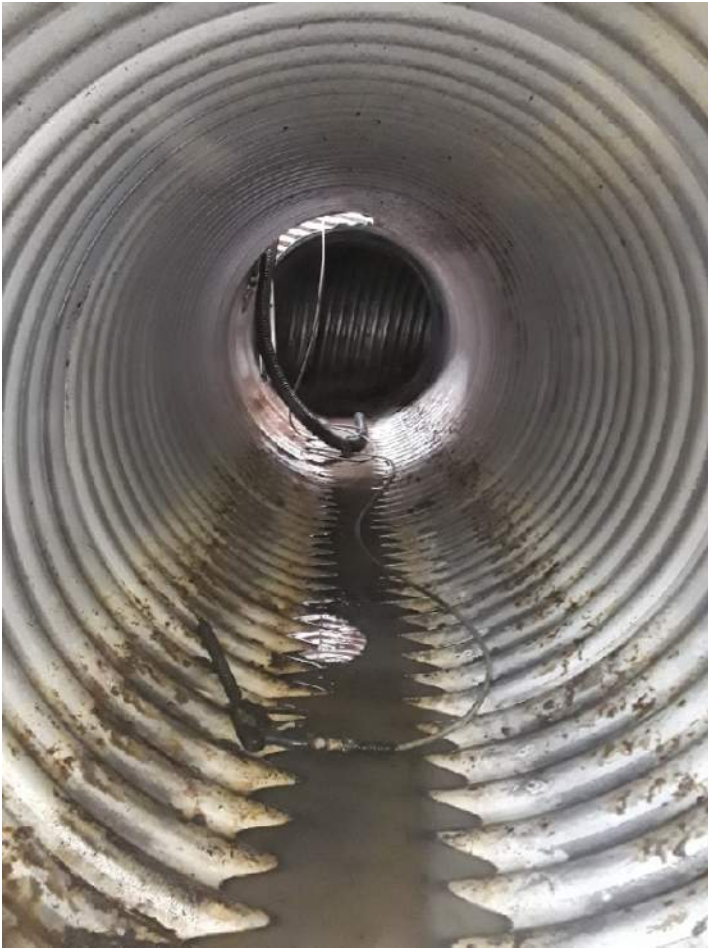
CMP 15 after. Removed 800 gal

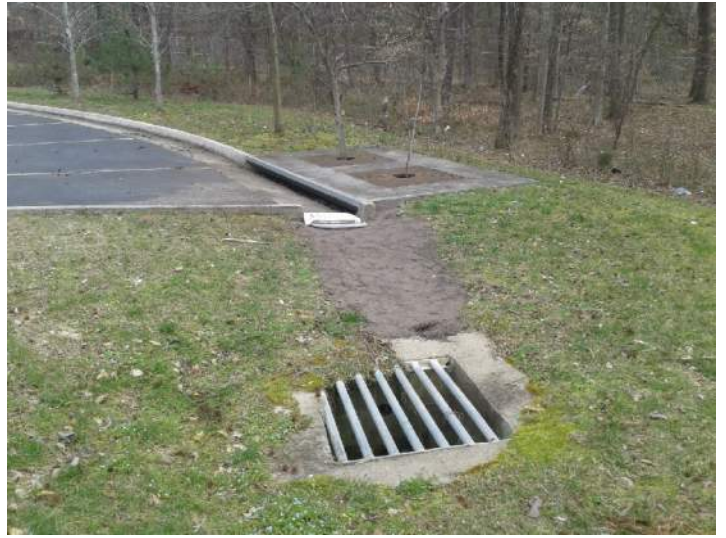
CMP 15 after.

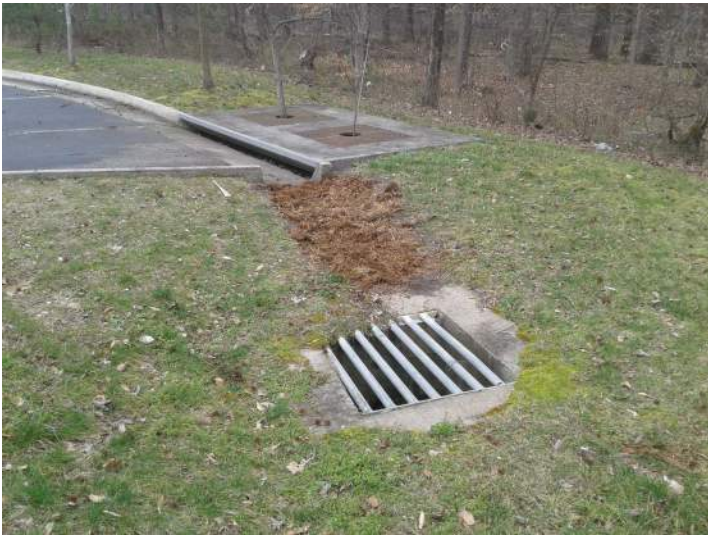
Filled erosion area with topsoil

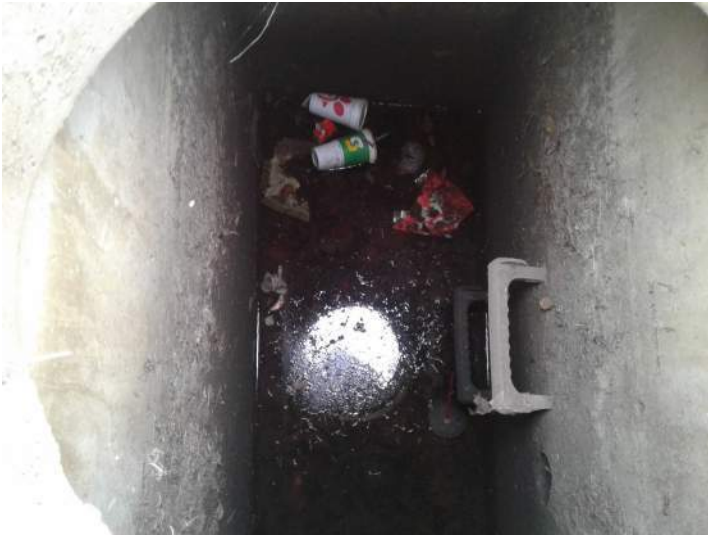
Opening up unit 31.

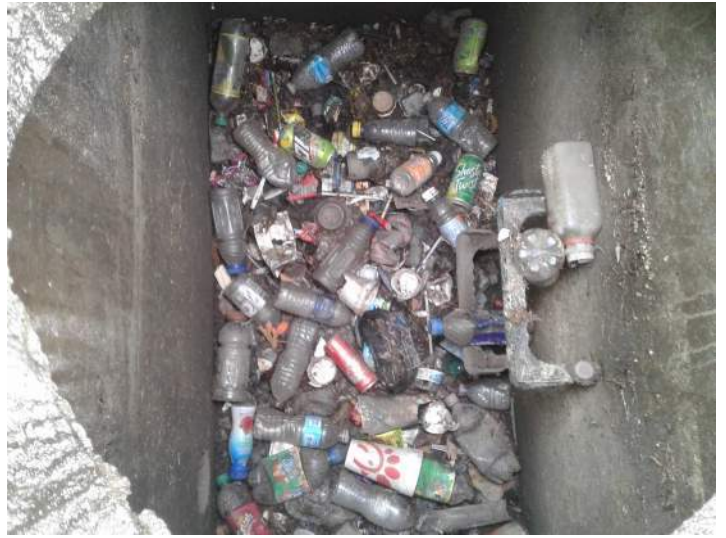
Before. Chamber 1 of unit 31.

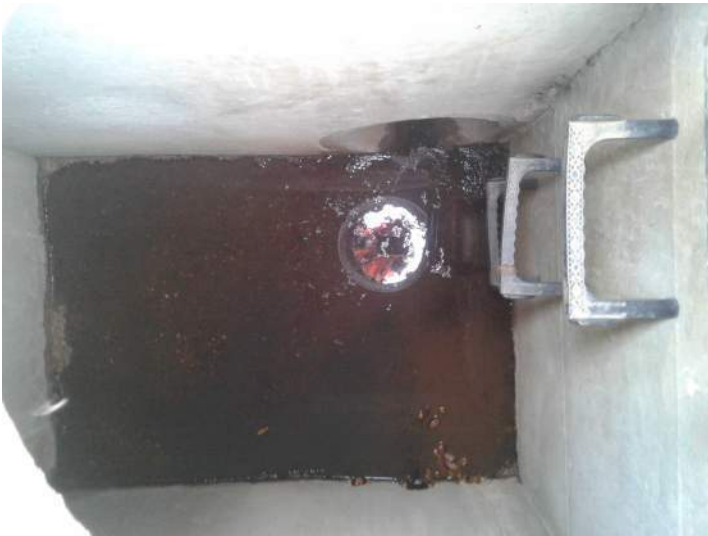
Before. Unit 31 chamber 2.

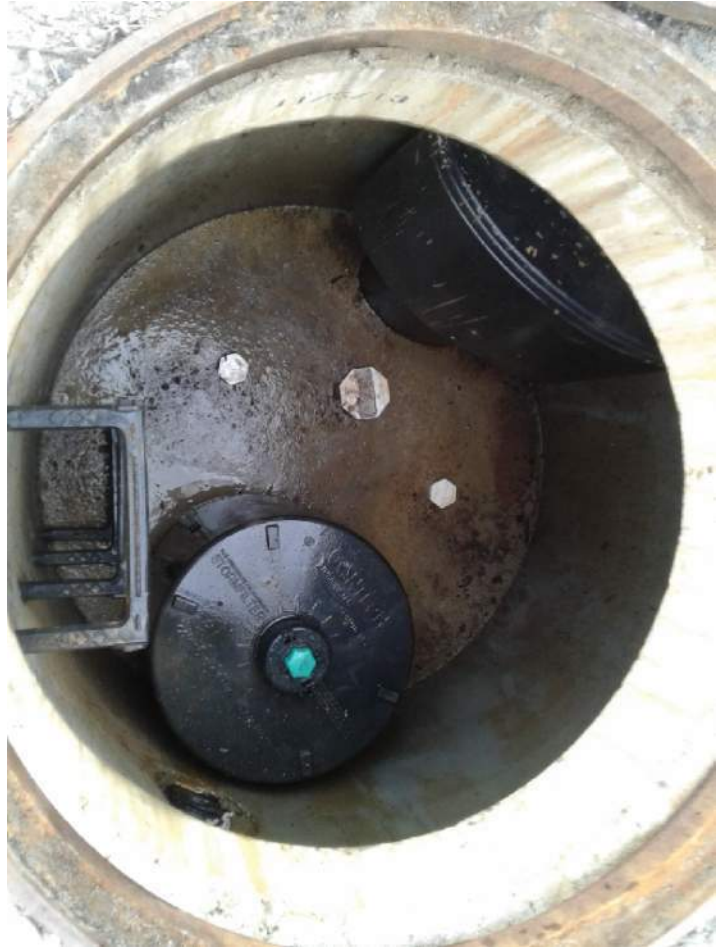
35 after pressure wash and vac.

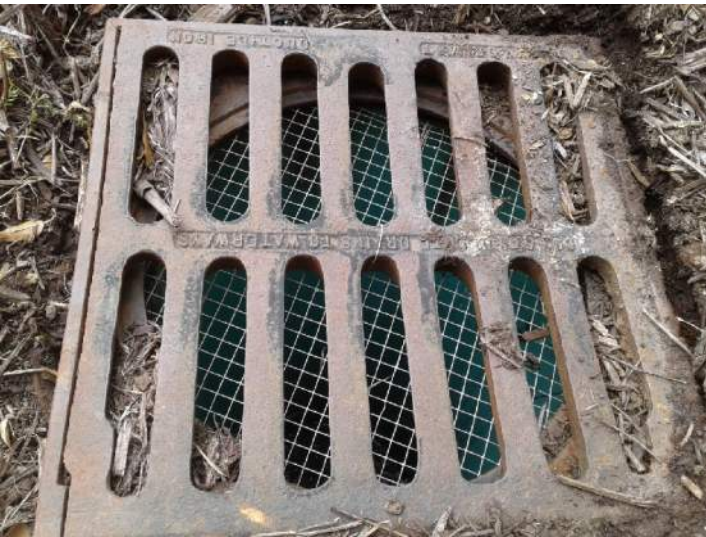
Unit 36. Screen installed. #1

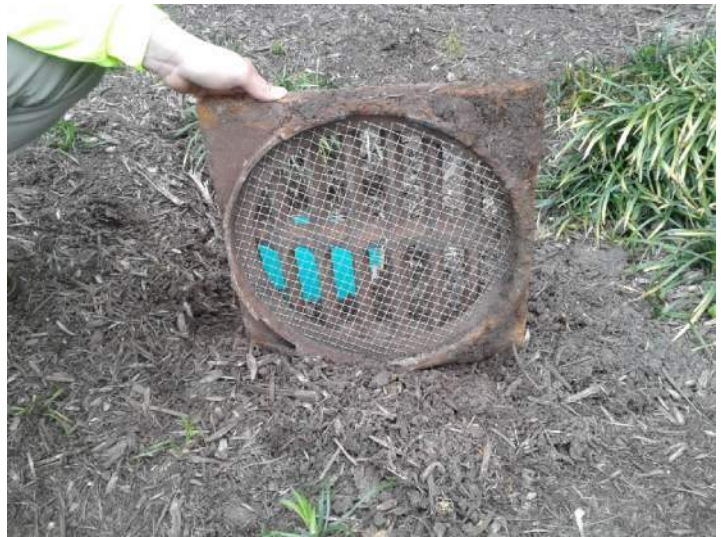
Unit 36. Screen installed #2

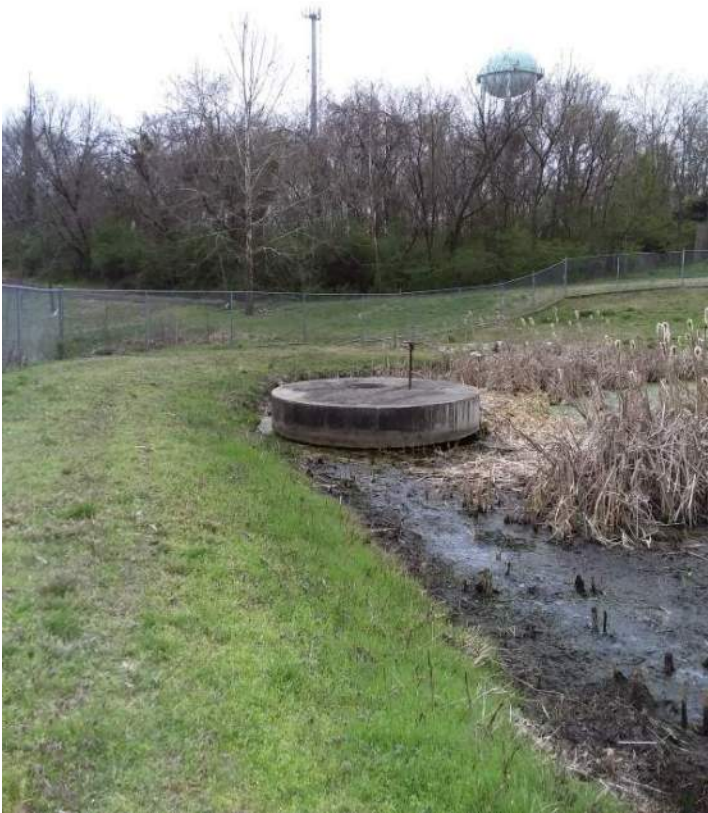
BMP 30: showing location of outfall structure near rip rap emergency spillway

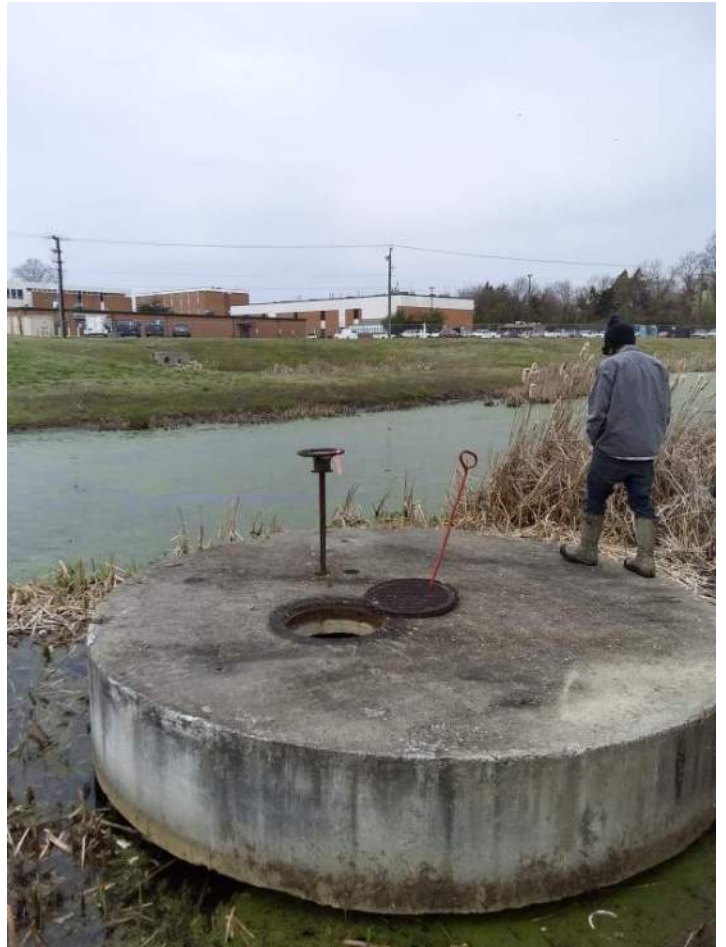
BMP 30: outfall structure

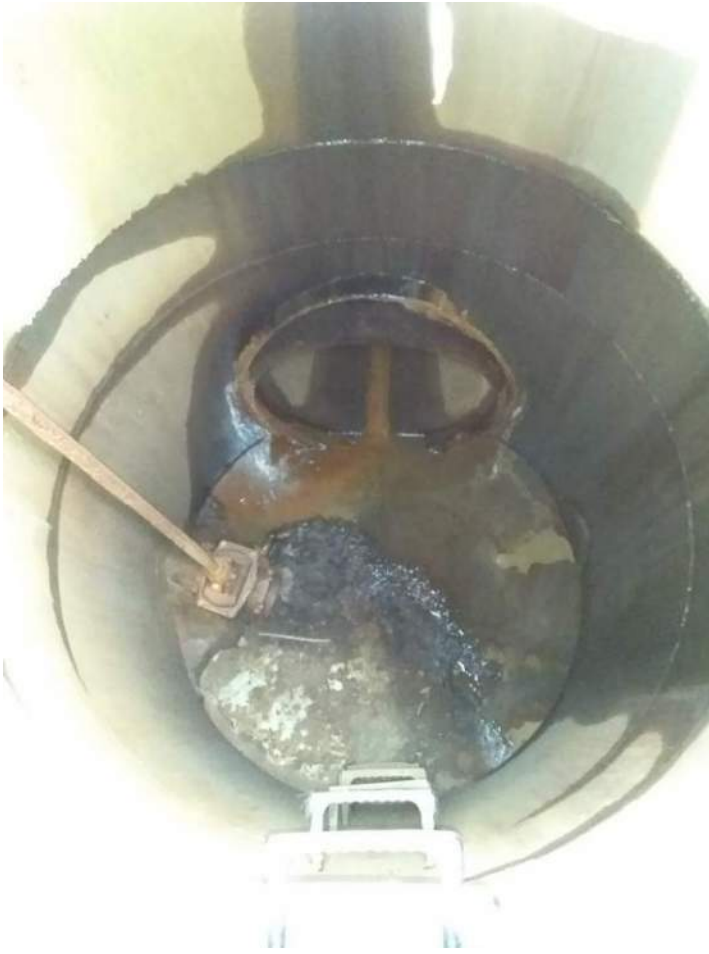
BMP 30: view under manhole

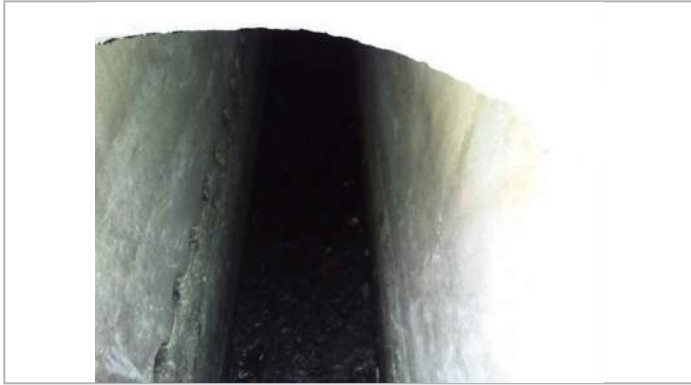
BMP 31: Sediment chamber facing south <1" of sediment in bottom

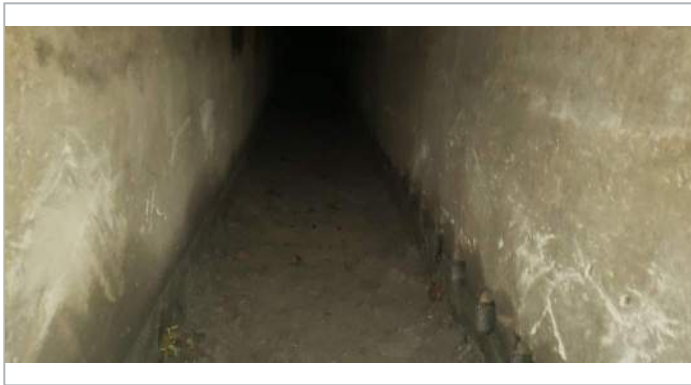
BMP 31 Beginning of Sand Filter, showing a thin layer of sediment on top of actual sand filter

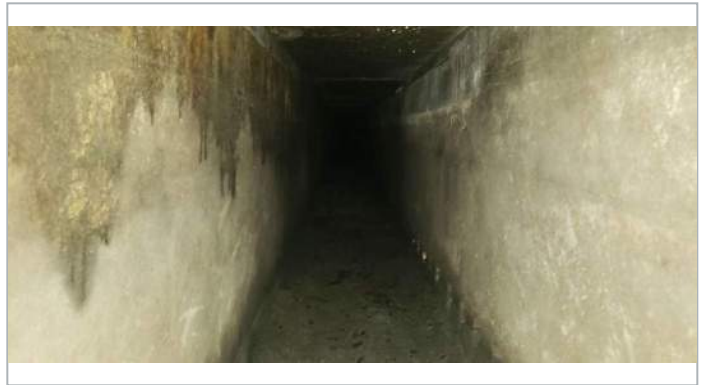
BMP 31 Progressing through the sand filter

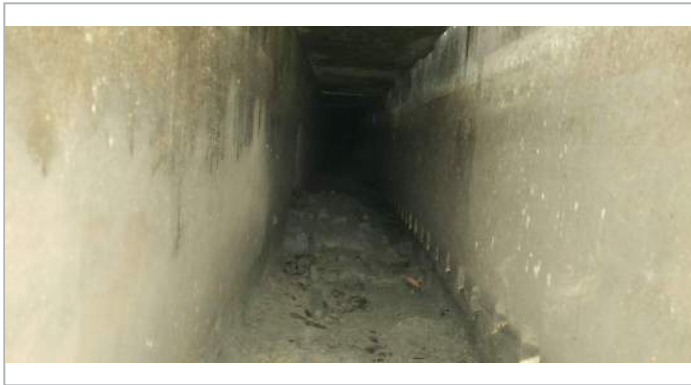
COMPLETION NOTES	
	Sediment removed from the first 30% of the sand filter. Note the sediment appears to be deposited in large piles.

BMP 31 Sediment piles on top of sand filter (roughly 3-5" of sediment)

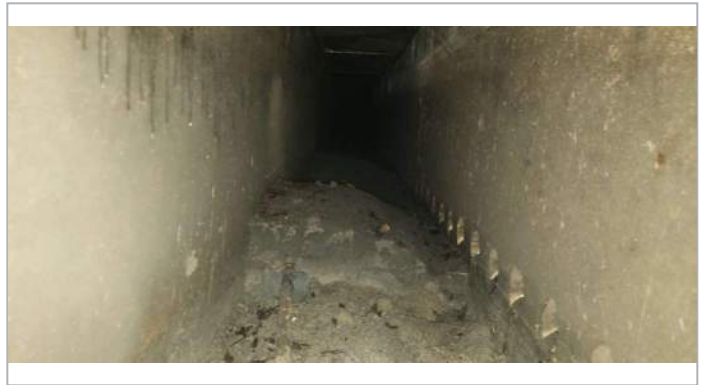
BMP 31 Continuing down the sand filter, showing more sediment piles.
