Virginia State University
MS-4 Permit: VAR040119
July 1, 2020 - June 30, 2021 Annual Report

Prepared for
Virginia State University
Capital Outlay & Facilities Management
PO Box 9414
Virginia State University, VA 23806

October 1, 2021

Prepared by: Timmons Group
1001 Boulders Parkway, Suite 300
Richmond, VA 23225
(804) 200-6500

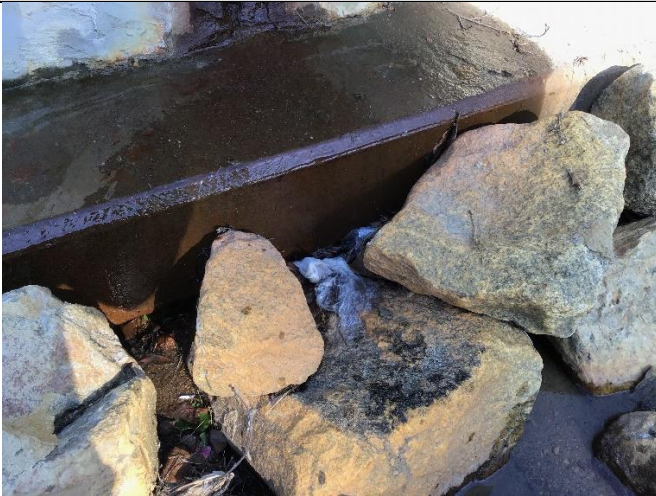
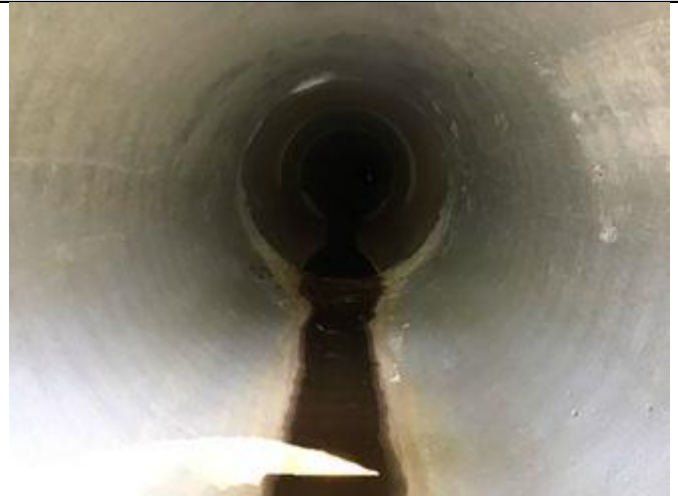
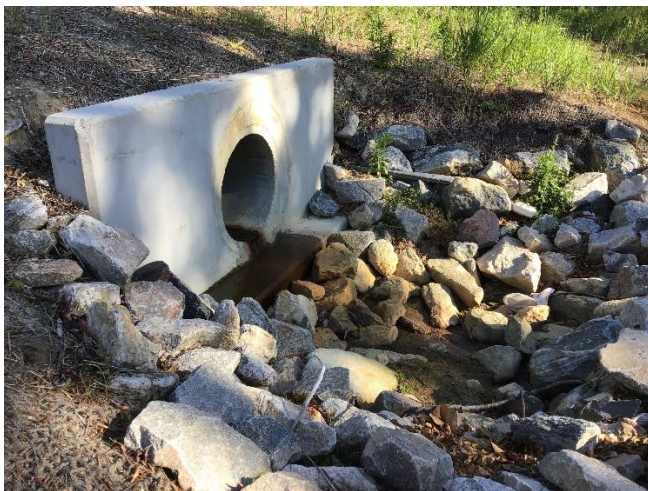
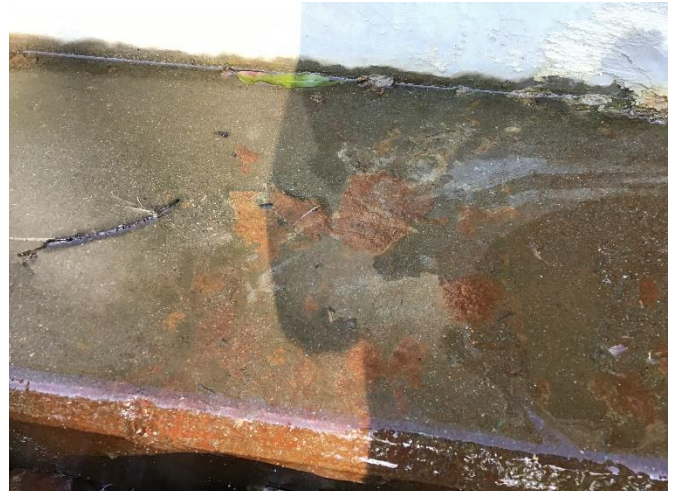
Outfall ID: 01	Date: 05/14/2021	Time: 08:24	Inspector: LRC
----------------	------------------	-------------	----------------

Indicator	Present?	Description	Relative Severity Index (1-3)
Odor	No	NA	NA
Turbidity	No	See Severity Index	NA
Floatables	No	NA	NA
Deposits/Stains	No	NA	NA
Poor Pool Quality	No	NA	NA
Pipe Benthic Growth	No	NA	NA

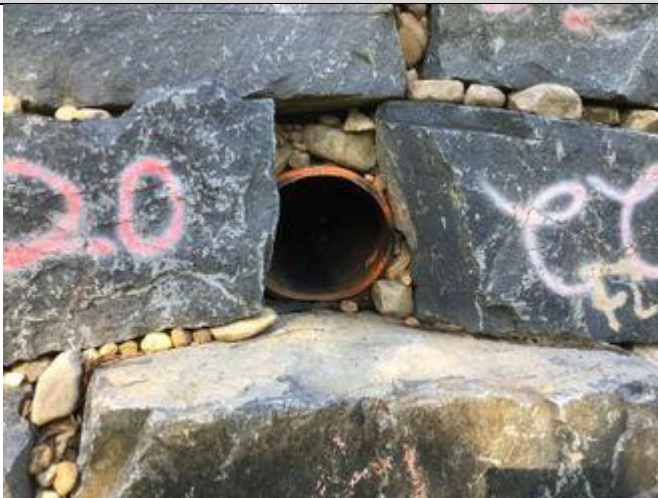
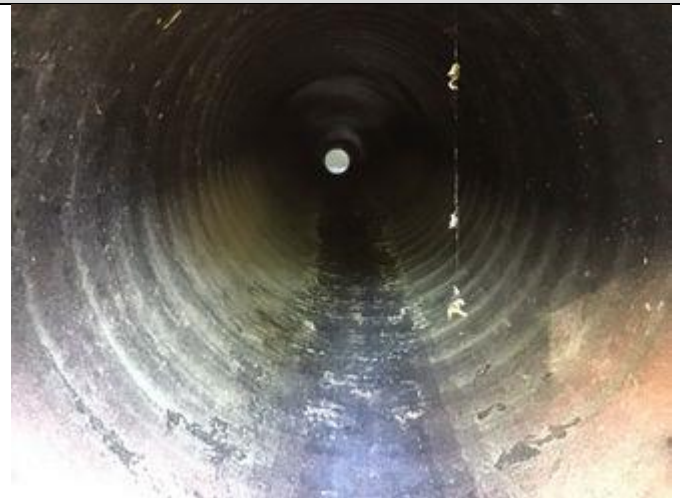
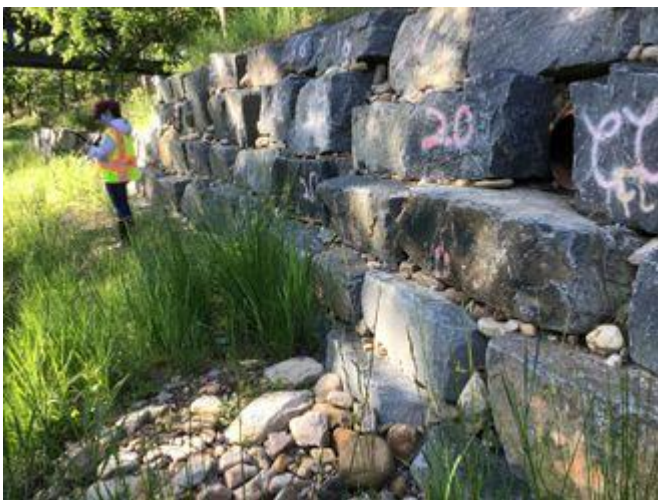
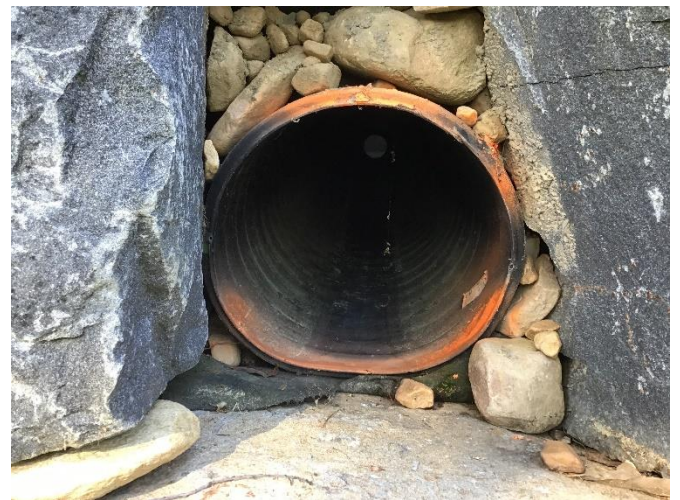
Outfall ID: 02	Date: 05/14/2021	Time: 08:39	Inspector: LRC
----------------	------------------	-------------	----------------

Indicator	Present?	Description	Relative Severity Index (1-3)
Odor	No	NA	NA
Turbidity	No	See Severity Index	NA
Floatables	Yes	Suds	1
Deposits/Stains	No	NA	NA
Poor Pool Quality	Yes	Suds	1
Pipe Benthic Growth	No	NA	NA

Notes:
 Not suspected of an illicit discharge because the flow rate is steady, there was no smell, and investigation upstream could not determine a source. No changes to the flow were found upstream within the investigated reach.

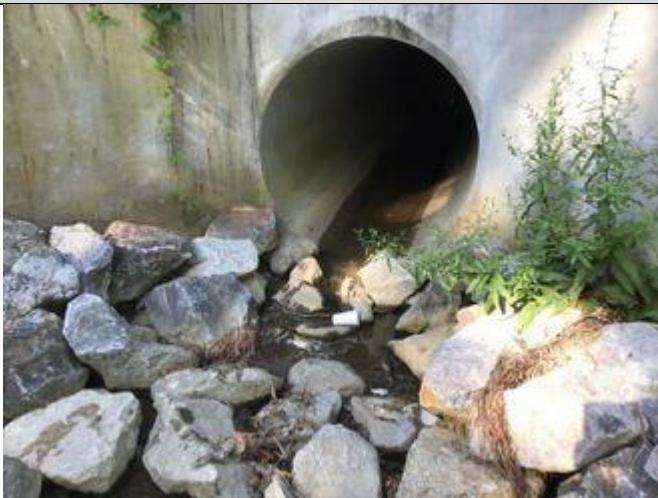
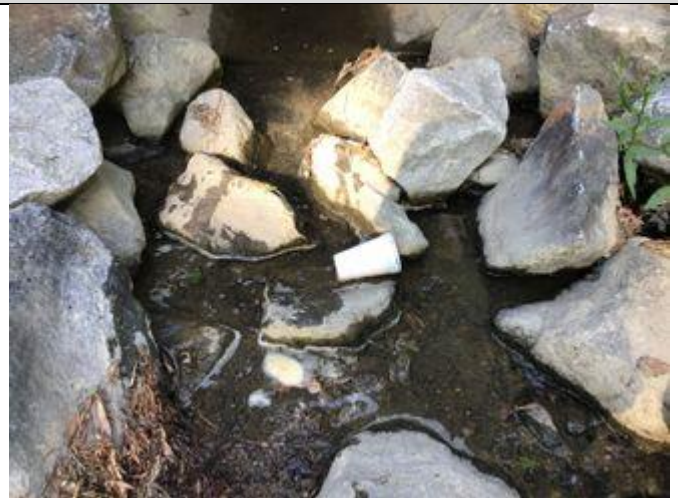
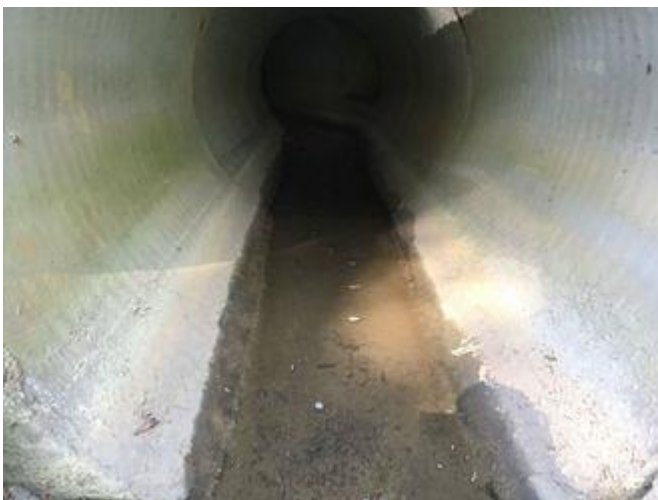
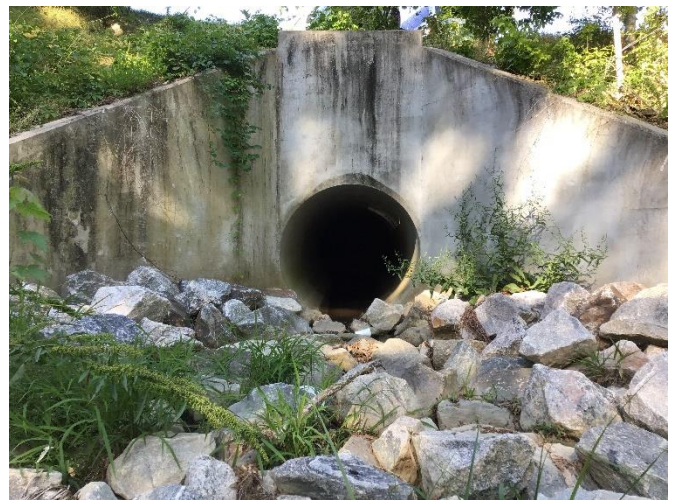
Outfall ID: 03	Date: 05/14/2021	Time: 08:48	Inspector: LRC
----------------	------------------	-------------	----------------

Indicator	Present?	Description	Relative Severity Index (1-3)
Odor	No	NA	NA
Turbidity	No	See Severity Index	NA
Floatables	No	NA	NA
Deposits/Stains	No	NA	NA
Poor Pool Quality	No	NA	NA
Pipe Benthic Growth	No	NA	NA

The pipe looked clear illicit discharge indicators, despite a small steady flow. Trash in outfall area but appeared to be from people throwing over adjacent bridge edge and not necessarily from the outfalls flow. It is recommended this trash be cleared.

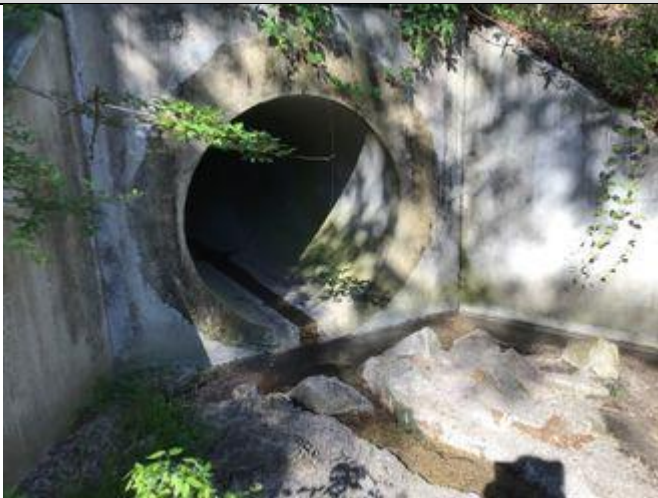
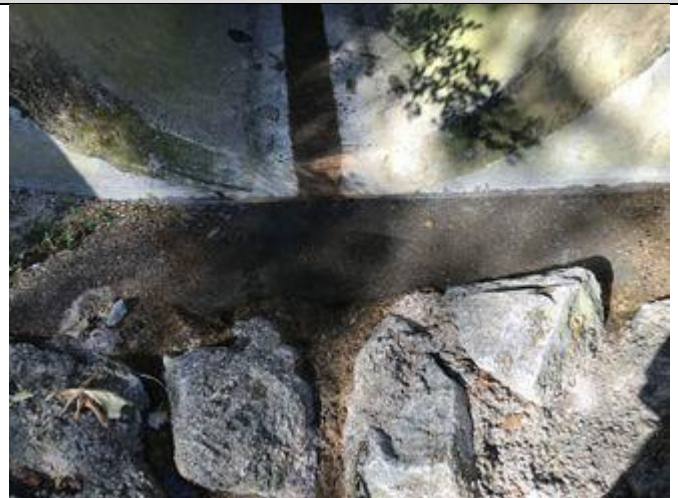
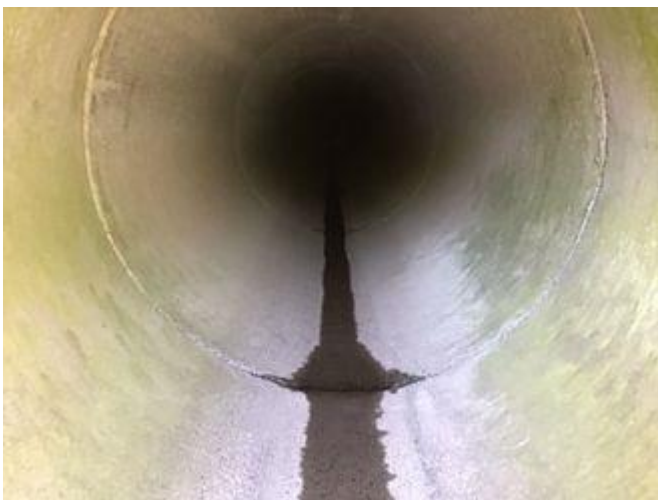
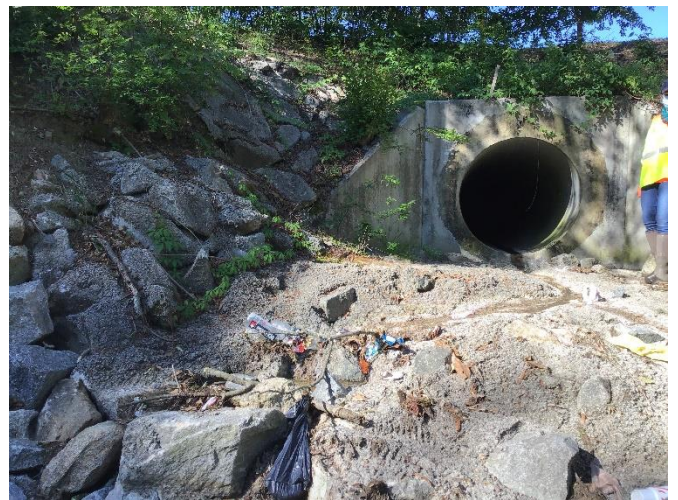
Outfall ID: 04	Date: 05/14/2021	Time: 08:58	Inspector: LRC
----------------	------------------	-------------	----------------

Indicator	Present?	Description	Relative Severity Index (1-3)
Odor	No	NA	NA
Turbidity	Yes	See Severity Index	1
Floatables	Yes	Suds, Trash	1
Deposits/Stains	No	NA	NA
Poor Pool Quality	Yes	Floatables, Some Algae, Trash	2
Pipe Benthic Growth	No	NA	NA

The outfall was difficult to access and partially submerged. There was excessive trash present. The BMP inspection upstream, which included confined space entry, indicated no pollutants present in the upstream BMP. Therefore, the discharges from this outfall are not suspected of illicit discharges. However, the water quality at the pool, including the presence of a dead turtle, algae, and trash could indicate pollutants due to the water sitting stagnant for long periods of time. Recommended actions would be to clear vegetation surrounding the outfall for easier access and removing excessive trash. With excessive trash removed, it is believed the water would be able to flow freely and the water quality would improve.

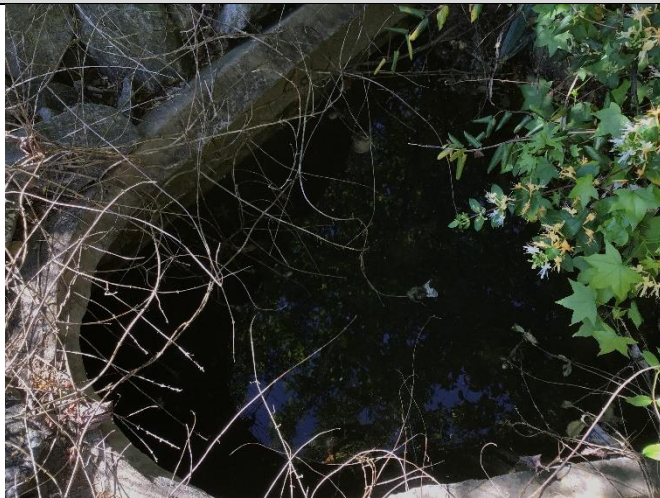
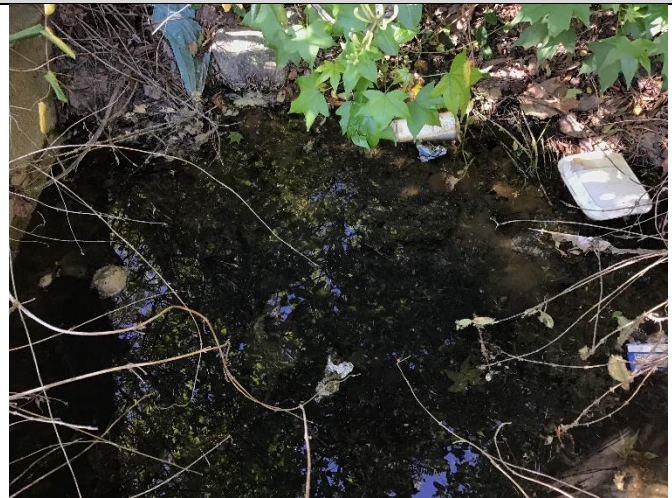
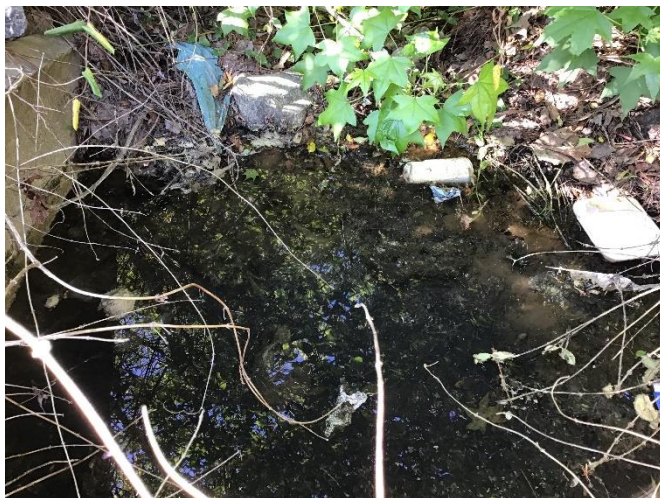
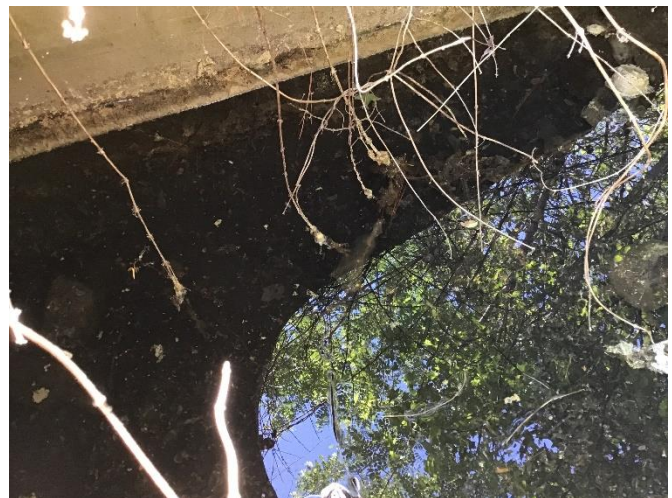
Outfall ID: 05	Date: 05/14/2021	Time: 09:07	Inspector: LRC
----------------	------------------	-------------	----------------

Indicator	Present?	Description	Relative Severity Index (1-3)
Odor	No	NA	NA
Turbidity	No	See Severity Index	NA
Floatables	No	NA	NA
Deposits/Stains	No	NA	NA
Poor Pool Quality	No	NA	NA
Pipe Benthic Growth	No	NA	NA

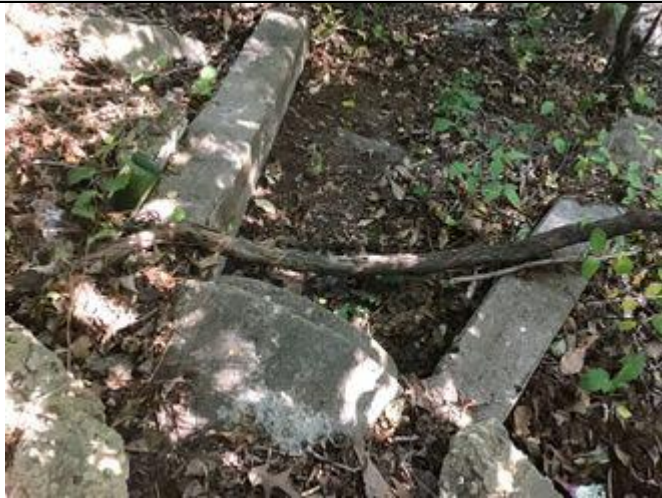
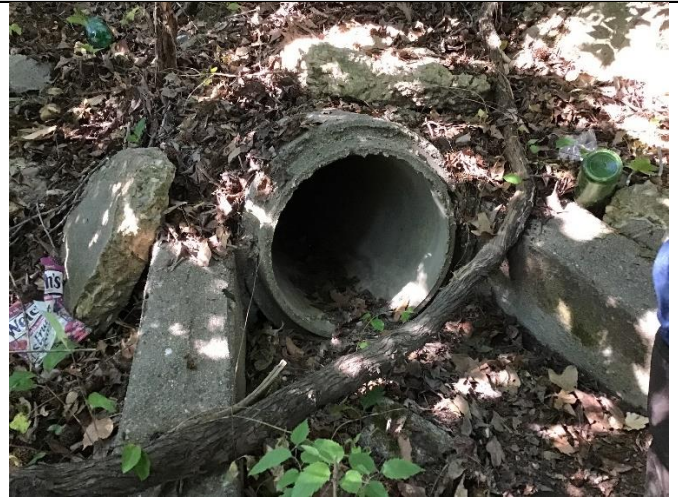
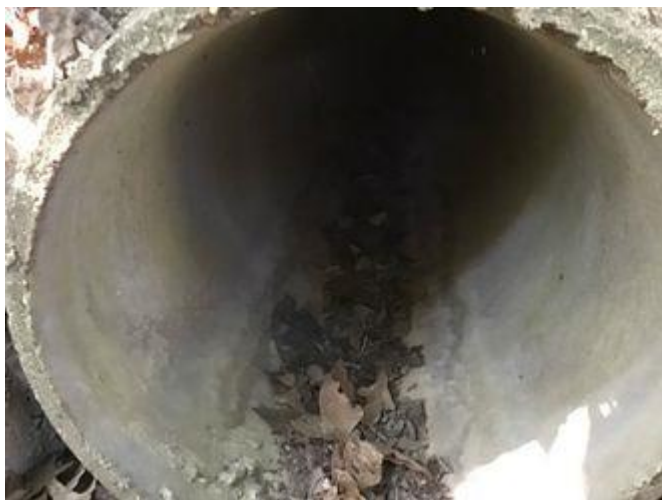
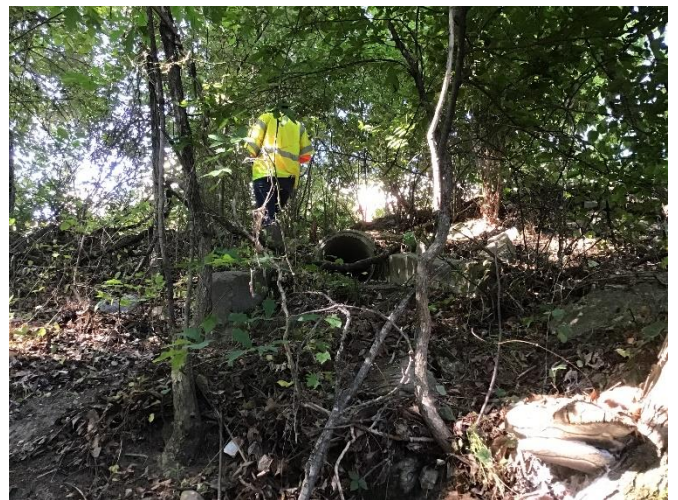
Outfall ID: 06	Date: 05/14/2021	Time: 09:29	Inspector: LRC
----------------	------------------	-------------	----------------

Indicator	Present?	Description	Relative Severity Index (1-3)
Odor	No	NA	NA
Turbidity	Yes	See Severity Index	1
Floatables	No	NA	NA
Deposits/Stains	No	NA	NA
Poor Pool Quality	No	NA	NA
Pipe Benthic Growth	Yes	Green	2

The pipe had a small flow that did not look to be illicit, with the only other indicator being pipe benthic growth along the energy dissipator section. This is presumed to be from water sitting for long periods of time. Upstream investigation revealed no other indicators. It is recommended the excess tree branches falling along the outfall be removed to allow water to flow freely.

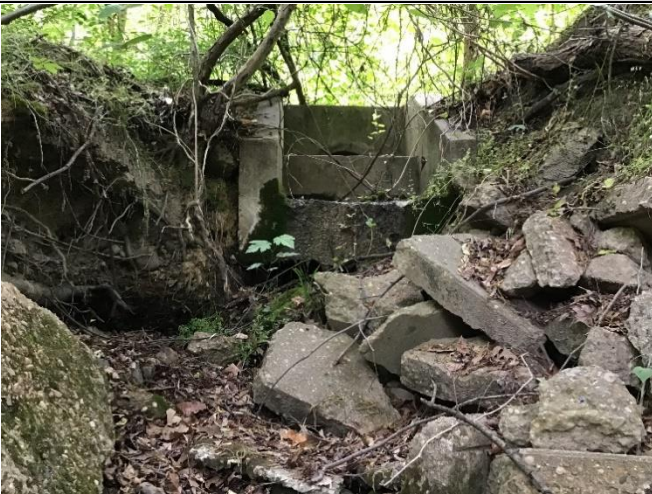
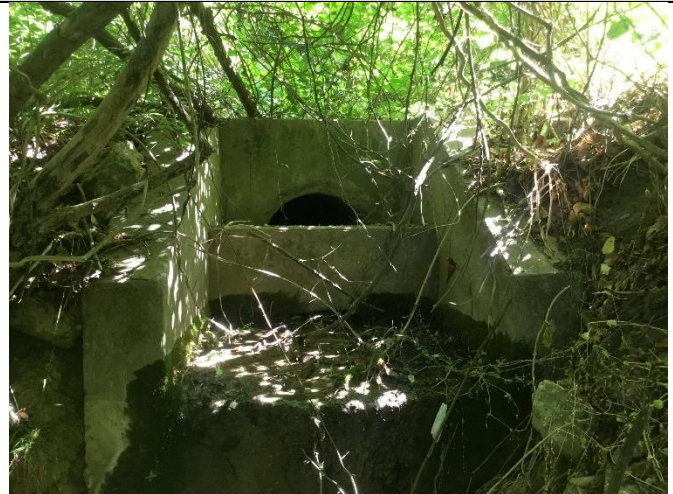
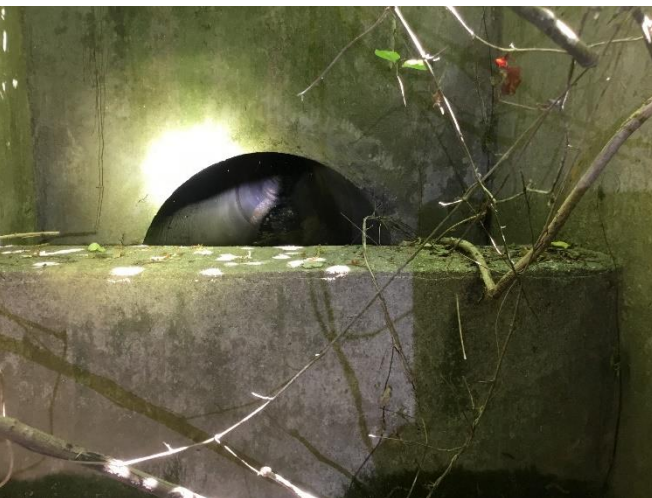
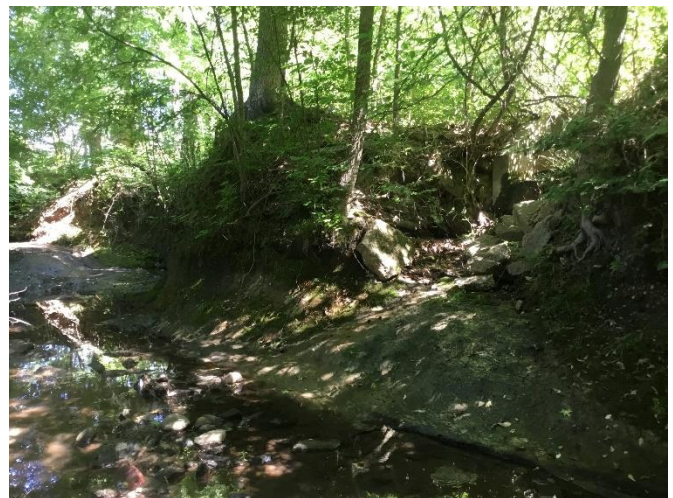
Outfall ID: 08	Date: 05/14/2021	Time: 12:44	Inspector: HMA
----------------	------------------	-------------	----------------

POTENTIAL POLLUTANT INDICATORS			
Indicator	Present?	Description	Relative Severity Index (1-3)
Odor	No	NA	NA
Turbidity	No	See Severity Index	NA
Floatables	No	NA	NA
Deposits/Stains	No	NA	NA
Poor Pool Quality	No	NA	NA
Pipe Benthic Growth	No	NA	NA

Notes:
 The pipe looked clear of both flow and illicit discharge indicators. The pipe has become disconnected from the flume. It is recommended this be repaired to prevent further erosion and potential end section separation and failure.

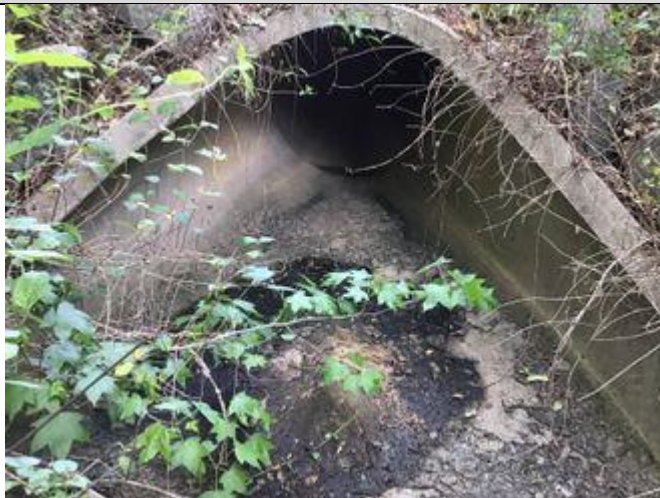
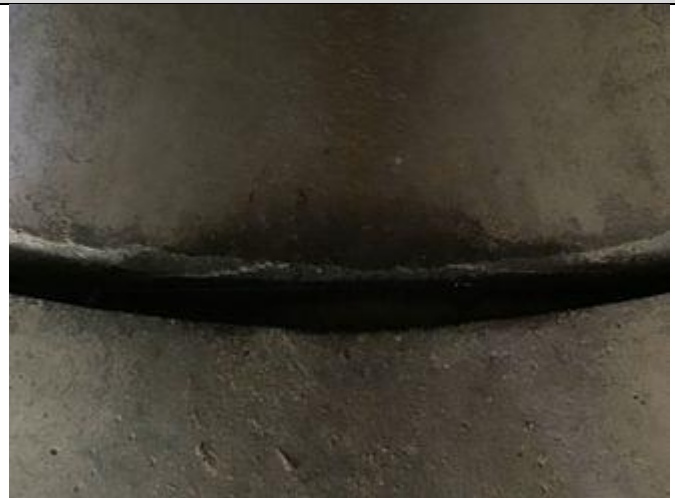
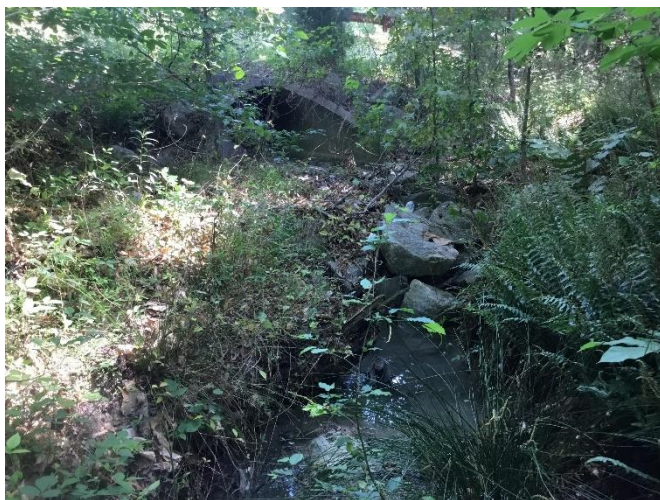
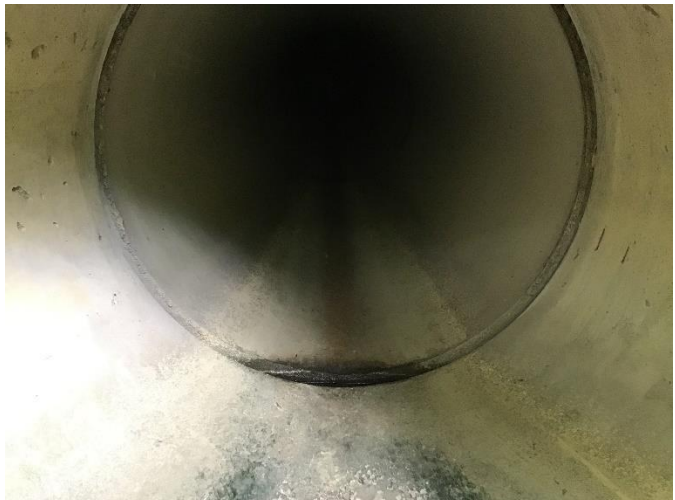
Outfall ID: 09	Date: 05/14/2021	Time: 12:33	Inspector: HMA
----------------	------------------	-------------	----------------

Indicator	Present?	Description	Relative Severity Index (1-3)
Odor	No	NA	NA
Turbidity	No	See Severity Index	NA
Floatables	No	NA	NA
Deposits/Stains	No	NA	NA
Poor Pool Quality	No	NA	NA
Pipe Benthic Growth	No	NA	NA

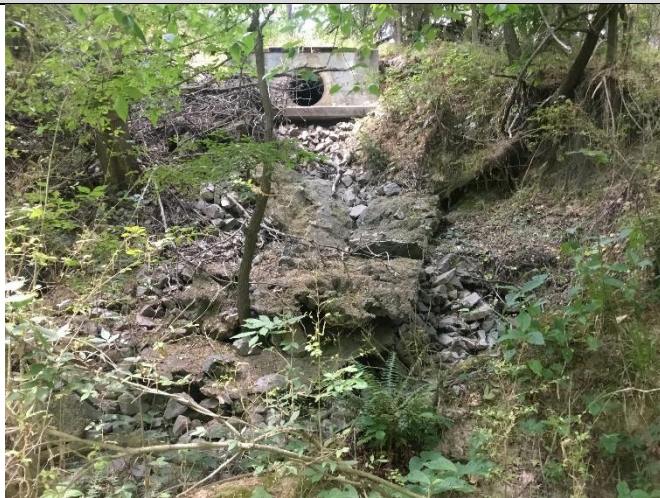
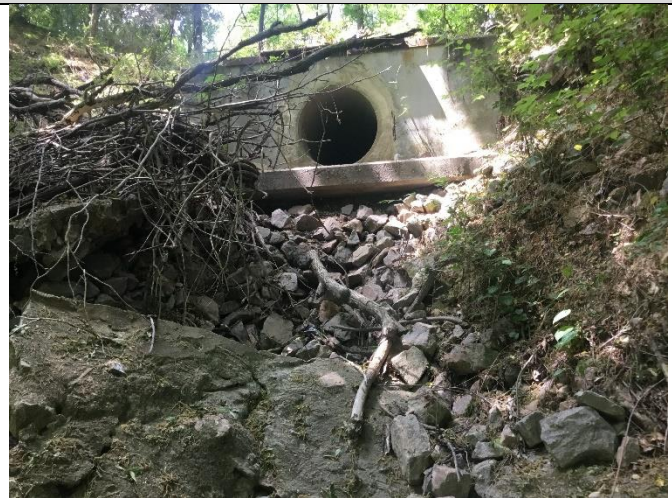
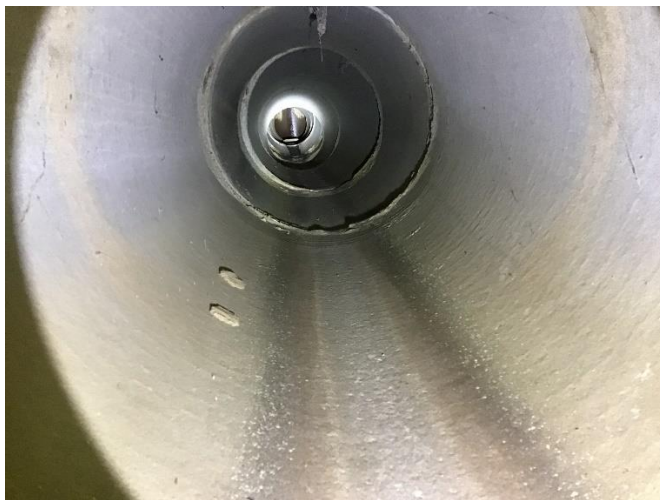
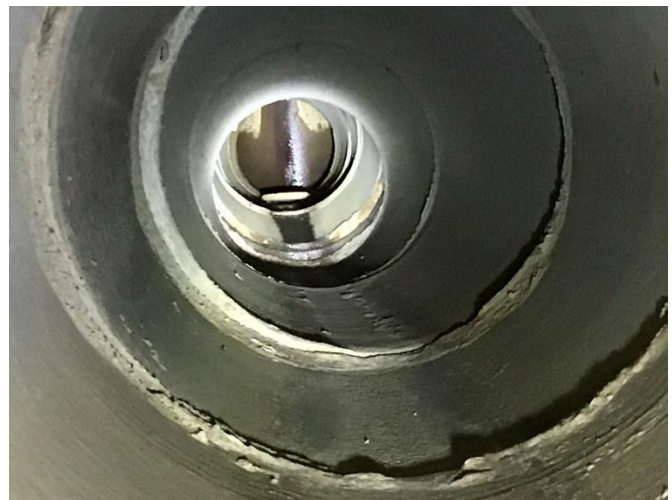
Outfall ID: 10	Date: 05/14/2021	Time: 09:39	Inspector: LRC
----------------	------------------	-------------	----------------

Indicator	Present?	Description	Relative Severity Index (1-3)
Odor	Yes	Rancid/Sour	2
Turbidity	Yes	See Severity Index	2
Floatables	Yes	Sheen	2
Deposits/Stains	Yes	Sheen	2
Poor Pool Quality	Yes	Colors, Floatables, Excessive Algae	2
Pipe Benthic Growth	No	NA	NA

The pipe looked to have a flow, as well as several other indicators present that could indicate illicit discharge. The outfall was difficult to access. It is important to note this is the outfall to an upstream BMP (BMP #30). The BMP inspection for this facility noted erosion, cattails, and excessive duckweed. It is suspected the excessive duckweed indicates the pond likely has turned anaerobic.

It is recommended once receiving the findings of this report, VSU take steps in removing the excessive duckweed to see if this improves the water quality of the discharge. Additionally, a review of the nutrient management plan and staff implementation of that plan may be required. There is a well-maintained lawn just upstream of the BMP that slopes towards the BMP, and the maintenance of this area could be impacting the water quality of the BMP.

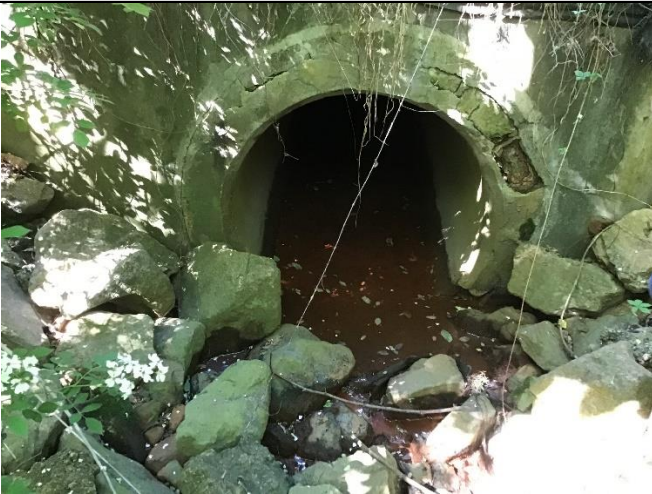
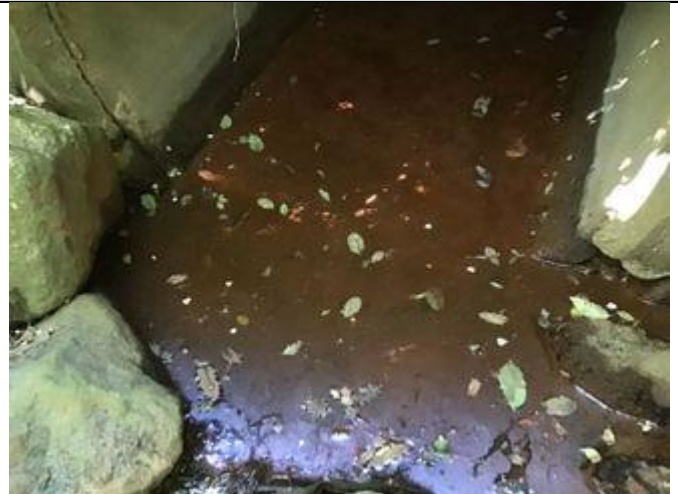
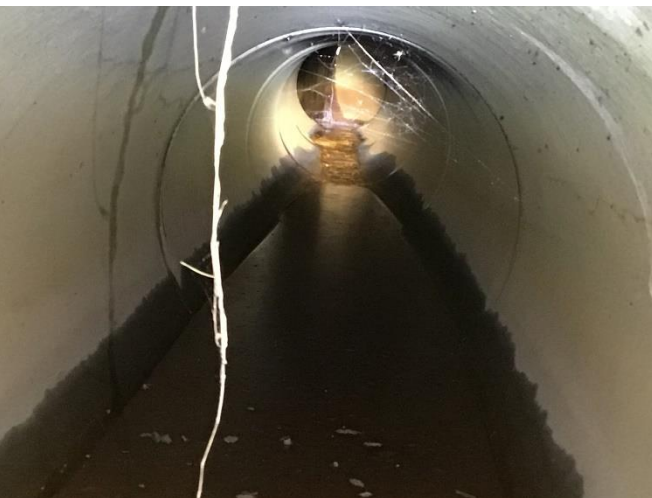
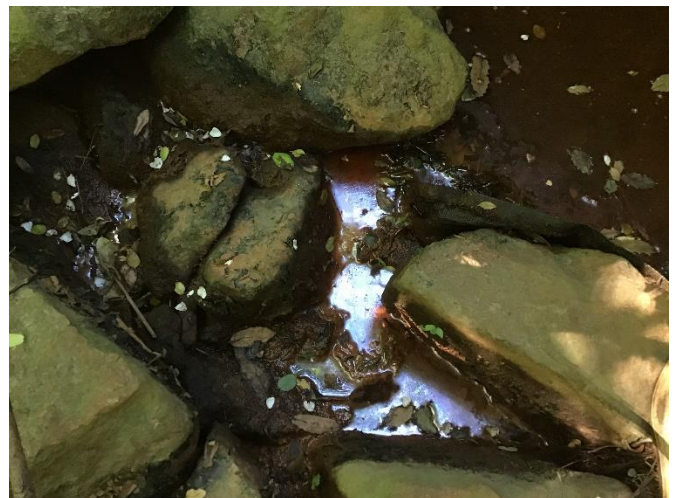
Outfall ID: 11	Date: 05/14/2021	Time: 10:02	Inspector: LRC
----------------	------------------	-------------	----------------

POTENTIAL POLLUTANT INDICATORS			
Indicator	Present?	Description	Relative Severity Index (1-3)
Odor	No	NA	NA
Turbidity	No	See Severity Index	NA
Floatables	No	NA	NA
Deposits/Stains	No	NA	NA
Poor Pool Quality	No	NA	NA
Pipe Benthic Growth	No	NA	NA

Notes:
 The pipe looked clear of both flow and illicit discharge indicators. It is recommended the outfall be cleared of tree branches and debris currently obstructing the outfall.

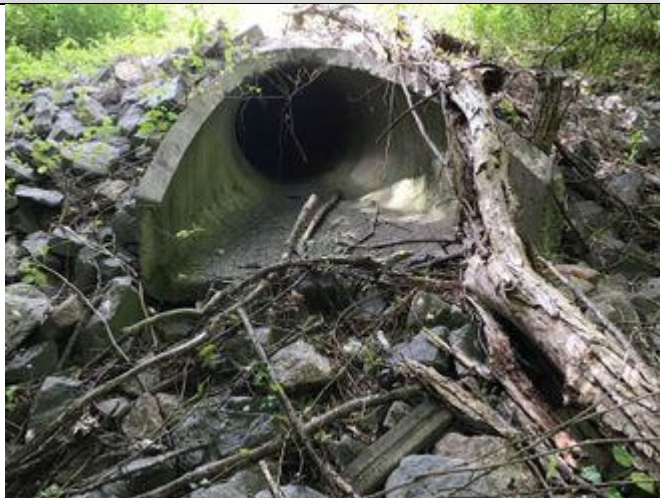
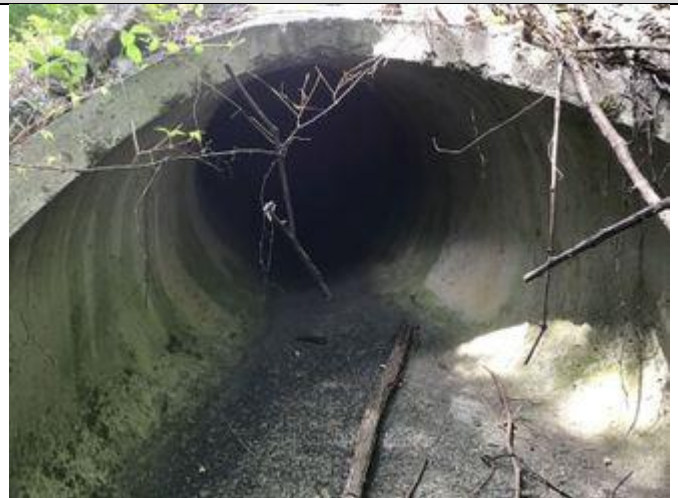
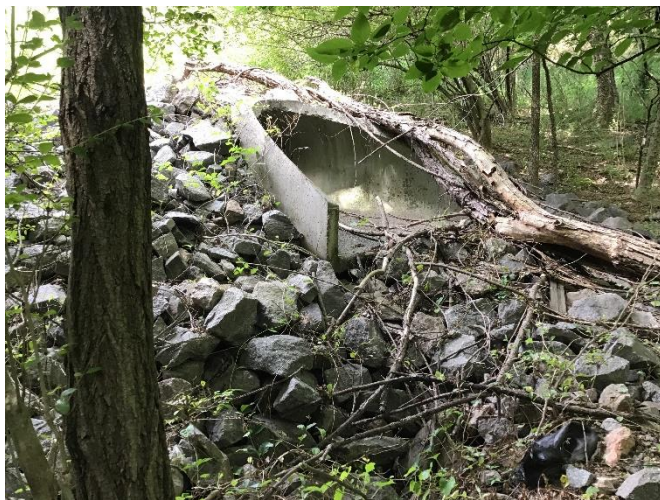
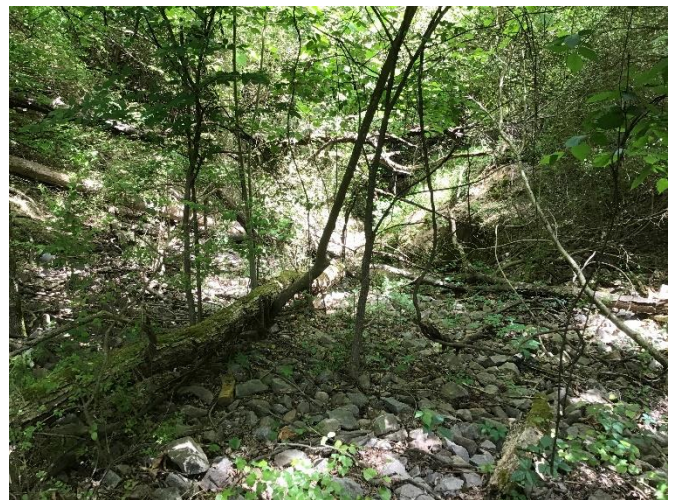
Outfall ID: 12	Date: 05/14/2021	Time: 12:21	Inspector: HMA
----------------	------------------	-------------	----------------

The pipe outfall did not have any flow and there were no indicators of illicit discharges present. This outfall area contained significant erosion, which could be dangerous to the adjacent road if not addressed soon. An entire section of the concrete outfall pipe has fallen off into the eroded area. Additionally, there is a plastic pipe, with an unknown origin of where it is discharging from, that is completely exposed next to the outfall location. It is recommended to follow up with a stabilization plan, as well as determining the purpose of the plastic exposed pipe.

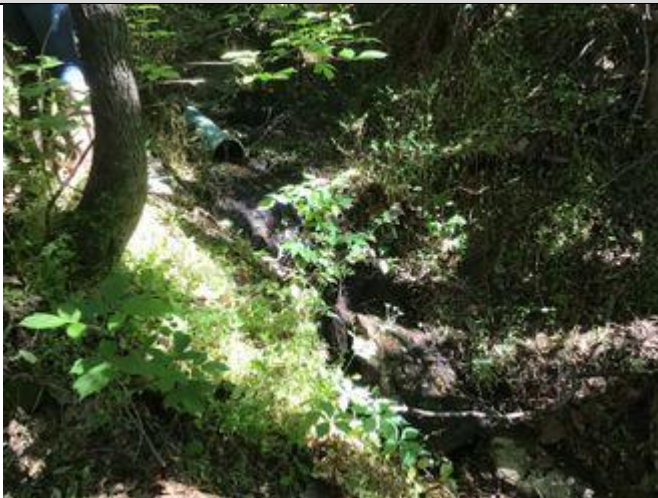
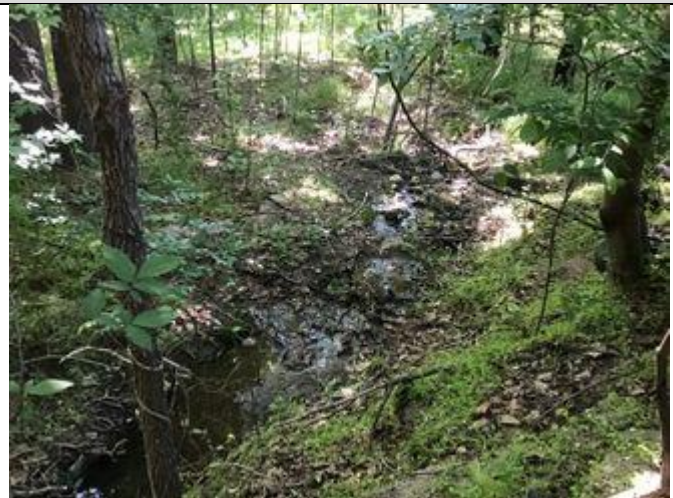
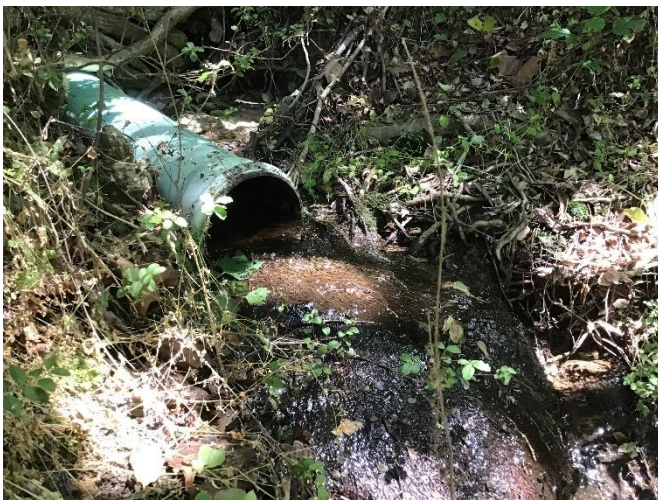
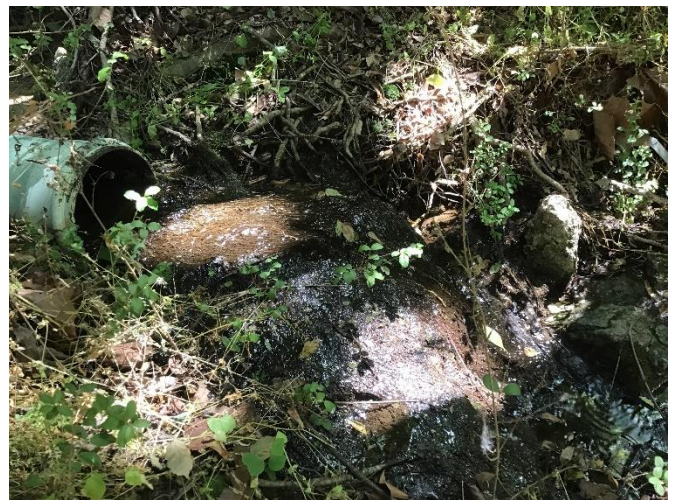
Outfall ID: 16	Date: 05/14/2021	Time: 10:39	Inspector: LRC
----------------	------------------	-------------	----------------

Indicator	Present?	Description	Relative Severity Index (1-3)
Odor	No	NA	NA
Turbidity	No	See Severity Index	NA
Floatables	No	NA	NA
Deposits/Stains	No	NA	NA
Poor Pool Quality	No	NA	NA
Pipe Benthic Growth	No	NA	NA

Notes:
 The pipe did not have a flow, and no indicators were present therefore no illicit discharge was suspected. There was a significant amount of sediment buildup, and it is recommended this be removed to allow the pipes to flow at full capacity.

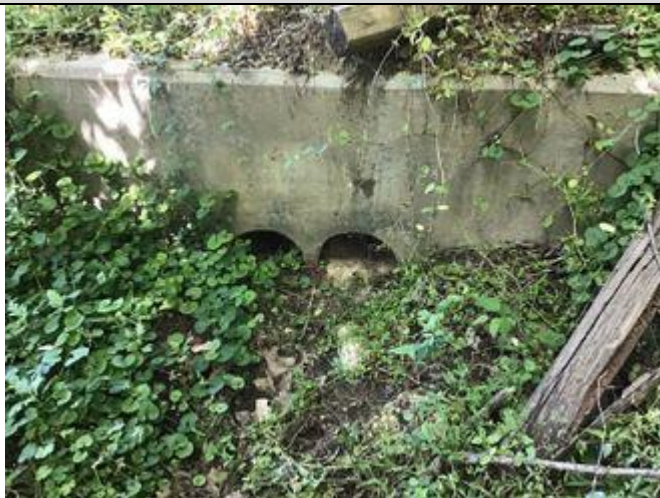
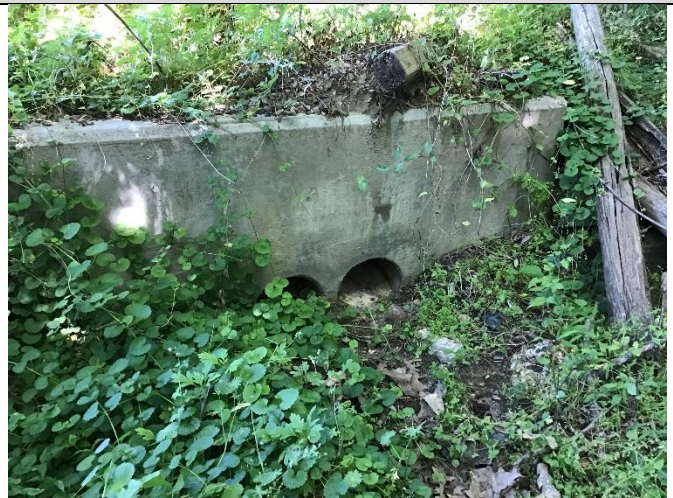
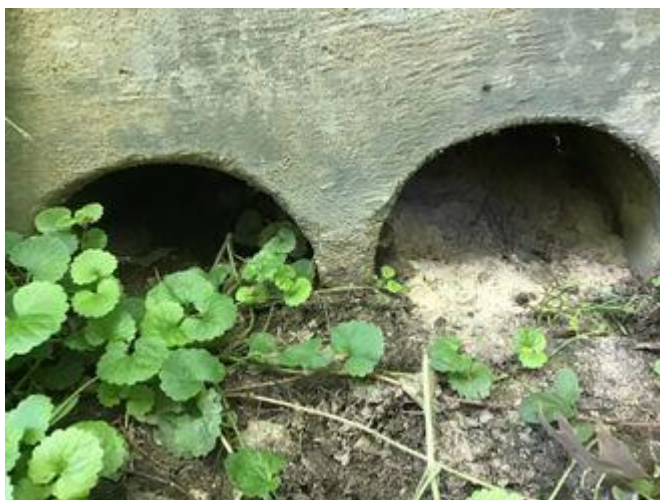
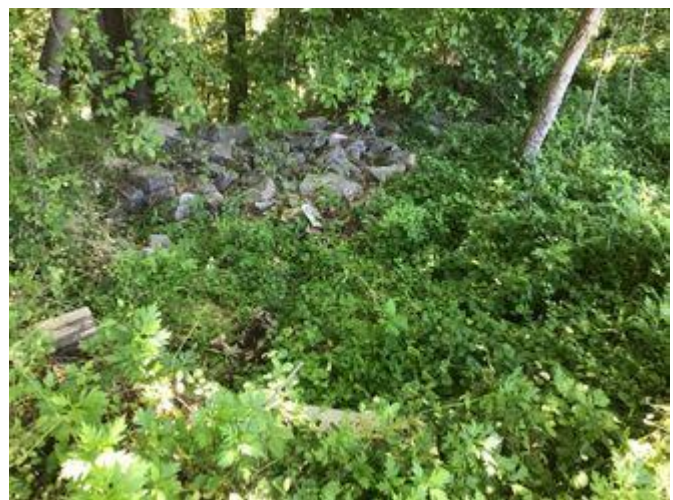
Outfall ID: 17	Date: 05/14/2021	Time: 10:33	Inspector: LRC
----------------	------------------	-------------	----------------

Indicator	Present?	Description	Relative Severity Index (1-3)
Odor	No	NA	NA
Turbidity	Yes	See Severity Index	1
Floatables	No	NA	NA
Deposits/Stains	No	NA	NA
Poor Pool Quality	Yes	Colors	1
Pipe Benthic Growth	Yes	Brown	1

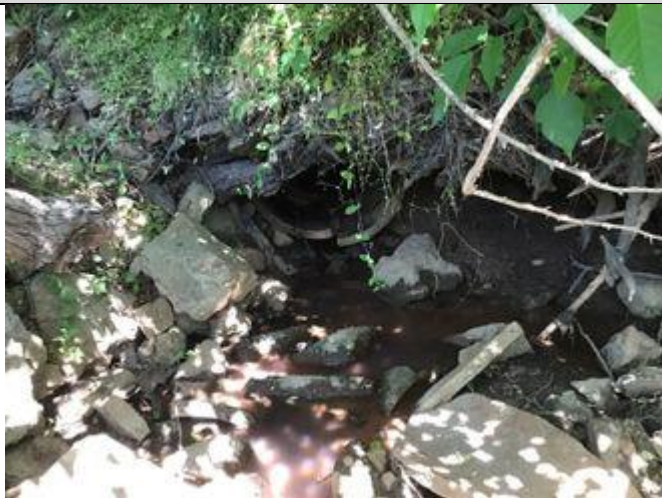
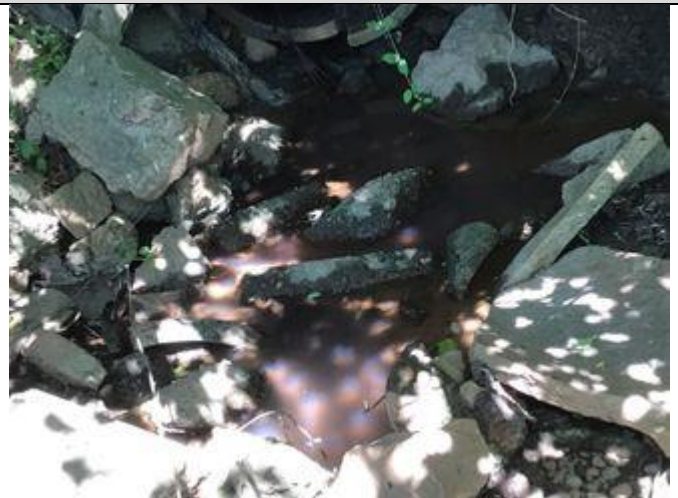
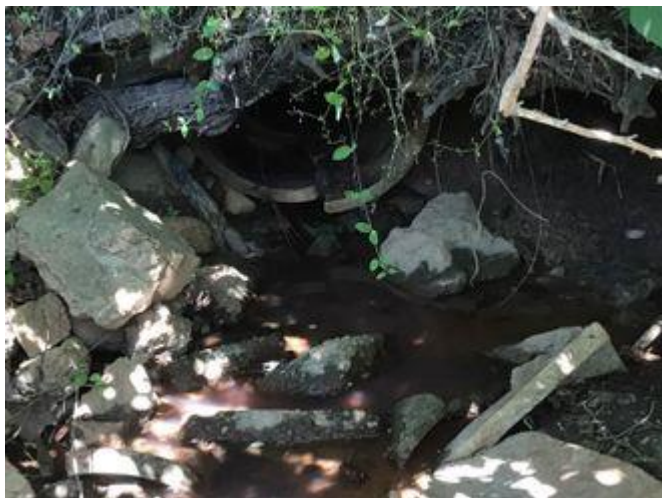
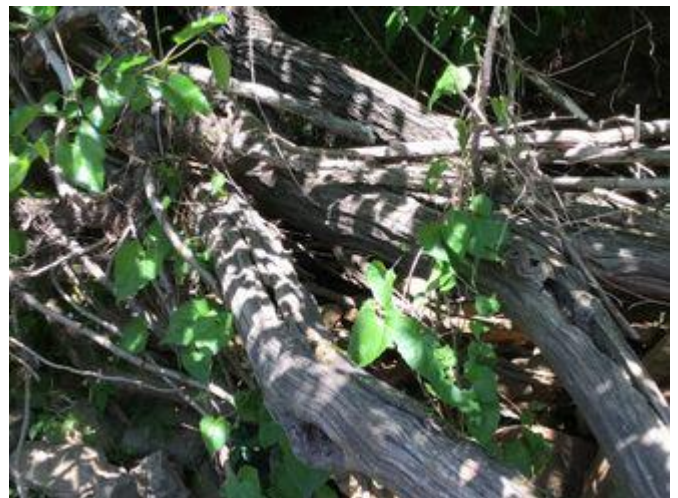
Outfall ID: 18	Date: 05/14/2021	Time: 11:04	Inspector: HMA
----------------	------------------	-------------	----------------

Indicator	Present?	Description	Relative Severity Index (1-3)
Odor	No	NA	NA
Turbidity	No	See Severity Index	NA
Floatables	No	NA	NA
Deposits/Stains	No	NA	NA
Poor Pool Quality	No	NA	NA
Pipe Benthic Growth	No	NA	NA

Notes:
 The pipe looked clear of both flow and illicit discharge indicators. It is recommended the outfall be cleared plants and grass that have started to grow over the outfall.

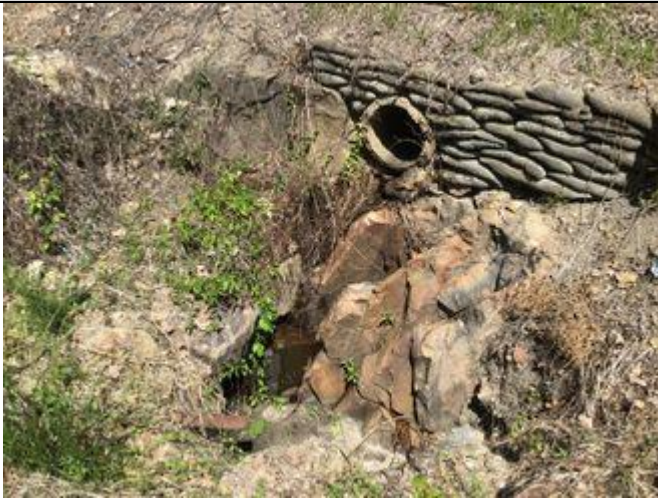
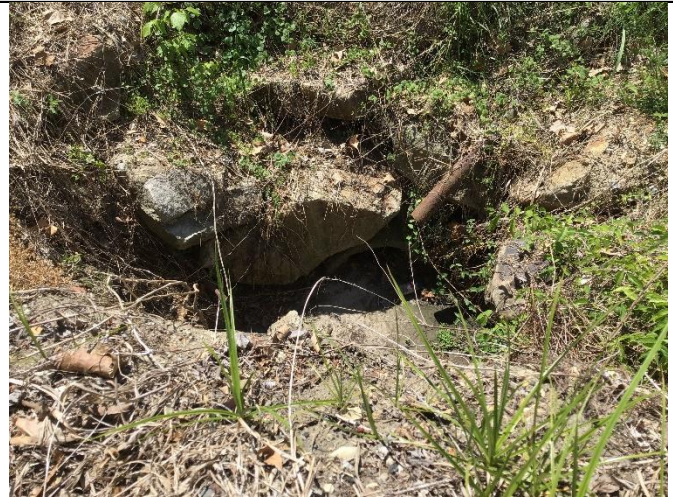
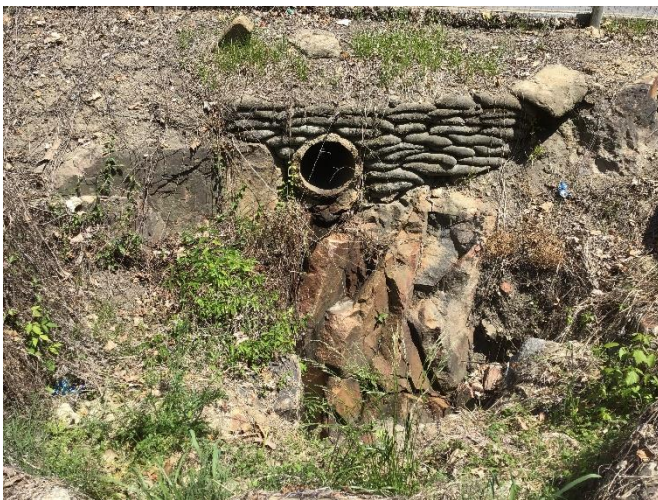
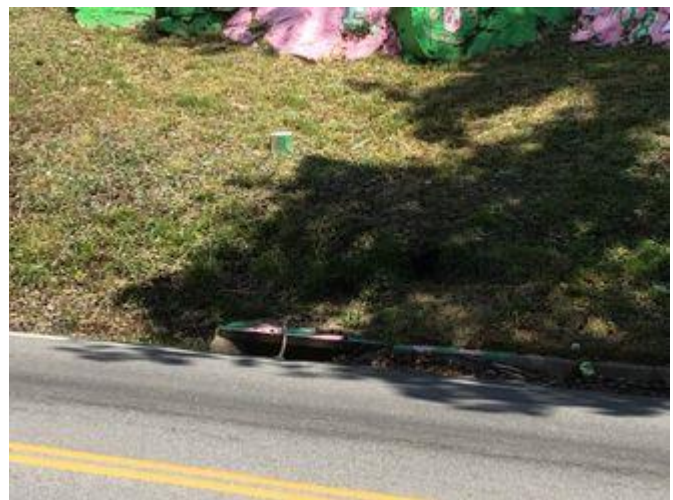
Indicator	Present?	Description	Relative Severity Index (1-3)
Odor	No	NA	NA
Turbidity	No	See Severity Index	NA
Floatables	No	NA	NA
Deposits/Stains	No	NA	NA
Poor Pool Quality	No	NA	NA
Pipe Benthic Growth	Yes	Green	1

Notes:
 Substantial flow was exiting this pipe. Based on upstream investigation, it is unclear where this flow is coming from. However, the flow was clear and besides the indicator of green algae pipe benthic growth, all other indicators would suggest the discharge is not illicit. The Illicit Discharge Detection and Elimination (IDDE) manual states benthic growth of this kind could be due to excessive use of lawn chemicals. It is recommended the nutrient management plan be reviewed and potentially revised if excessive chemicals are being used on the lawn area just north of the outfall. If this area is noted in the nutrient management plan, additional education to lawn care staff should be communicated.
