Virginia State University
MS-4 Permit: VAR040119
July 1, 2020 - June 30, 2021 Annual Report

Prepared for
Virginia State University
Capital Outlay & Facilities Management
PO Box 9414
Virginia State University, VA 23806

October 1, 2021

Prepared by: Timmons Group
1001 Boulders Parkway, Suite 300
Richmond, VA 23225
(804) 200-6500

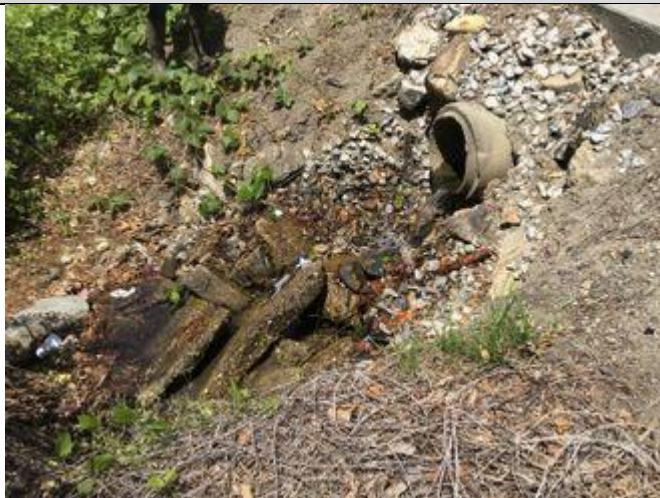
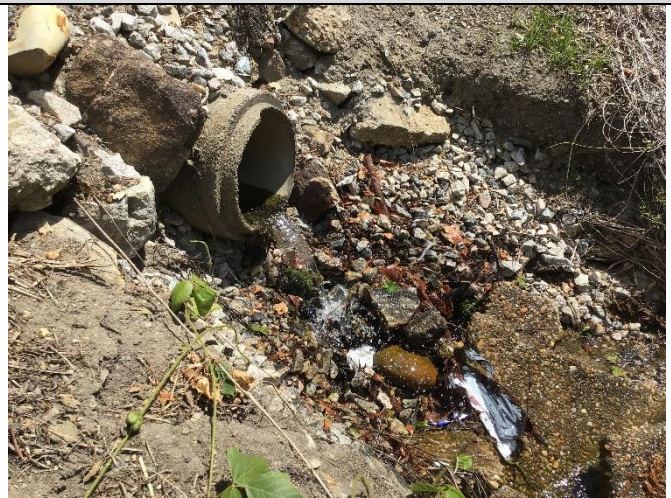
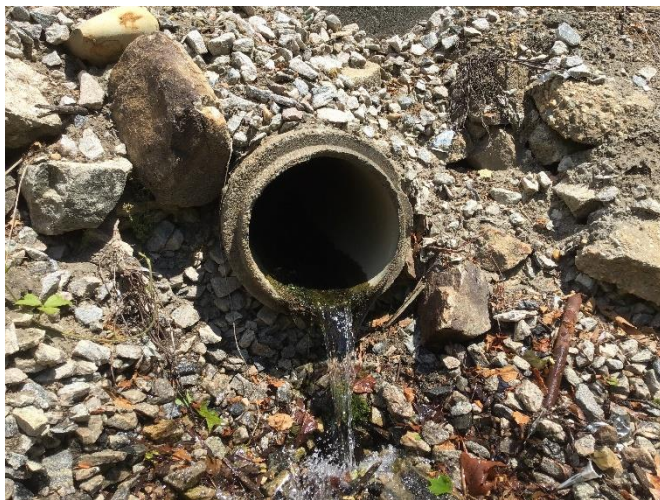
Outfall ID: 22	Date: 05/14/2021	Time: 11:42	Inspector: HMA
----------------	------------------	-------------	----------------

The pipe looked clear of both flow and illicit discharge indicators. It is recommended that the current rip rap be relocated to ensure it is not above the pipe invert.

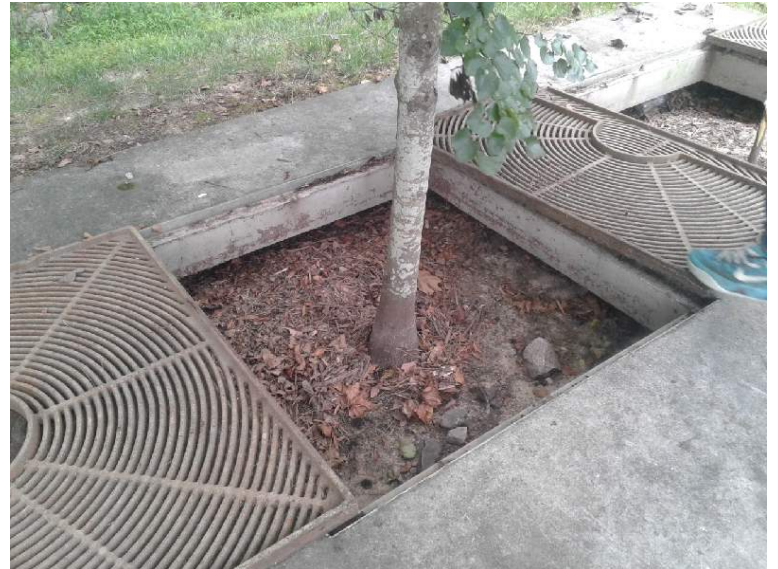
Unit 10: Before

Unit 10: before Tree is dead and broken. Customer would like price to replace both trees with red buds or dogwoods.

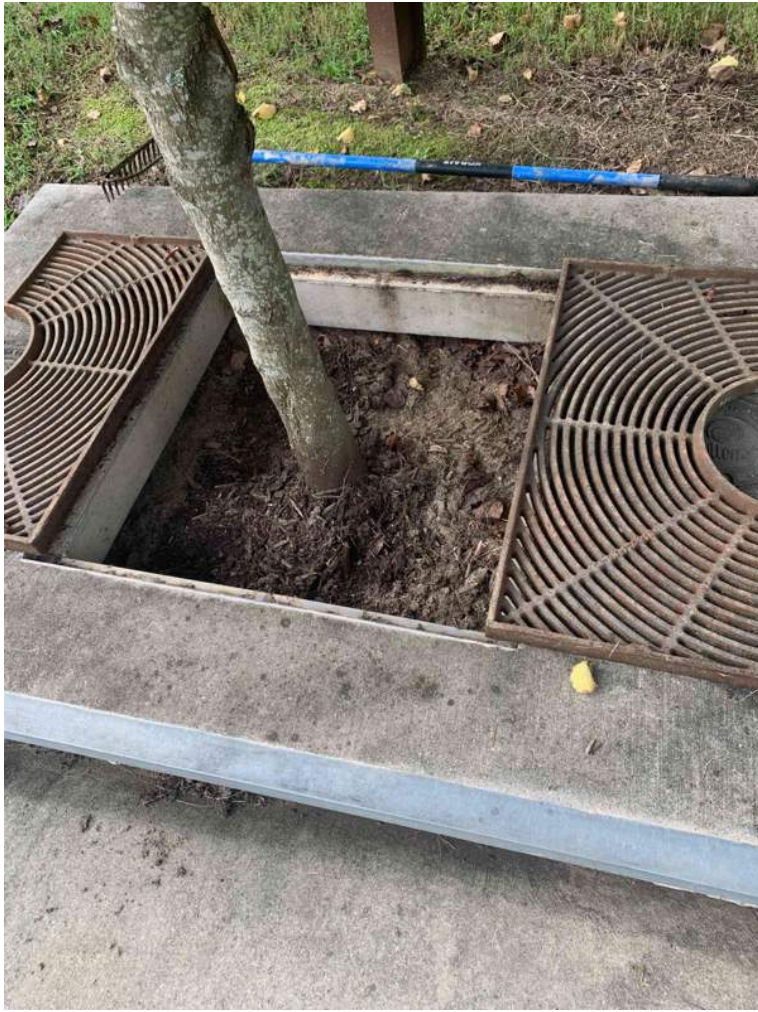
Unit 11: Before

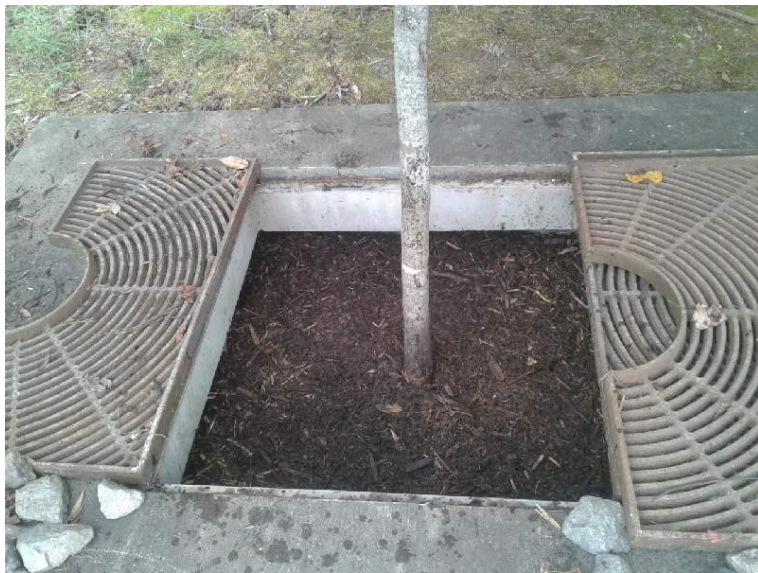
Unit 11: After

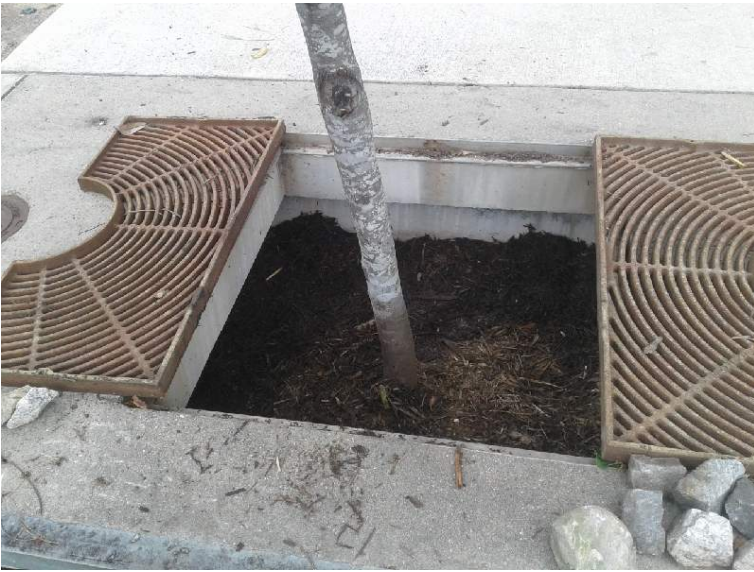
Unit 12: After

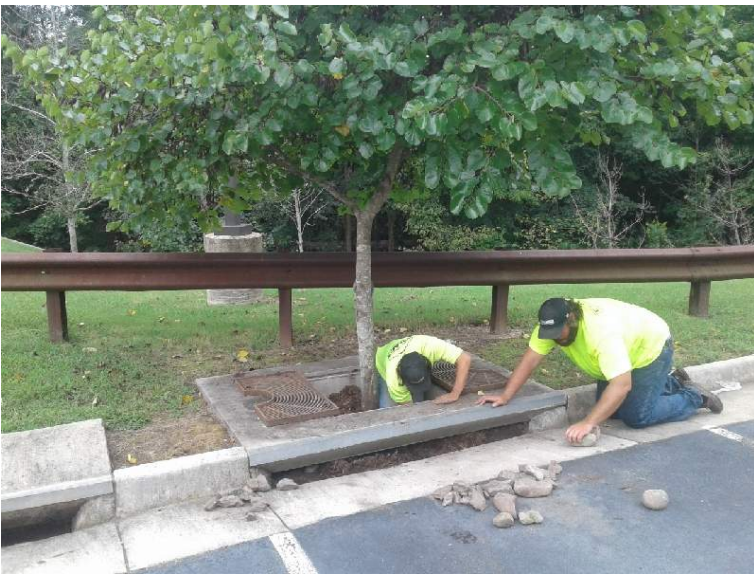
Unit 13: needs new tree, its root bound.

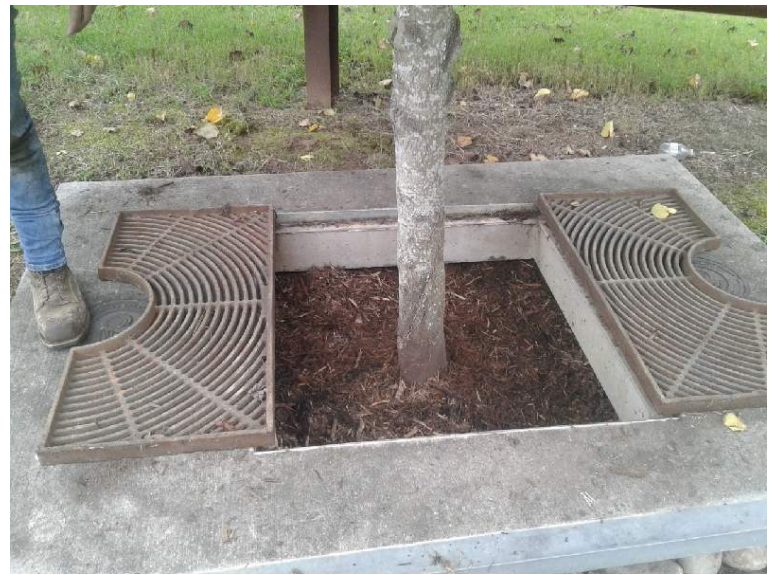
Unit 13: After

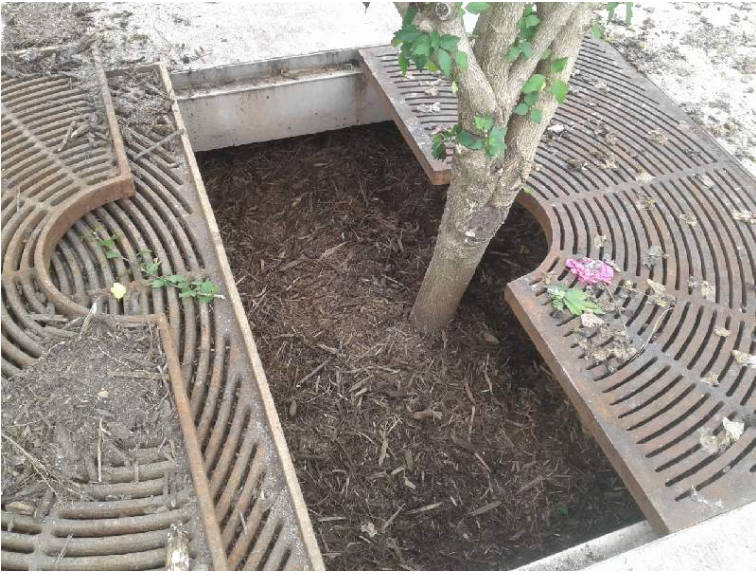
Unit 41: After

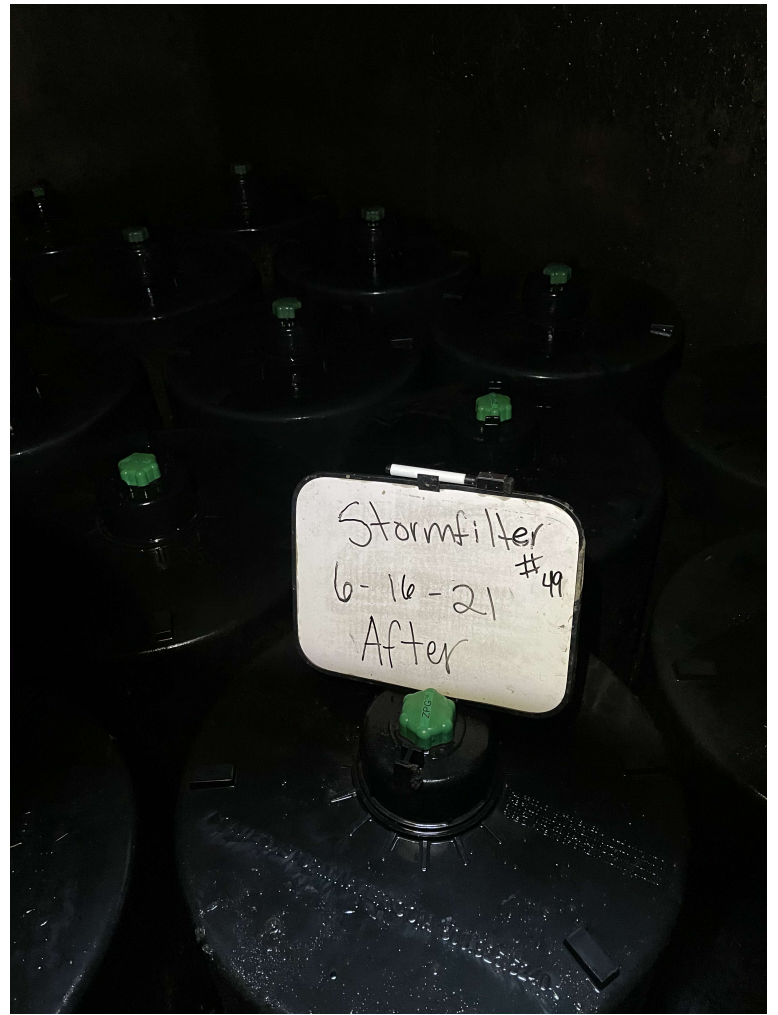
BMP 49 Stormfilter After

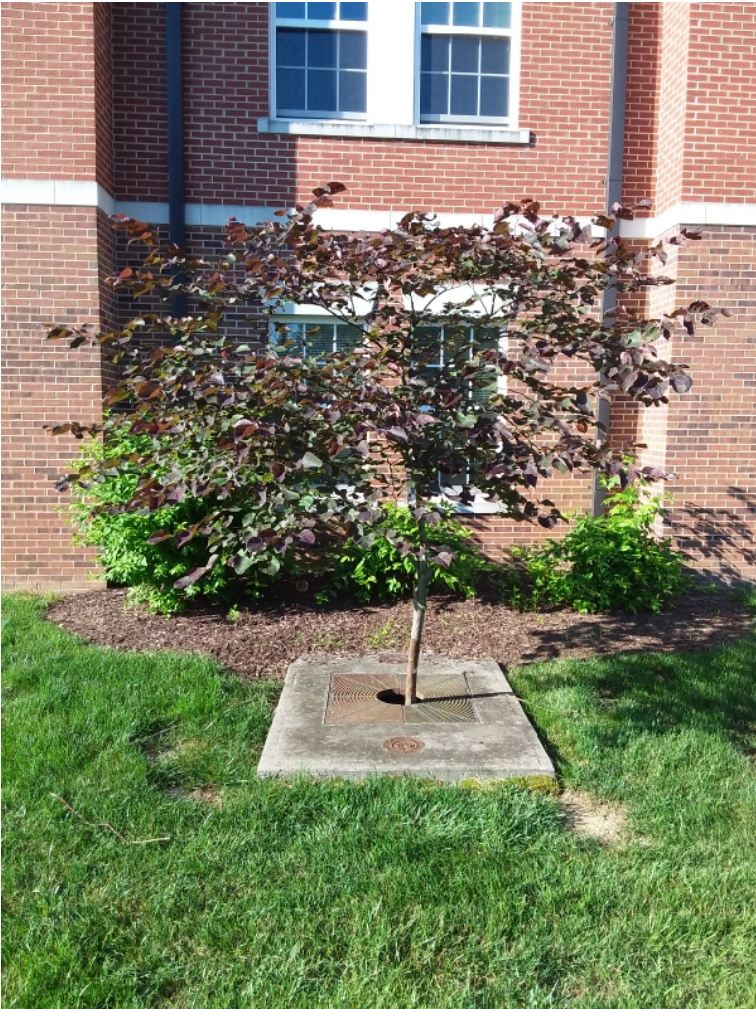
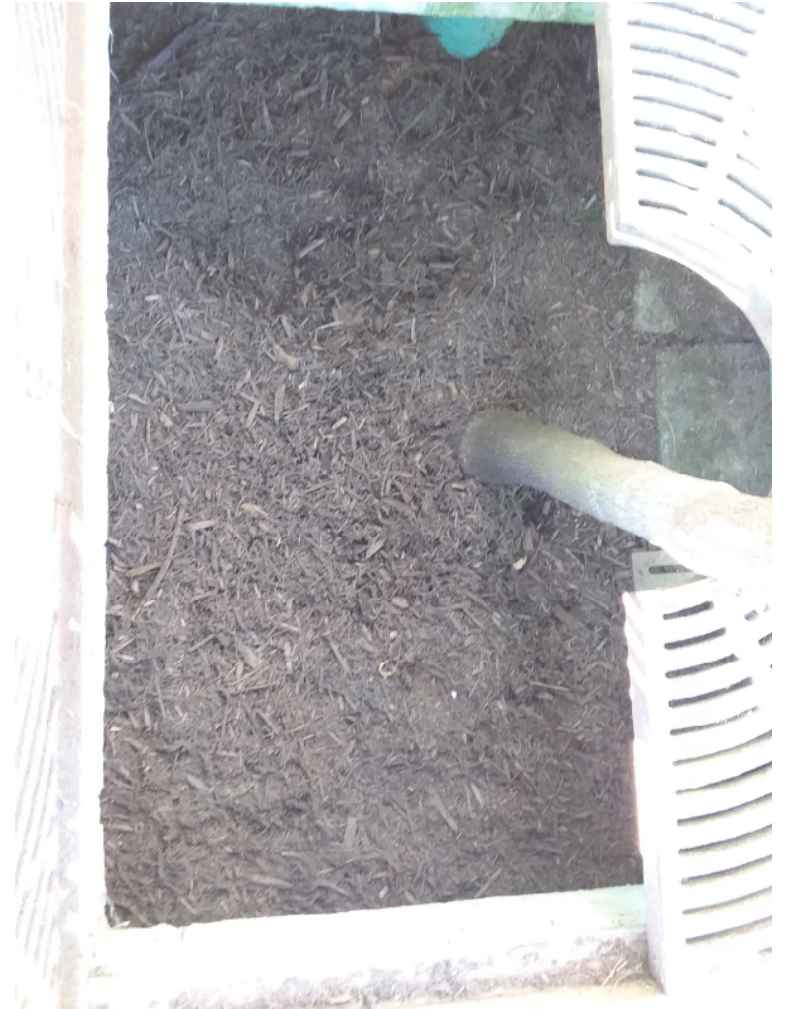
BMP 1

Maintenance was performed on this filterra unit on 6/16/2021. At the time of the inspection/maintenance visit there did not appear to be any other necessary repairs to be completed at this time. Continue performing routine inspection/maintenance twice per year to ensure the overall functionality and longevity of this system.

Amount of mulch to be added or replaced	3"
Type of mulch to be added or replaced	Hardwood Double Shredded
Date mulch added or replaced	6/16/2021

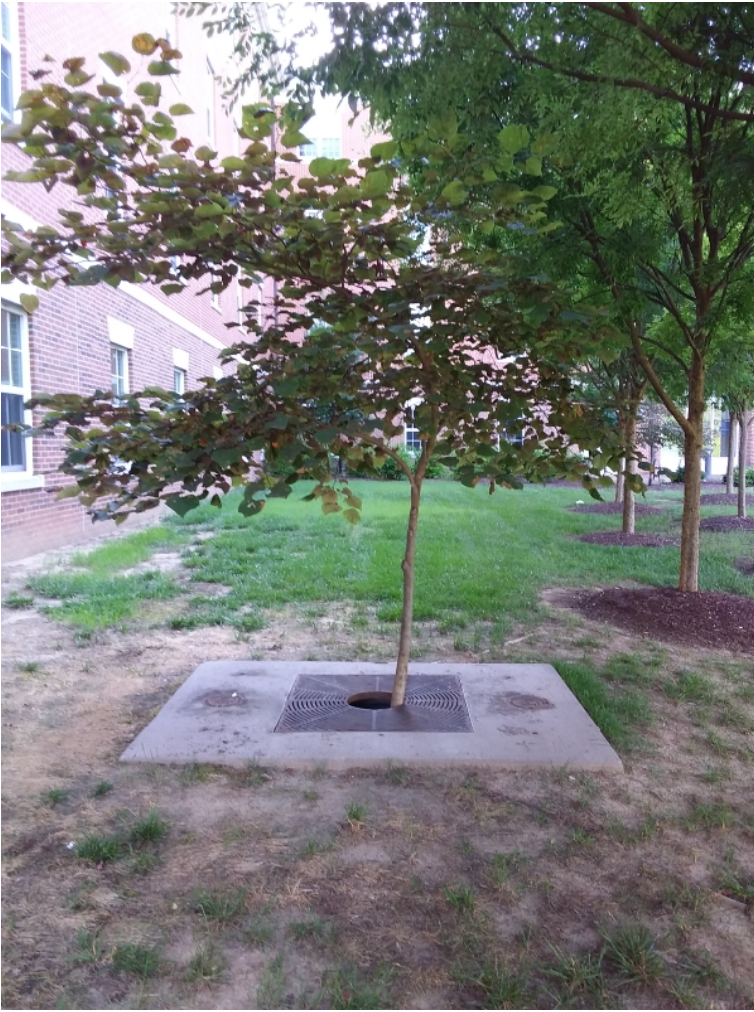
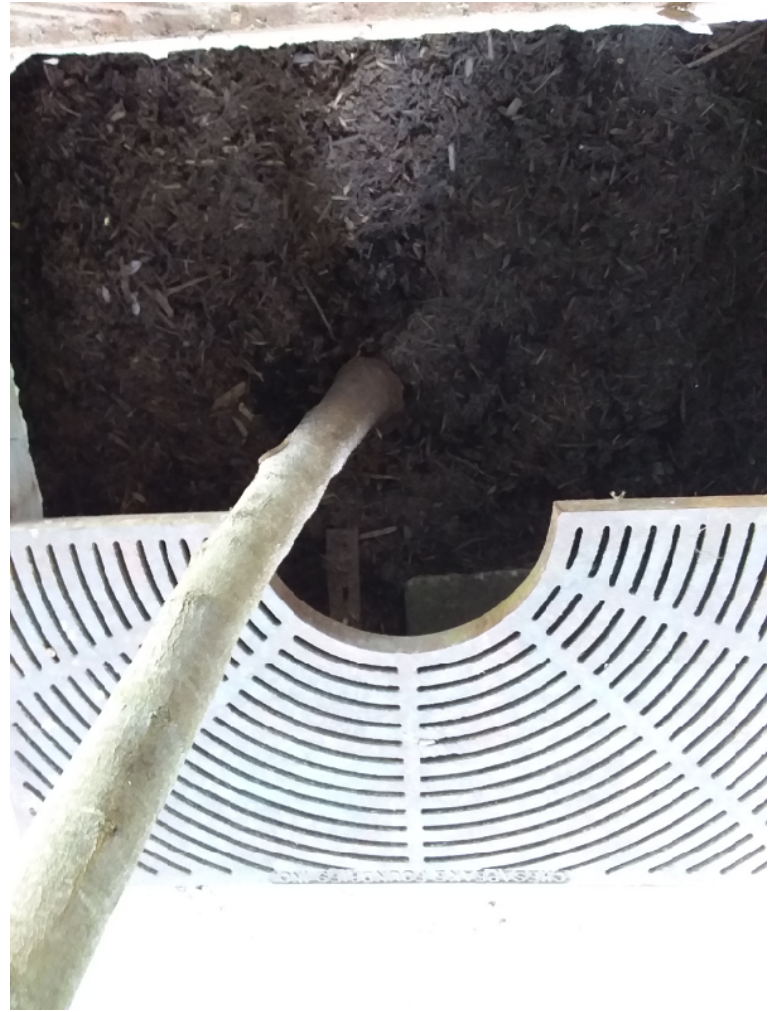
BMP 2

Maintenance was performed on this filterra unit on 6/16/2021. At the time of the inspection/maintenance visit there did not appear to be any other necessary repairs to be completed at this time. Continue performing routine inspection/maintenance twice per year to ensure the overall functionality and longevity of this system.

Amount of mulch to be added or replaced	3"
Type of mulch to be added or replaced	Hardwood Double Shredded
Date mulch added or replaced	6/16/2021

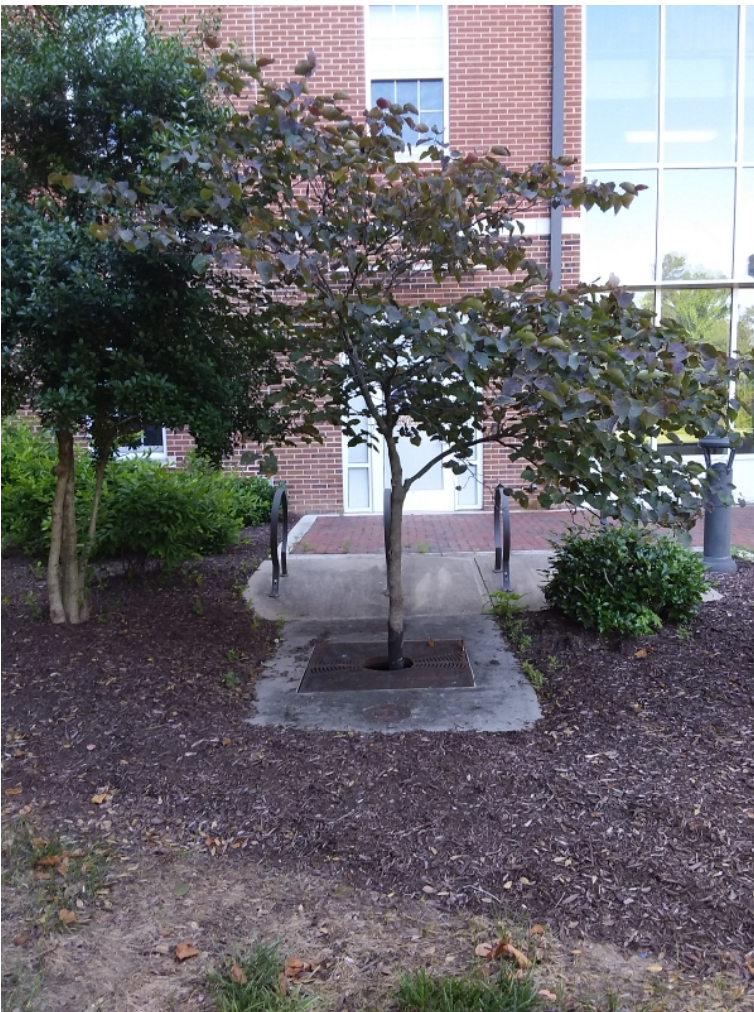
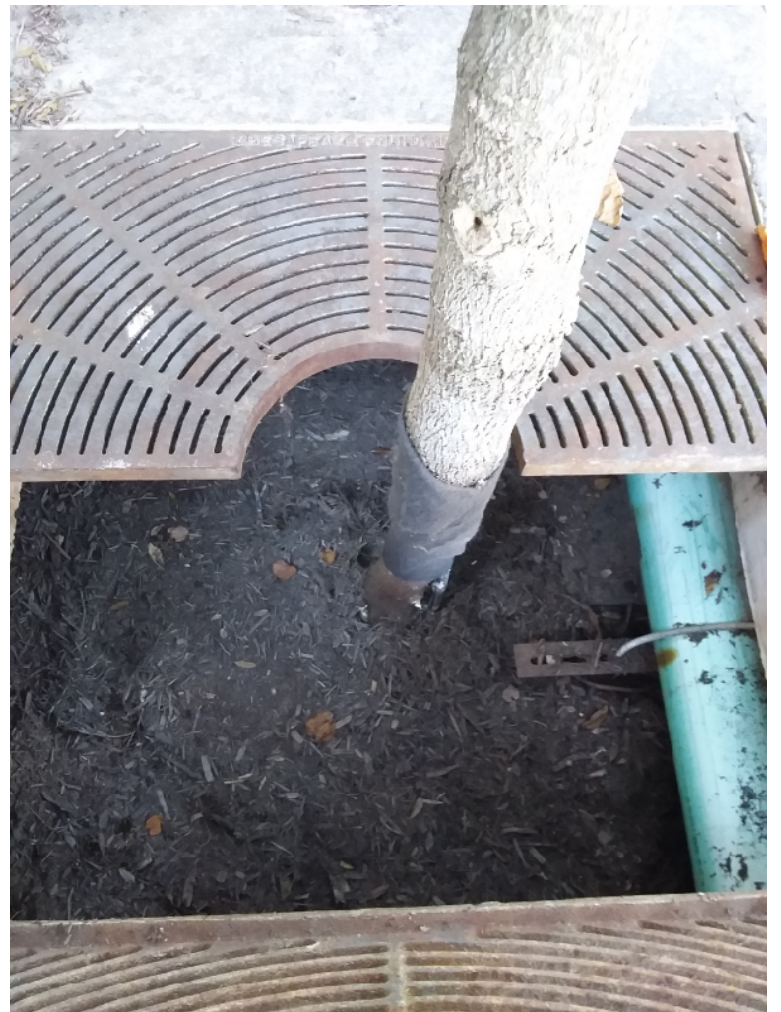
BMP 3

Maintenance was performed on this filterra unit on 6/16/2021. At the time of the inspection/maintenance visit there did not appear to be any other necessary repairs to be completed at this time. Continue performing routine inspection/maintenance twice per year to ensure the overall functionality and longevity of this system.

Amount of mulch to be added or replaced	3"
Type of mulch to be added or replaced	Hardwood Double Shredded
Date mulch added or replaced	6/16/2021

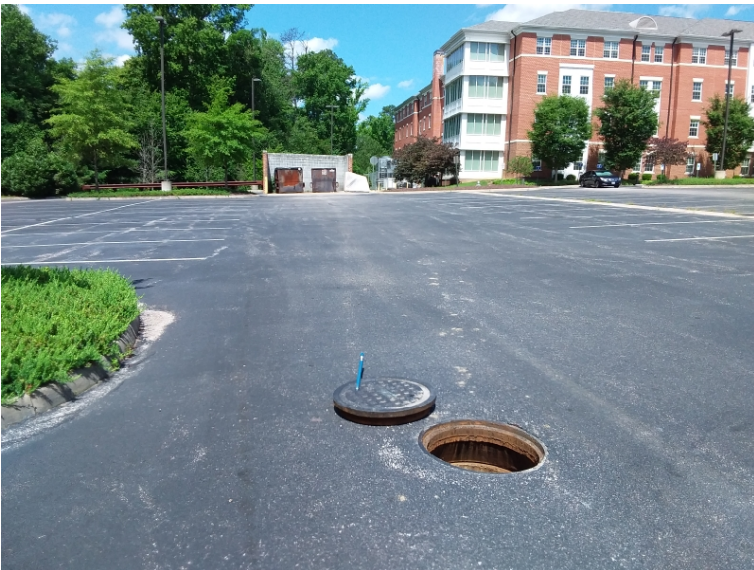
BMP 15- minimal sediment found

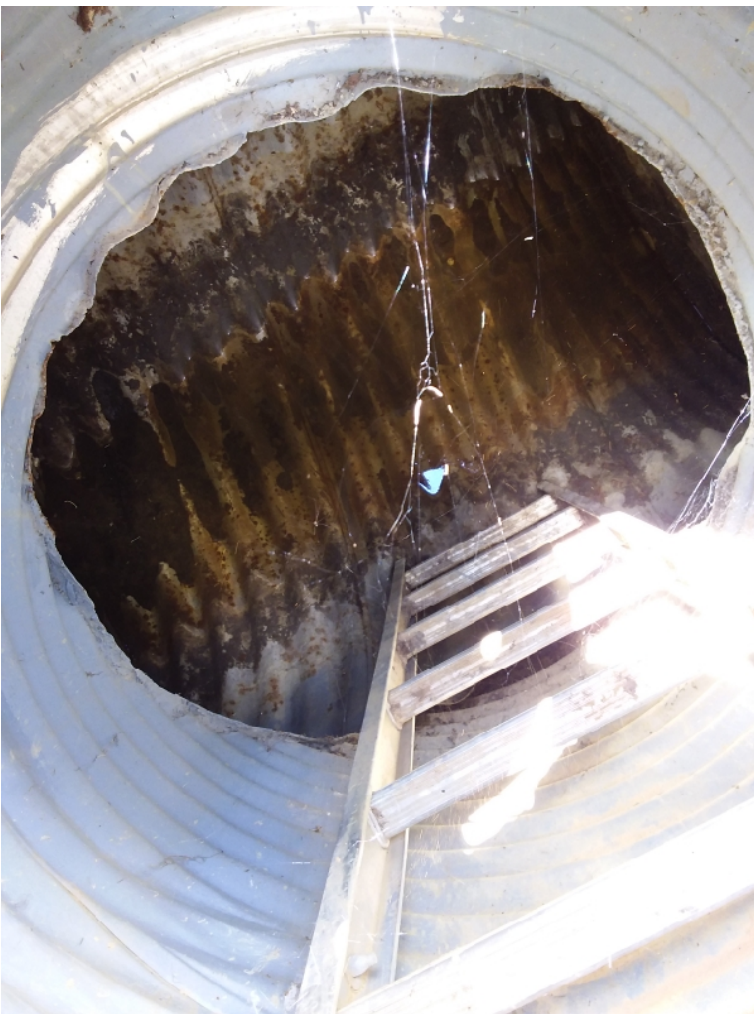
BMP 25: minimal sediment

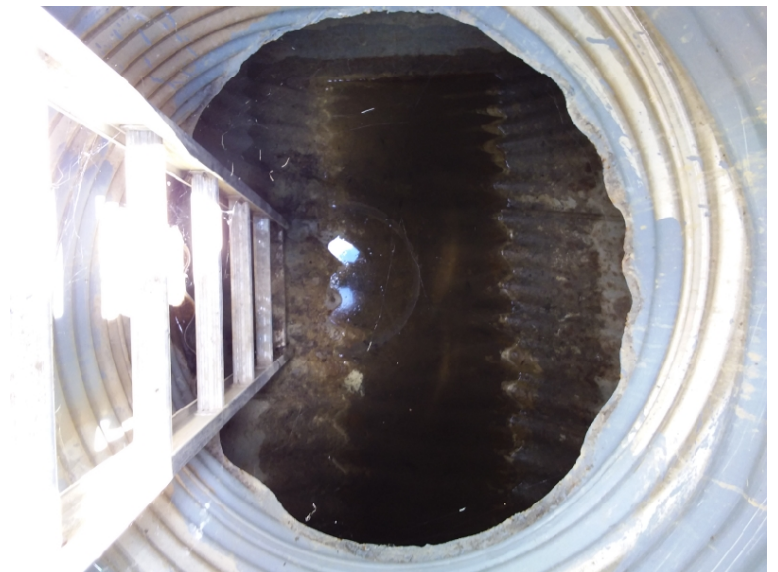
BMP 25: minimal sediment

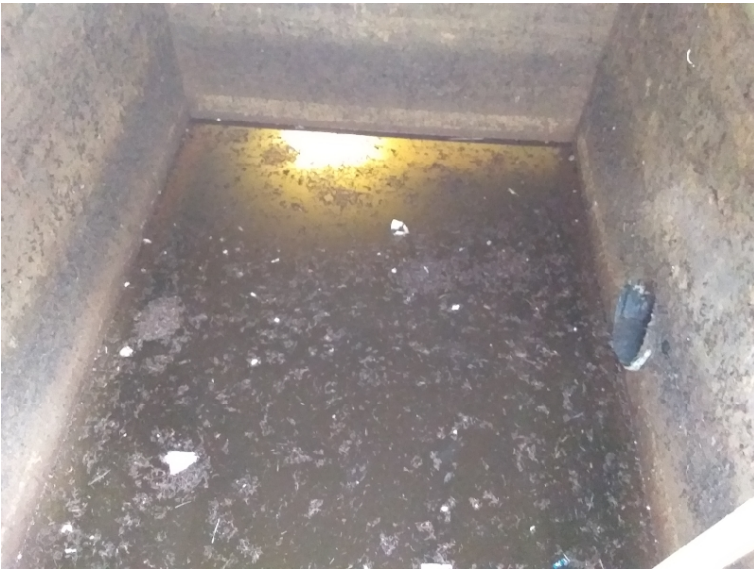
BMP 27- trace amounts of sediment and minor trash

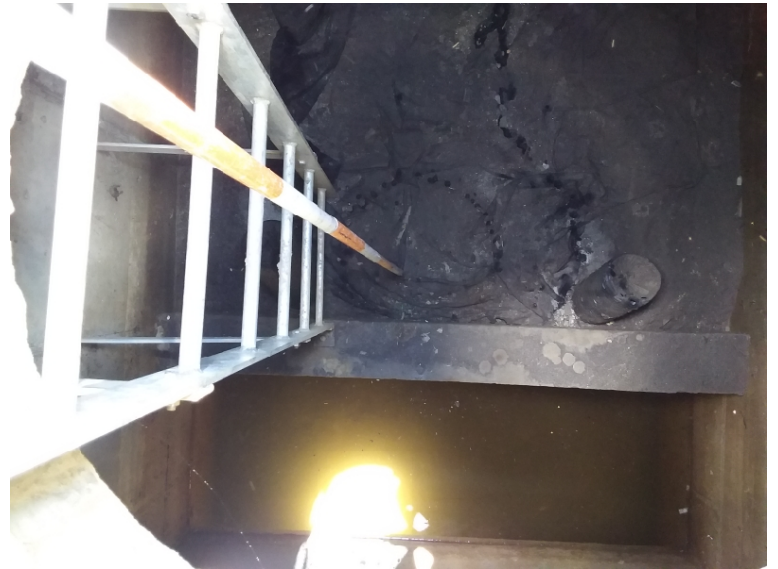
BMP 27- fabric needs to be re-positioned on sand filter side

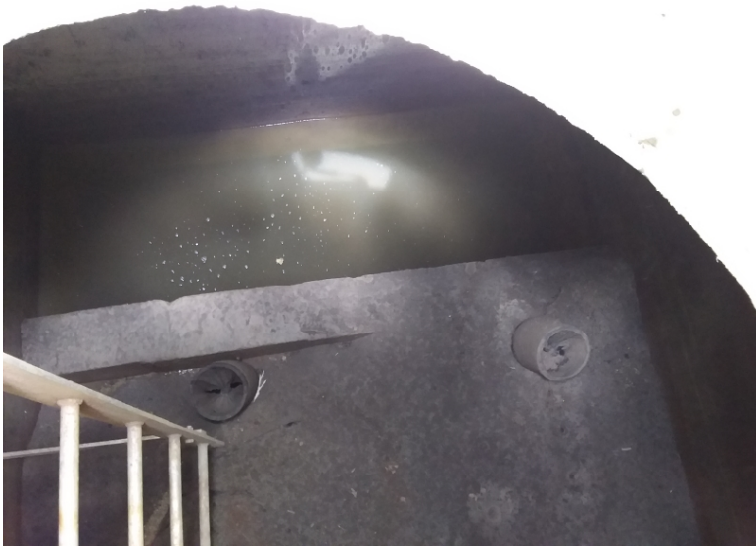
BMP 28- dewater chamber and remove from far side of weir wall

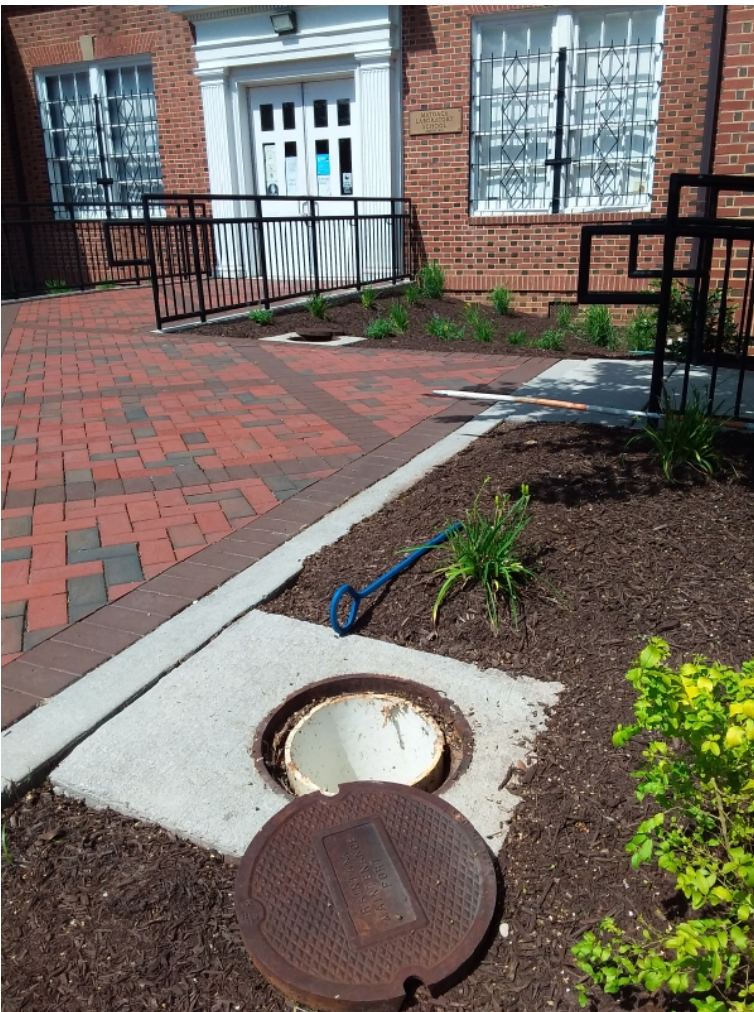
BMP 36: 16" of water standing in maintenance port

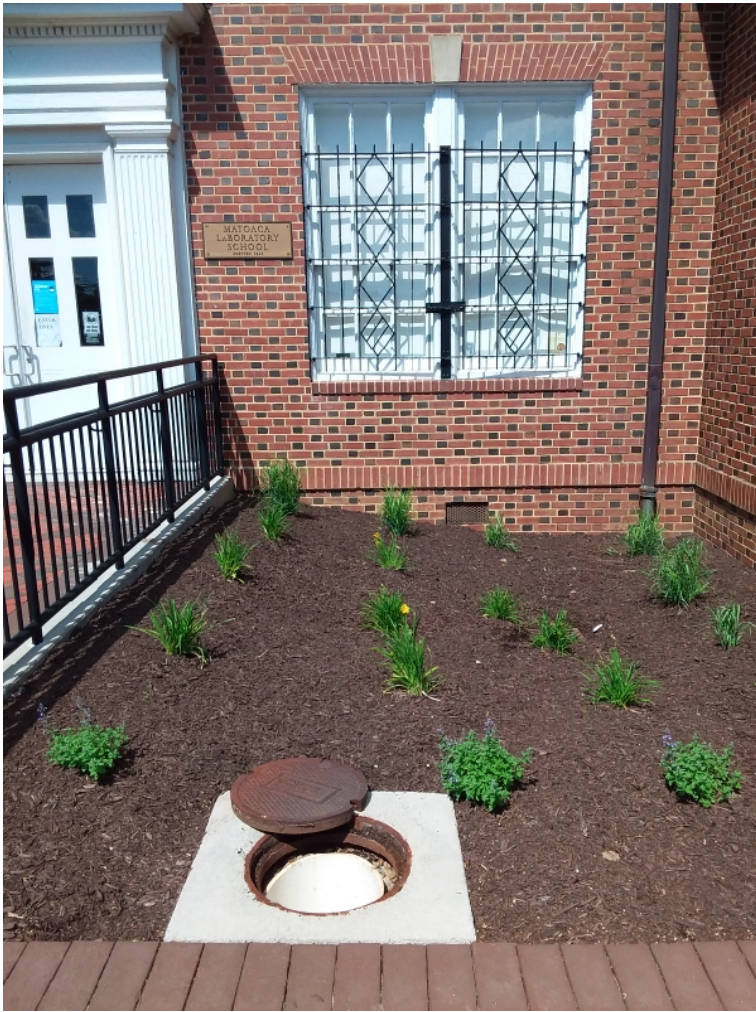
BMP 36: 16" of water standing in maintenance port

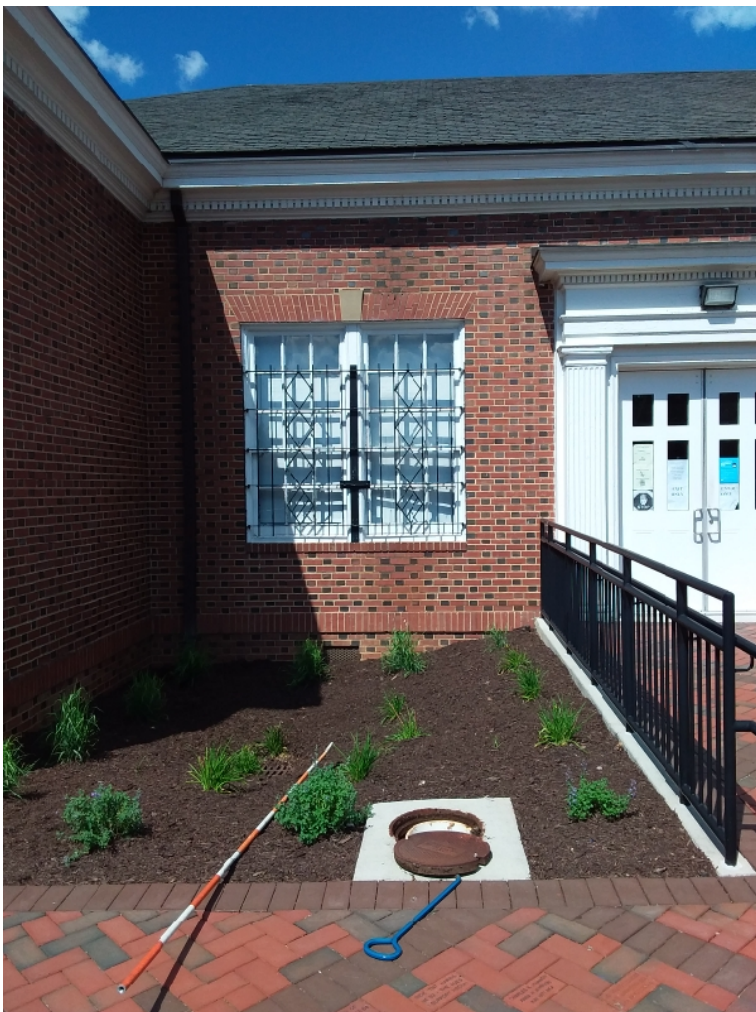
BMP 36: 16" of water standing in maintenance port

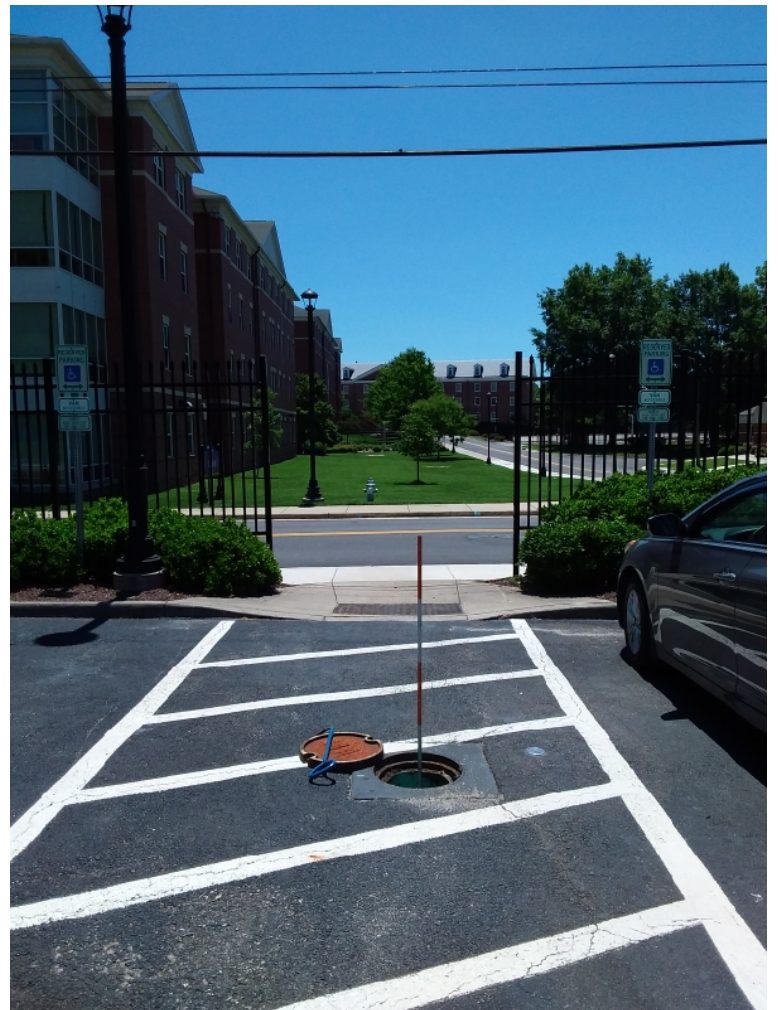
BMP 38- minimal sediment and gravel found in maintenance port

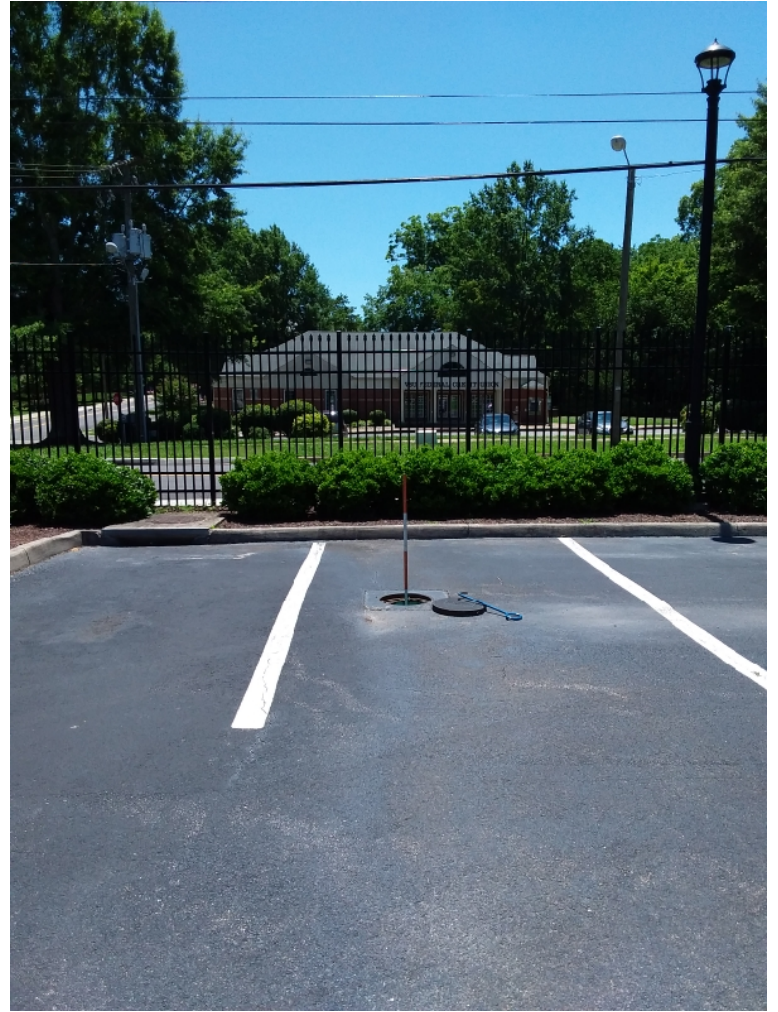
BMP 39- minimal sediment and gravel found in maintenance port

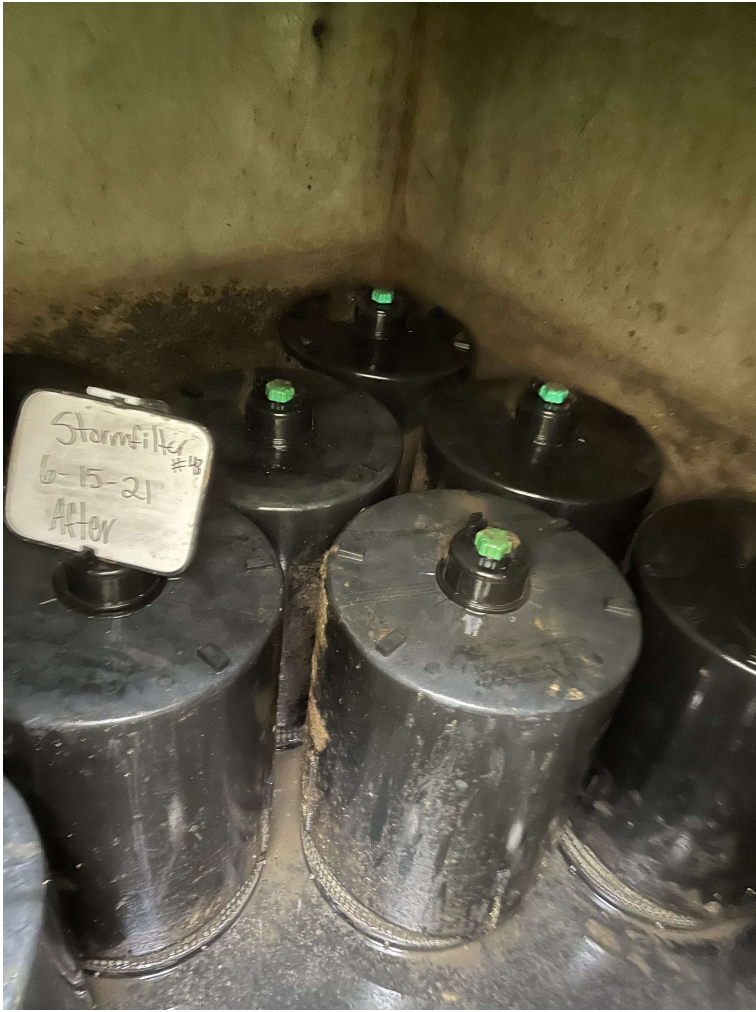
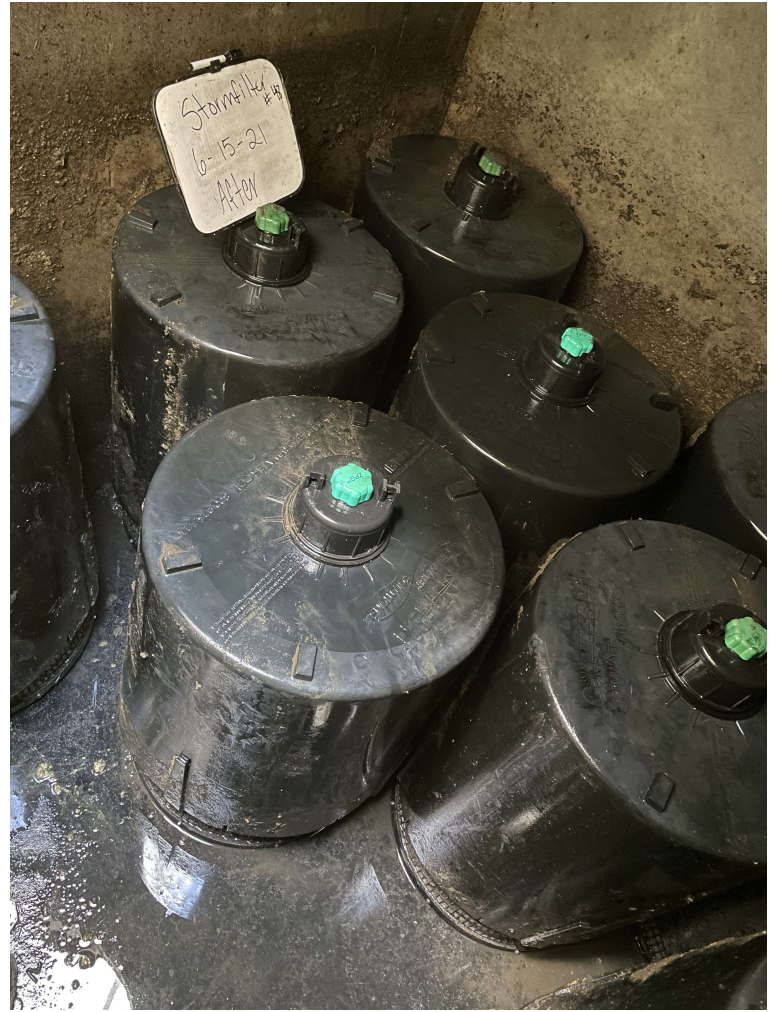
BMP 48

Notes: This stormfilter vault facility appeared to be functioning in moderate condition during the time of inspection. Maintenance was just performed on (6/15/2021) and during that cleanout we checked the media inside the cartridges. After checking the cartridge media it is evident that a cartridge replacement (12 cartridges) will be necessary during the next maintenance visit. Continue to perform routine inspections/maintenance to ensure the help ensure the overall functionality and longevity of this system.

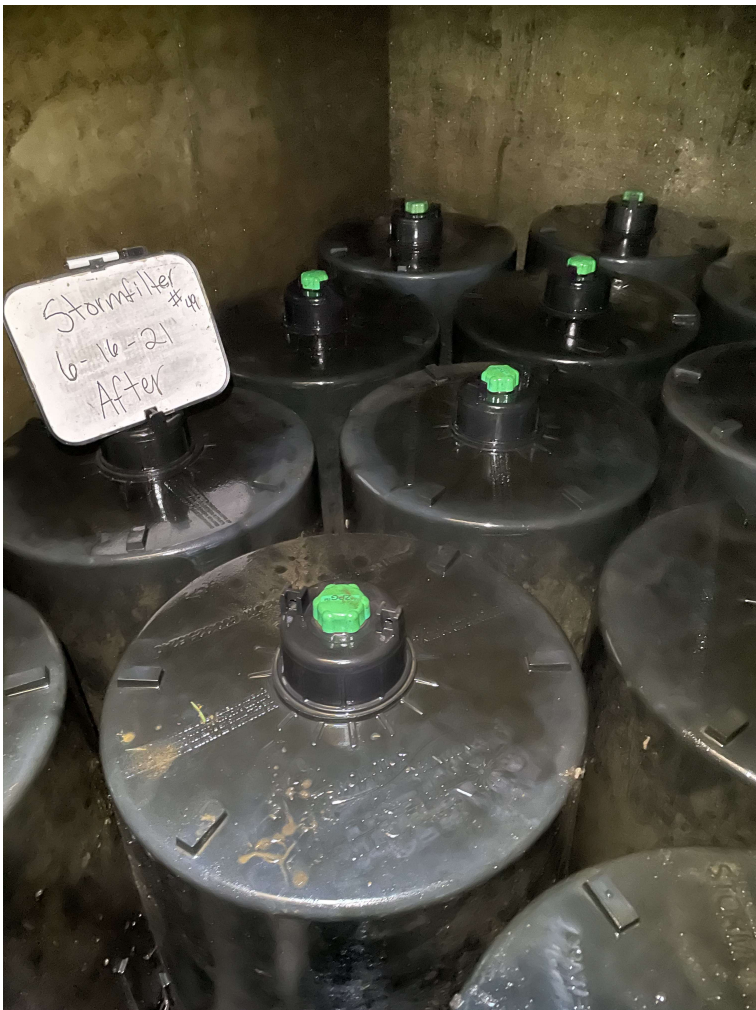
BMP 49

Notes: This stormfilter vault facility appeared to be functioning in moderate condition during the time of inspection. Maintenance was just performed on (6/16/2021) and during that cleanout we checked the media inside the cartridges. After checking the cartridge media it is evident that a cartridge replacement (21 cartridges) will be necessary during the next maintenance visit. Continue to perform routine inspections/maintenance to ensure the help ensure the overall functionality and longevity of this system.

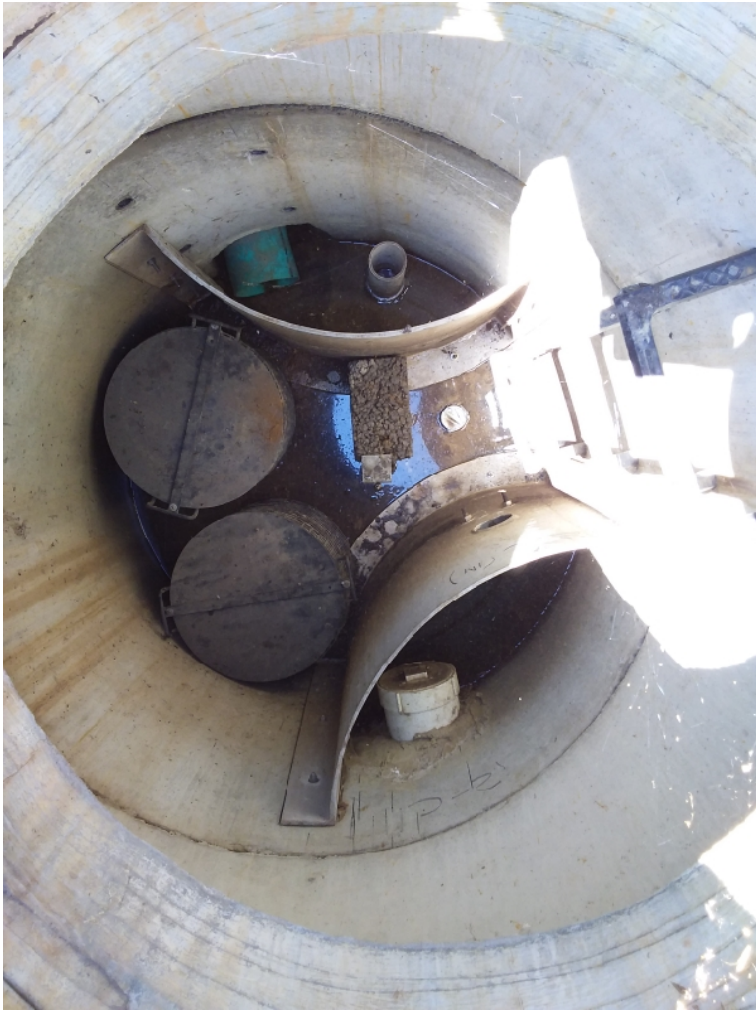
BMP 32- minimal sediment

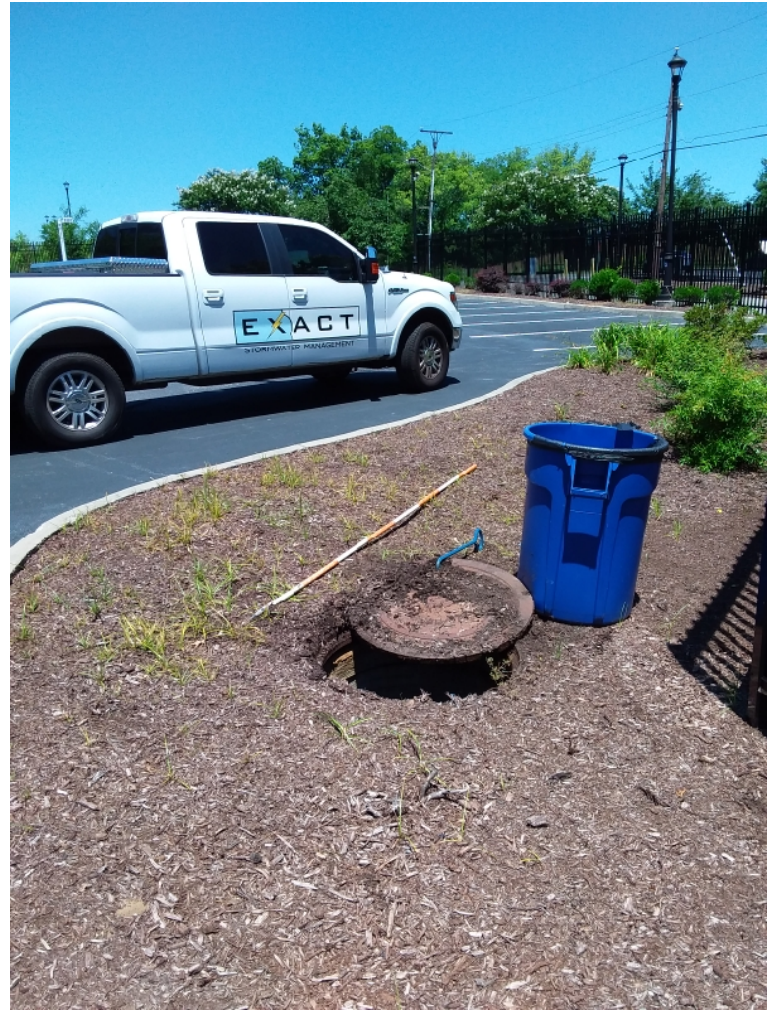
BMP 33- recycle trash can was sitting on top of lid and had to be uncovered with 2" of mulch on top of entire manhole lid

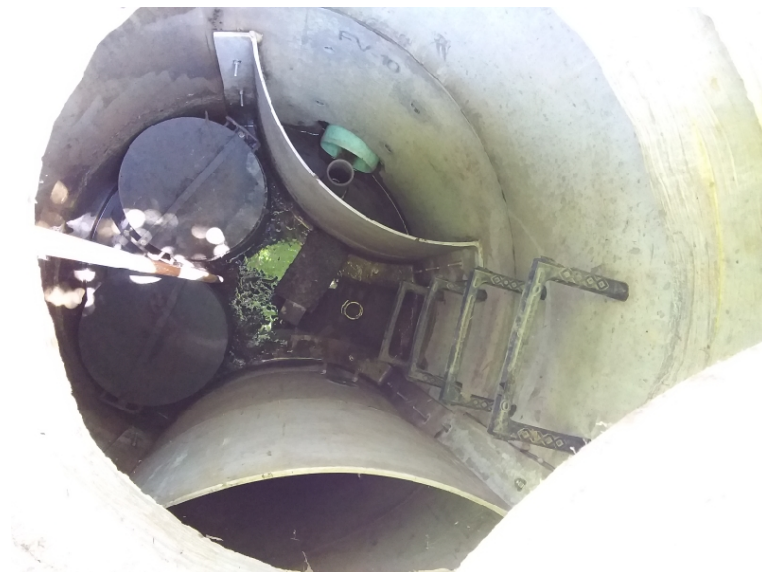
BMP 34- minimal sediment
