Virginia State University
MS-4 Permit: VAR040119
July 1, 2023 - June 30, 2024 Annual Report

Prepared for
Virginia State University
Capital Outlay & Facilities Management
PO Box 9414
Virginia State University, VA 23806

October 1, 2024

Prepared by: Timmons Group
1001 Boulders Parkway, Suite 300
Richmond, VA 23225
(804) 200-6500

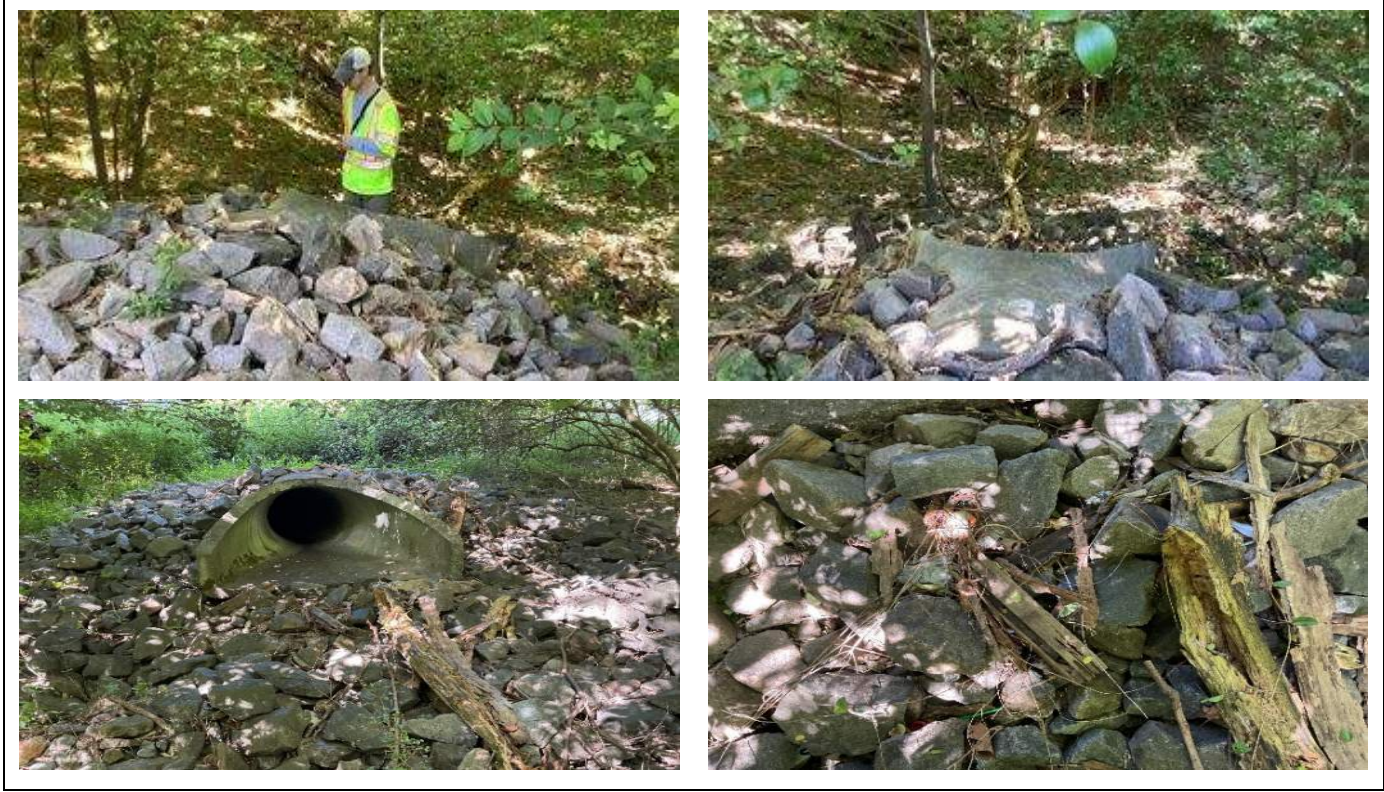
DESCRIPTION		
Outfall ID: 12	Date and Time: May 30, 2024 10:12 AM	Inspector: HF & RH

Outfall ID	Potential Illicit Discharge Detected?	Recommendations
1	No	Trash, sediment and debris removal recommended. Erosion of the pool and concrete should be monitored.
2	No	Monitor head cut into receiving stream.
3	No	Trash and debris removal recommended.
4	No	Rip rap repair, and removal of trees and woody vegetation along head wall recommended.
5	No	Trash removal, sediment and landscaping debris removal recommended.
6	No	Vegetation maintenance and sediment removal recommended.
8	No	Headcutting present, repair recommended. Debris and sediment removal from weir recommended.
9	No	Tree has fallen and likely disjointed pipe, repair recommended. Sediment, debris, and trash removal recommended.
10	No	Outfall stabilization needed ASAP due to significant erosion. Trash removal recommended.
11	No	BMP outfall. The BMP is covered with duckweed. Headwall of pipe is eroding. Trash removal recommended.
12	No	Recommend removal of tree debris/branches.

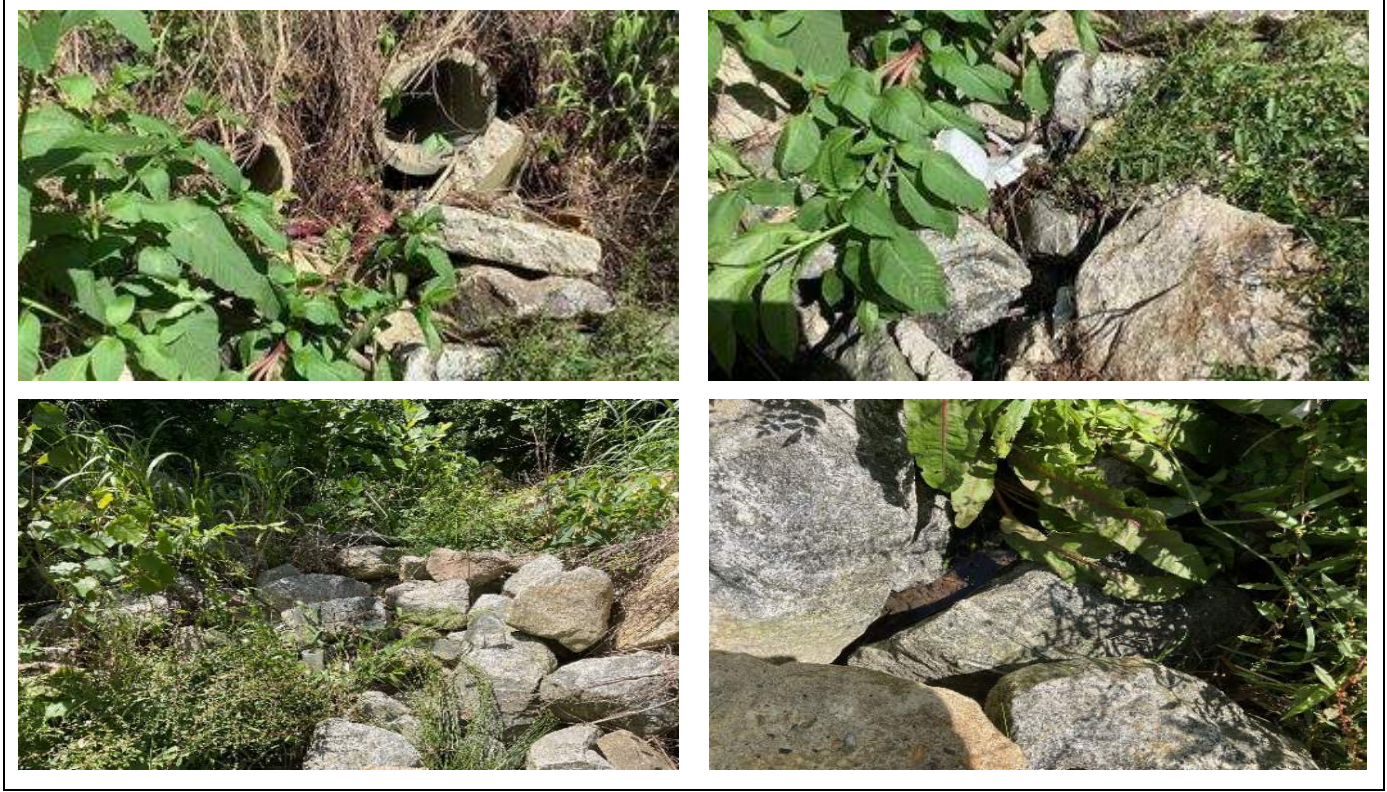
DESCRIPTION		
Outfall ID: 14	Date and Time: May 30, 2024 10:24 AM	Inspector: HF & RH

Recommend stabilization. Could hear flow in the pipe but not observed (indicates possible disjointed pipe upstream).
14	No	Recommend removal of trash and excess vegetation.
16	No	Trash and debris recommended for removal. Downstream stabilization recommended due to erosion.
17	No	Trash, sediment, and debris recommended for removal.
18	No	Pipe(VC) is crushed and needs repair. Excess vegetation and debris recommended for removal. A VSU staff member reported that changes to the flow leading to the outfall have been observed over time. The staff member suspects there could be a water line leak upstream that contributes flow to this outfall. It is recommended that VSU staff perform follow-up investigations to determine the presence of cross-connection or water line break.
20	No	Trash, vegetation, and sediment removal recommended.
21	No	Trash and debris removal recommended. Eroding channel and headwall stability should be monitored.

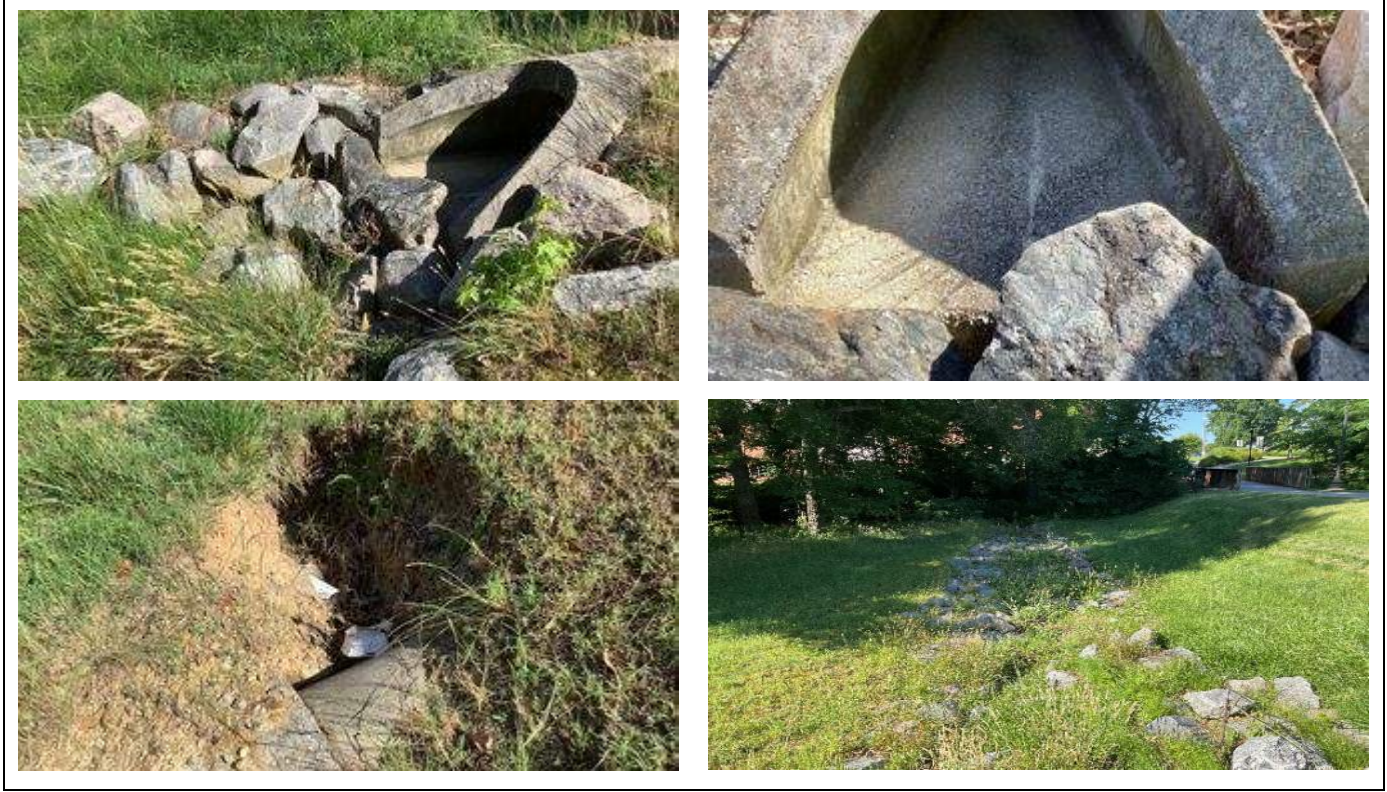
DESCRIPTION		
Outfall ID: 24	Date and Time: May 30, 2024 9:14 AM	Inspector: HF & RH

22	No	Trash removal recommended. Erosion in pool and concrete pipe deterioration should be monitored.
24	No	Sink hole on pipe, head cutting at outfall, maintenance required.
27	No	Vegetation and debris removal recommended.

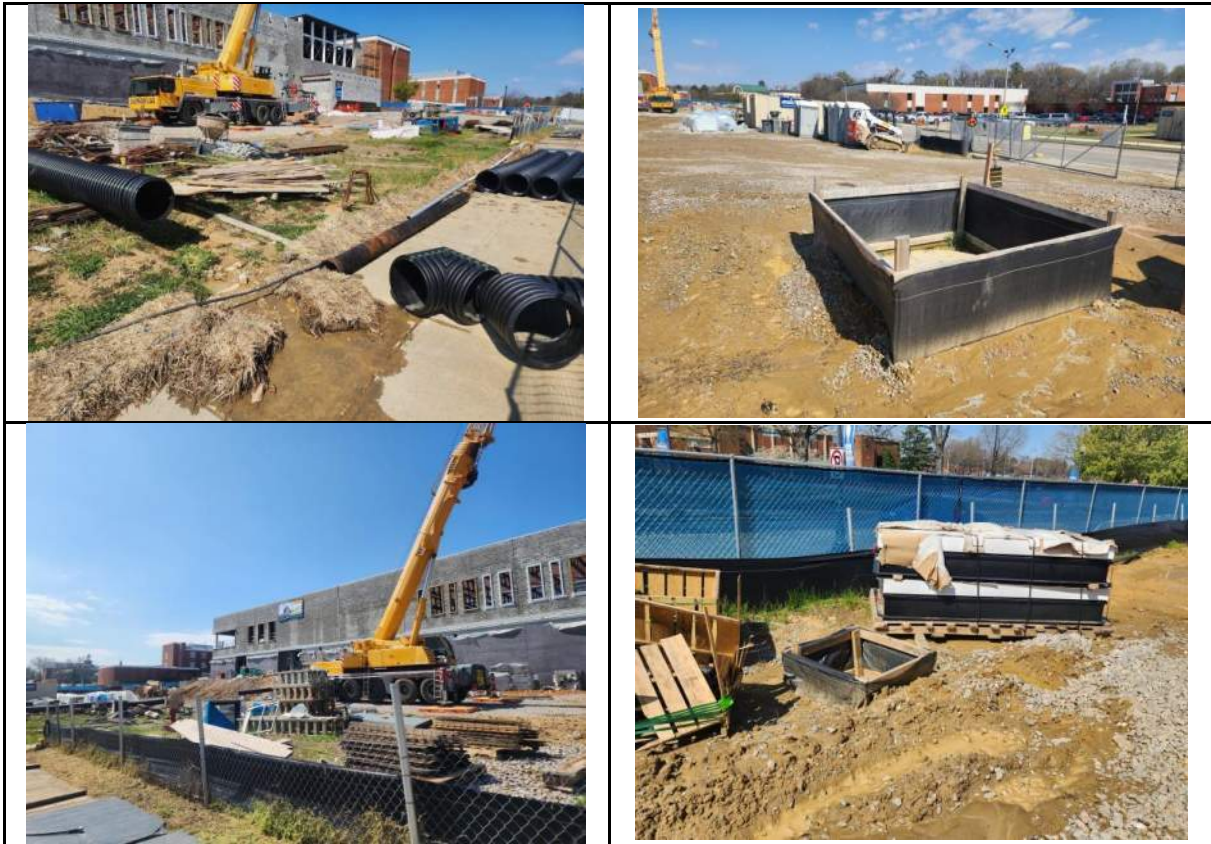
Item#	State/Local Regulation(1)	Violation		Description and Location of Problem/Violation(2), Required or Recommended Corrective Actions, and Other Comments/Notes
		Initial	Repeat	
1				Silt fence fabric detached from stakes around soil stockpile. See notes on next page for details.
2				Straw bales flattened along Carter G Woodson Avenue. See notes on next page for details.
3				
4

Silt fence fabric detached from stakes at northwest site entrance, along College Avenue. Fabric replacement required.

Straw bales flattened along Carter G Woodson Avenue, replacement recommended to improve perimeter control effectiveness.

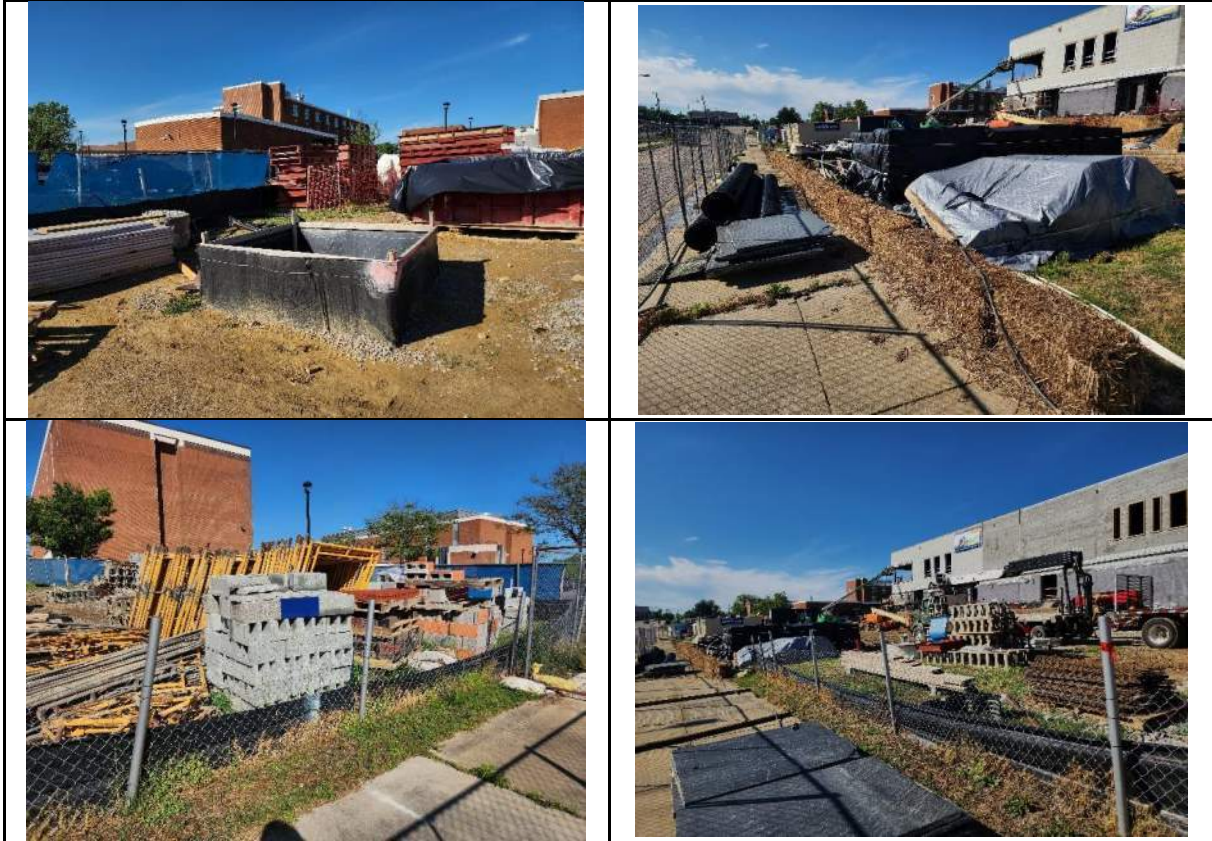
Item#	State/Local Regulation(1)	Violation		Description and Location of Problem/Violation(2), Required or Recommended Corrective Actions, and Other Comments/Notes
		Initial	Repeat	
1				Straw bales flattened along Carter G Woodson Avenue. See notes on next page for details.
2				Silt fence fabric detached from stakes along Carter G Woodson Avenue, reattachment of fabric required.
3				Silt fence fabric repaired around College Avenue soil stockpile, stored materials relocated.
4

Item# 1: Straw bales flattened along Carter G Woodson Avenue, recommend avoiding placement of materials on top of bales. Replacement required to improve perimeter control effectiveness.

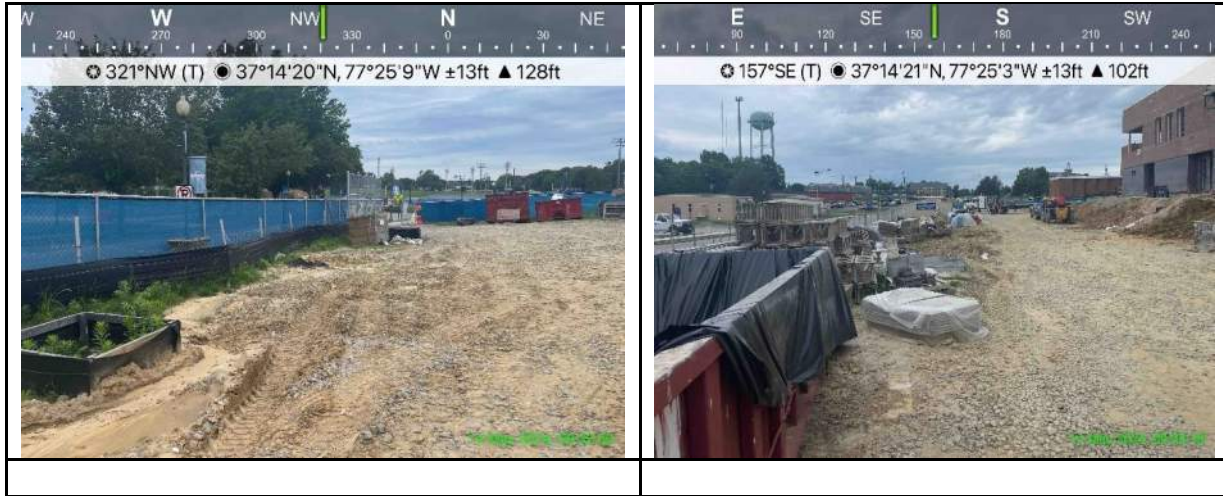
Notes: Ensure to monitor CE's and refresh as needed to mitigate any tracking onto adjacent roadways.

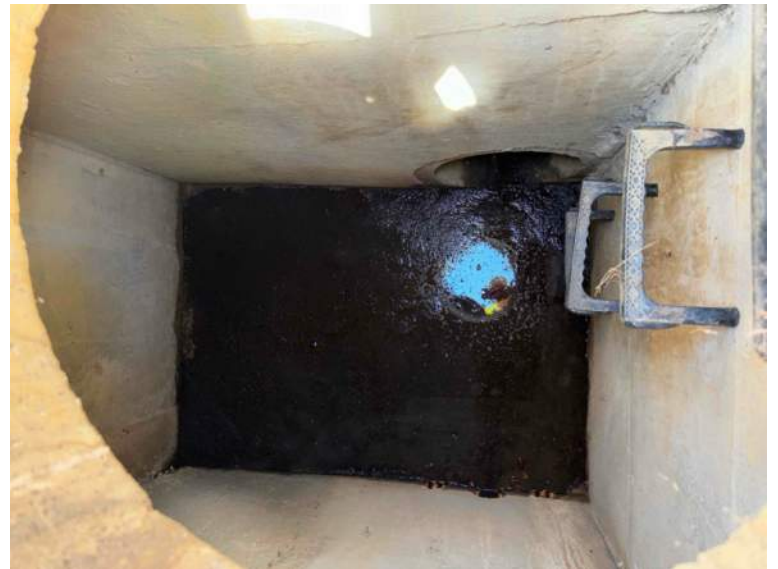
BMP 31- Outlet

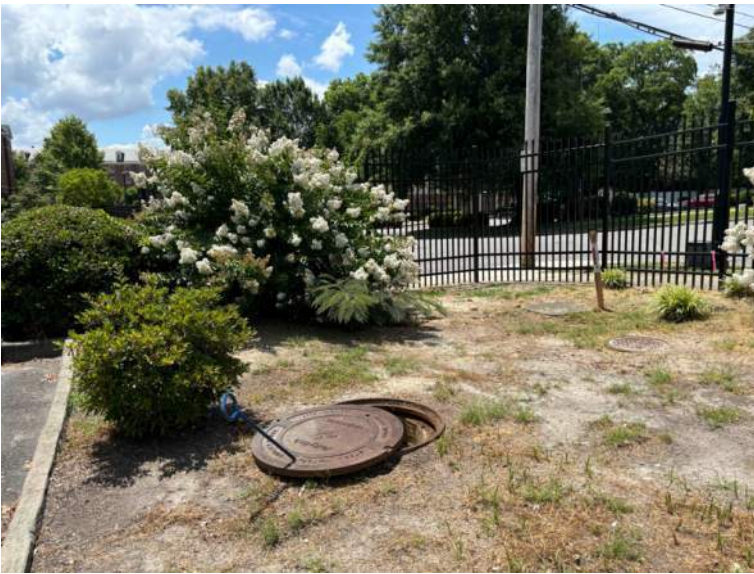
BMP 32- overall

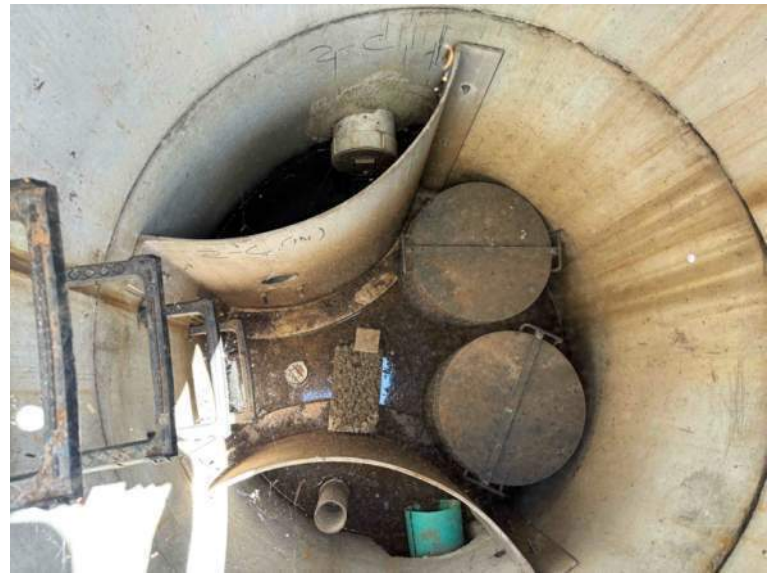
BMP 32- inside view

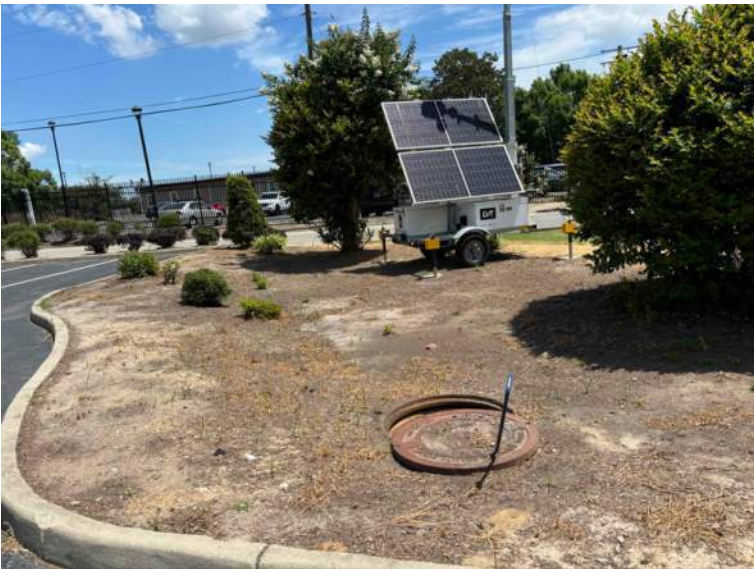
BMP 33- overall

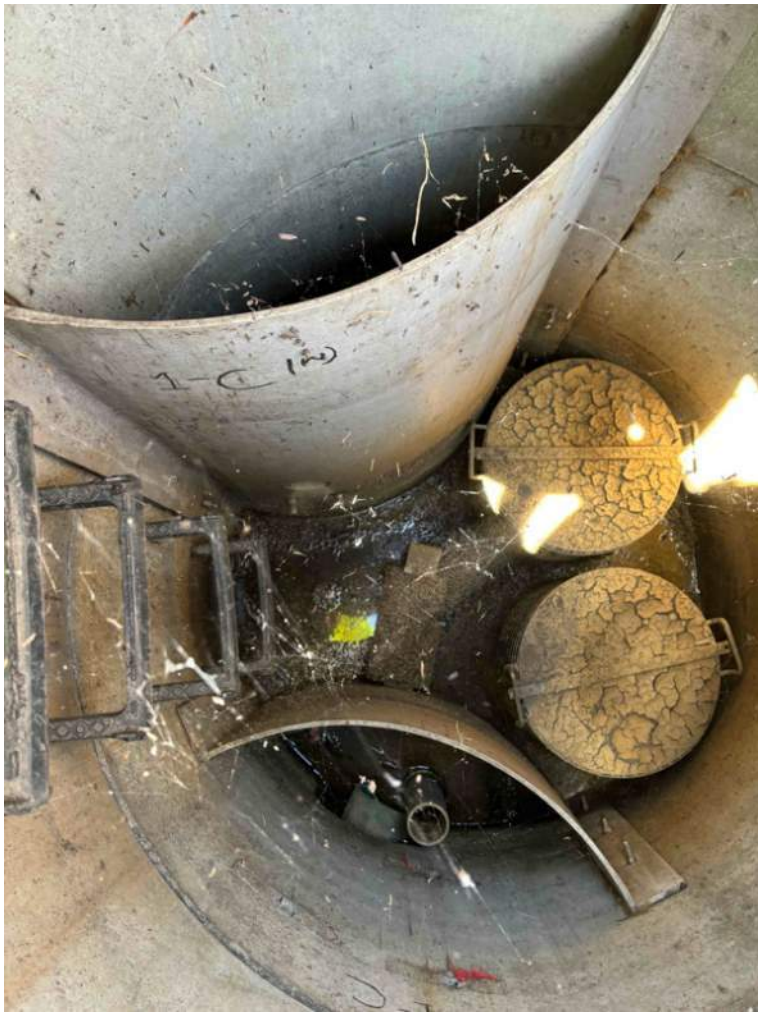
BMP 33- inside view

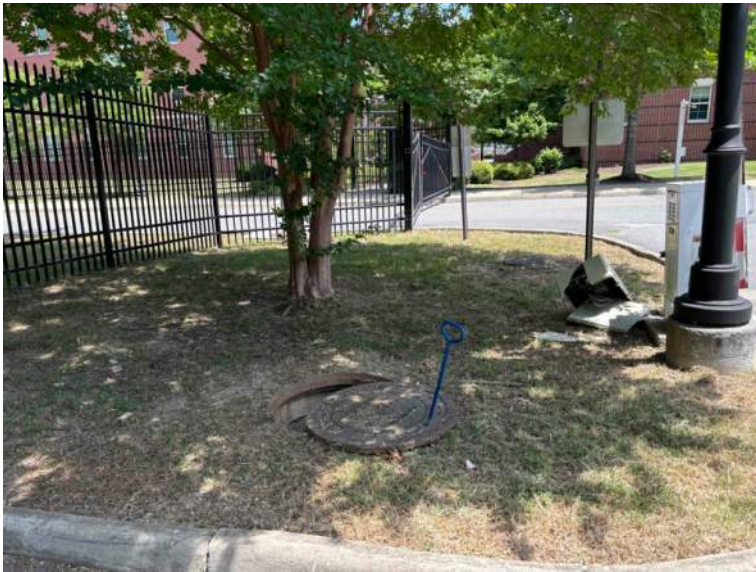
BMP 34- overall

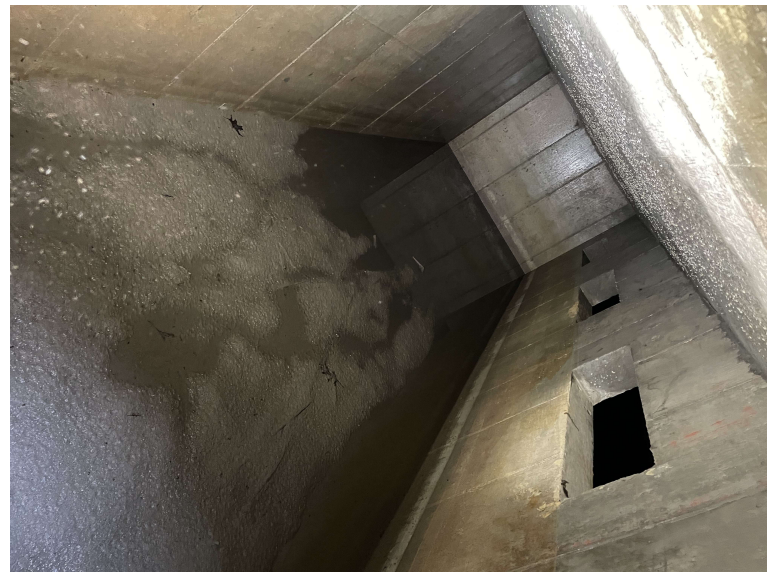
BMP 21- inside view after maintenance

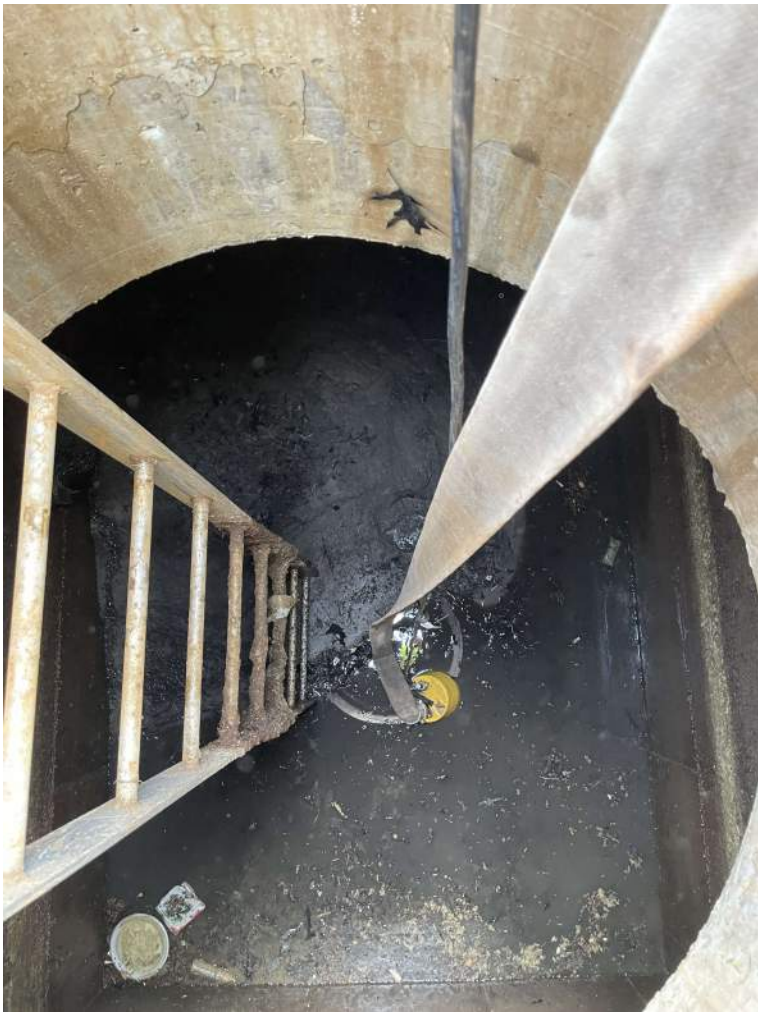
BMP 28- before

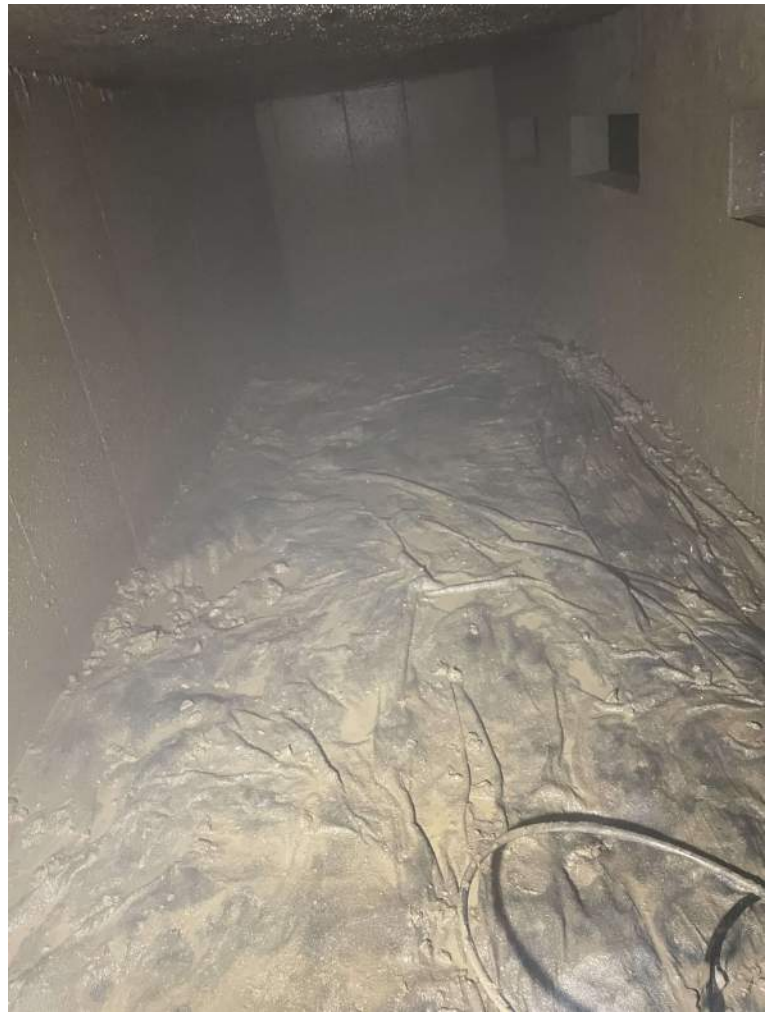
BMP 28- before

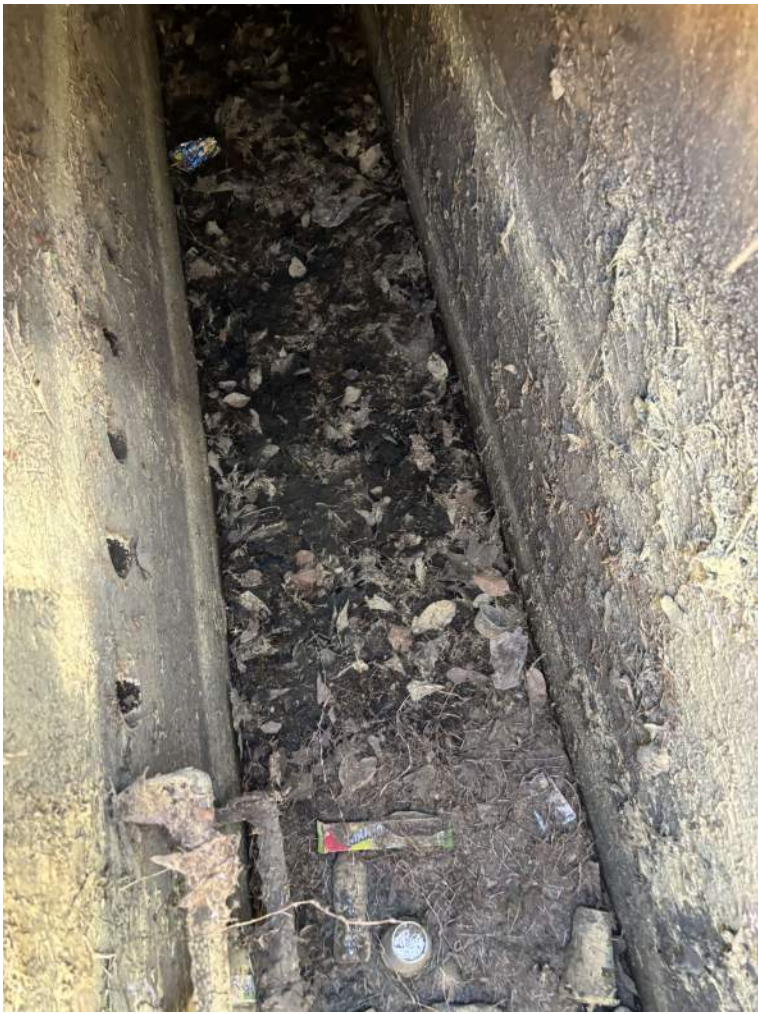
BMP 28- after

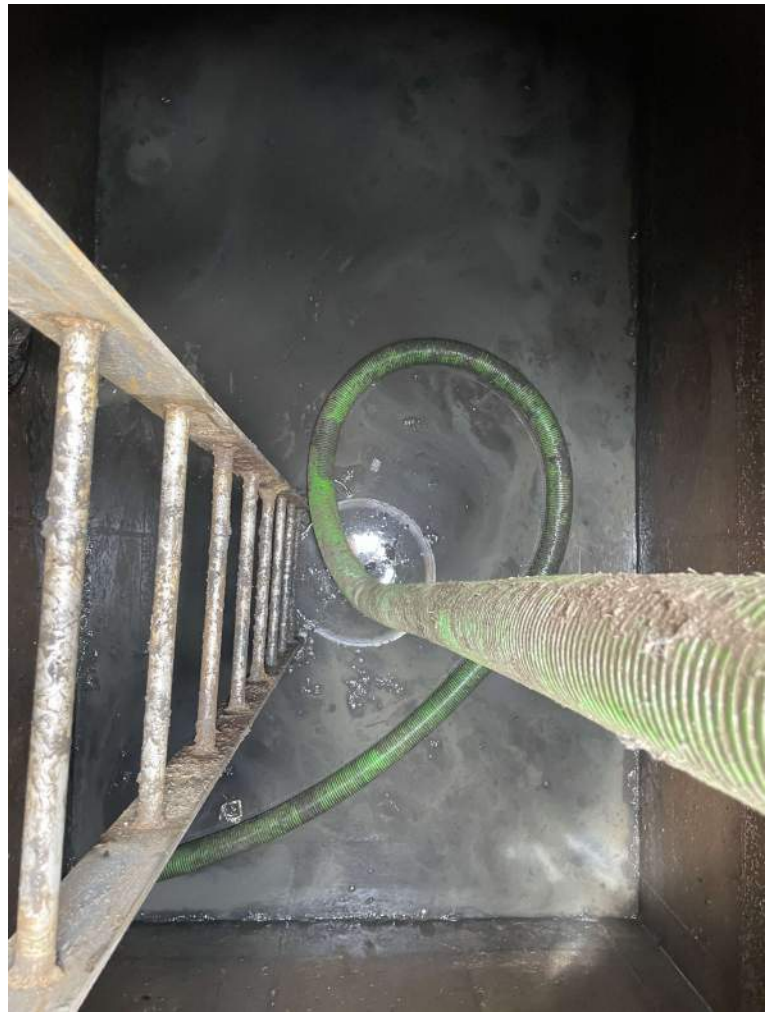
BMP 28- before

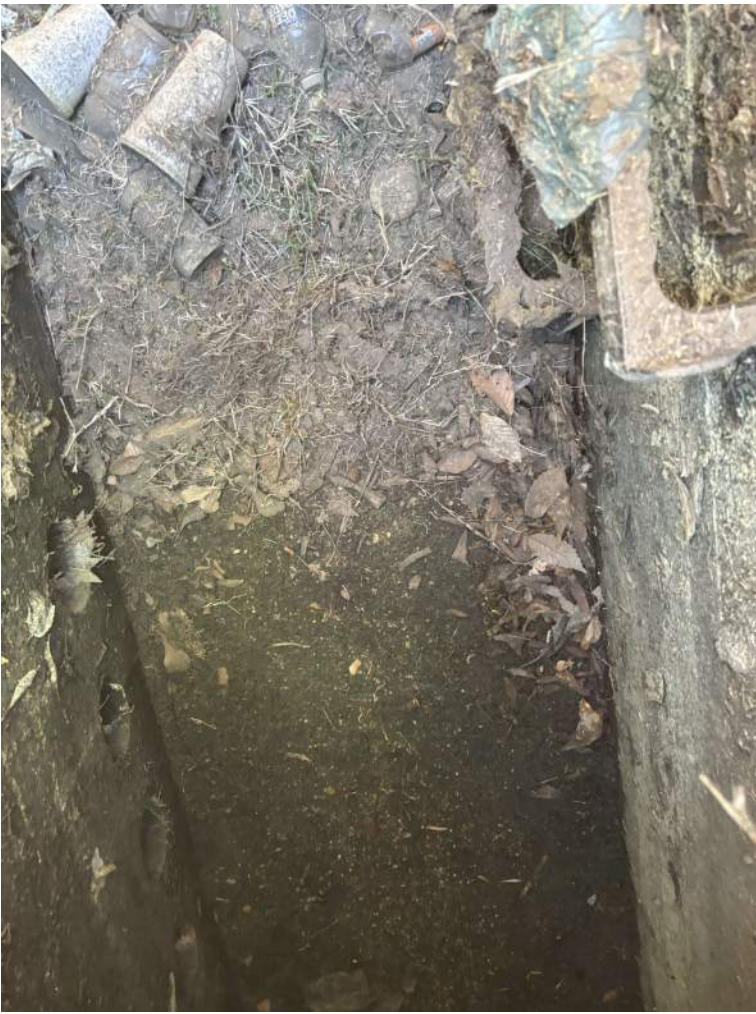
BMP 28- after

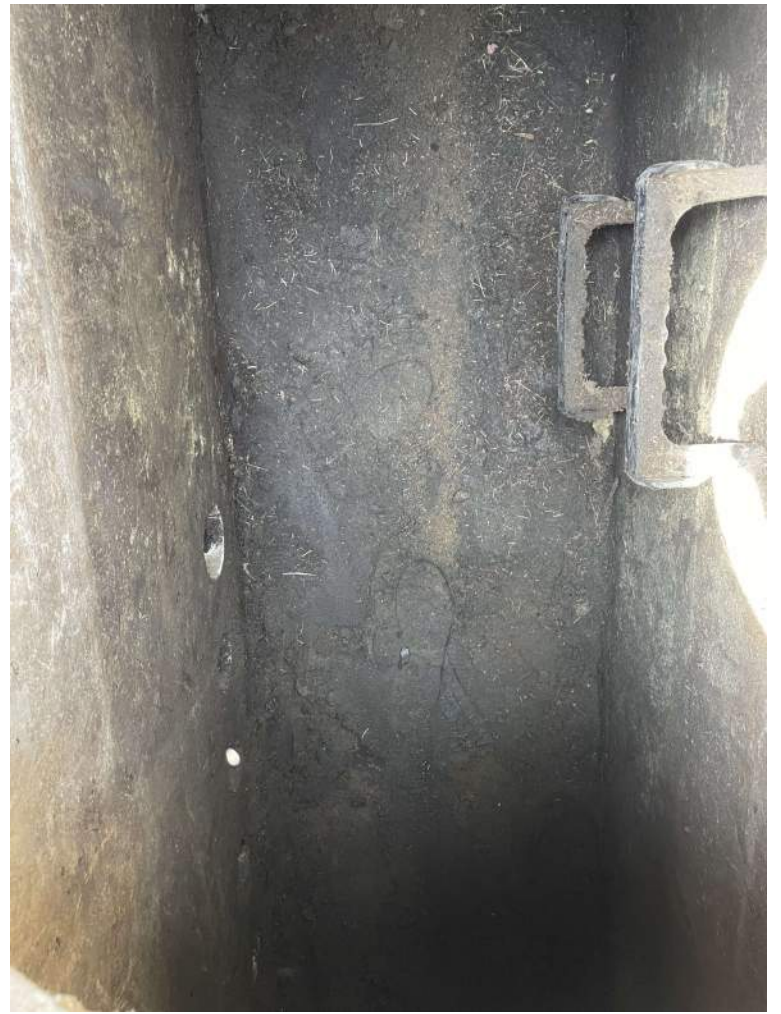
BMP 31- before

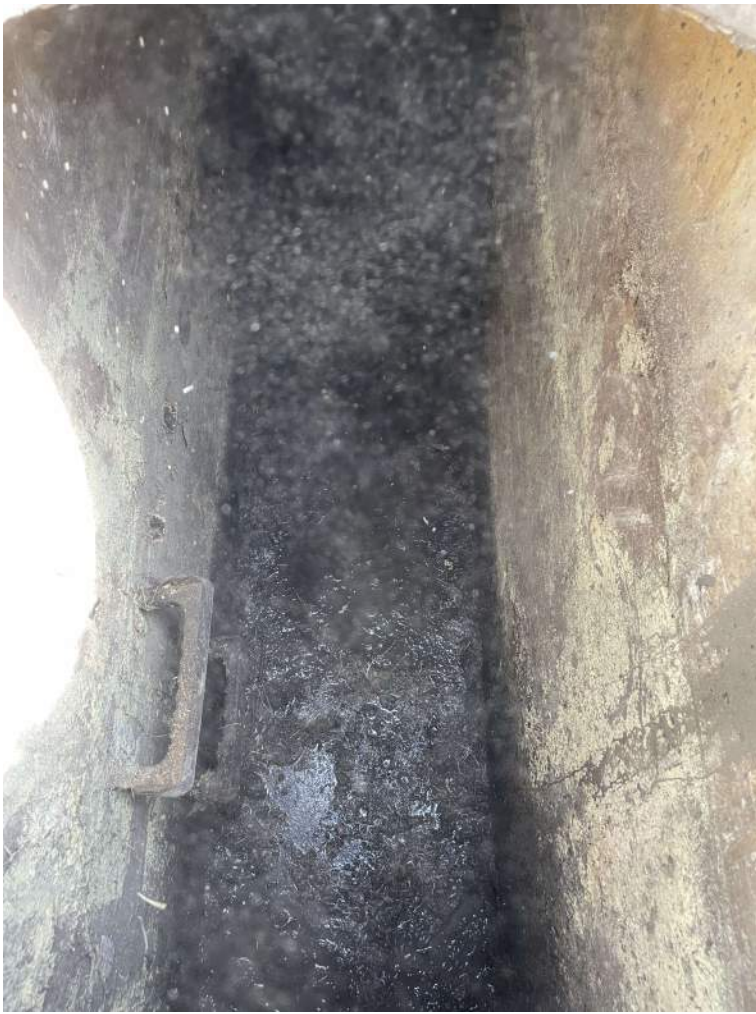
BMP 31- after

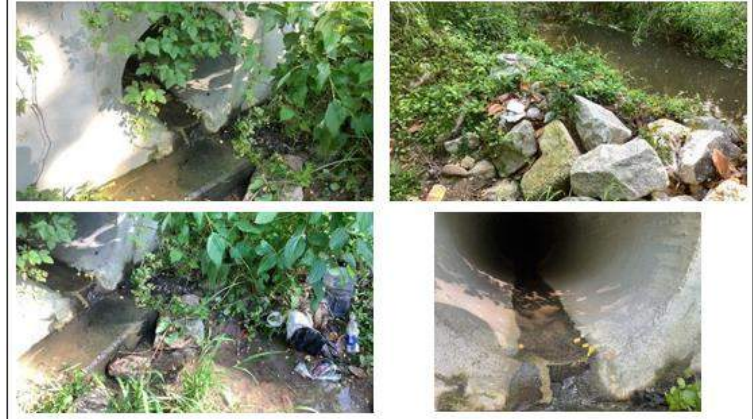
POTENTIAL POLLUTANT INDICATORS			
Indicator	Present?	Description	Relative Severity Index (1-3)
Odor	No	N/A	N/A
Turbidity	No	See Severity Index	N/A
Floatables	No	N/A	N/A
Deposits/Stains	YES	Flowline	3
Poor Pool Quality	No	N/A	N/A
Pipe Benthic Growth	YES	Green	2

MAINTENANCE			
Issue	Present?	Notes	Relative Severity Index (1-3)
Sediment	No		N/A
Trash	YES	Accumulation in pool and rip rap	3
Erosion	YES	Pool erosion	3
Physical Damage	YES	Concrete deteriorating	2

NOTES	
<input checked="" type="checkbox"/>	An illicit discharge is not suspected at this location.
<input type="checkbox"/>	An illicit discharge is suspected at this location but the source of the discharge cannot be found. A minimum of three (3) separate follow-up investigations is required to attempt to identify the source of the discharge within a 6-month period.
<input type="checkbox"/>	An illicit discharge was observed and the source of the discharge has been determined. The Stormwater Program Manager has been contacted immediately.
Not suspected of illicit discharge due to consistent flow through the years. Erosion of pool and stability of concrete should be monitored. Some trash, sediment and debris present in outfall pool that is recommended to be removed.
