Virginia State University
MS-4 Permit: VAR040119
July 1, 2019 - June 30, 2020 Annual Report

Prepared for
Virginia State University
Capital Outlay & Facilities Management
PO Box 9414
Virginia State University, VA 23806

September 21, 2020

Prepared by: Timmons Group
1001 Boulders Parkway, Suite 300
Richmond, VA 23225
(804) 200-6500

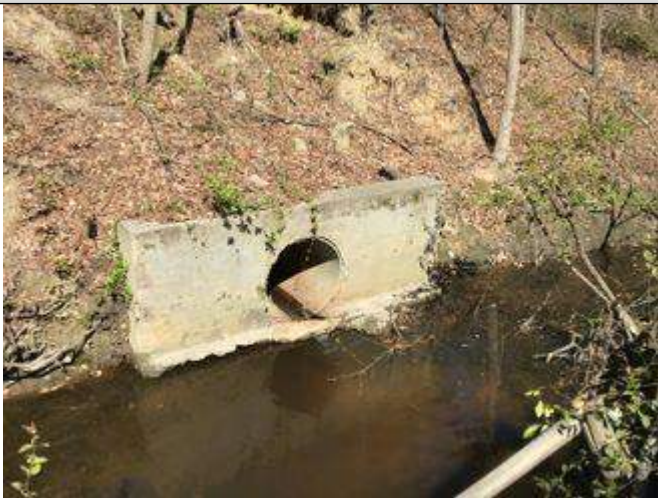
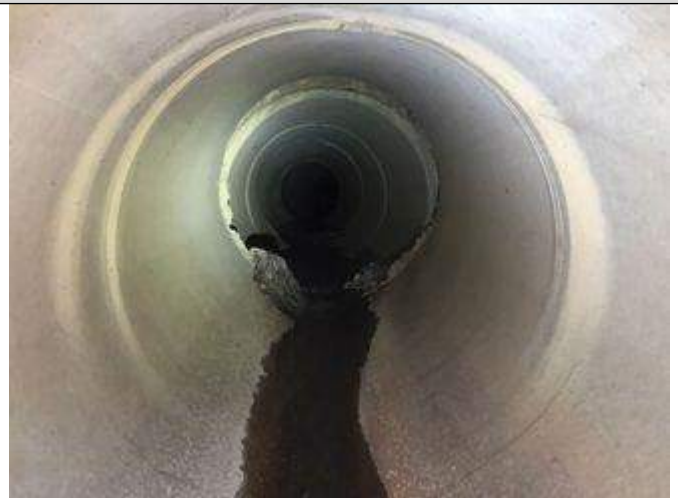
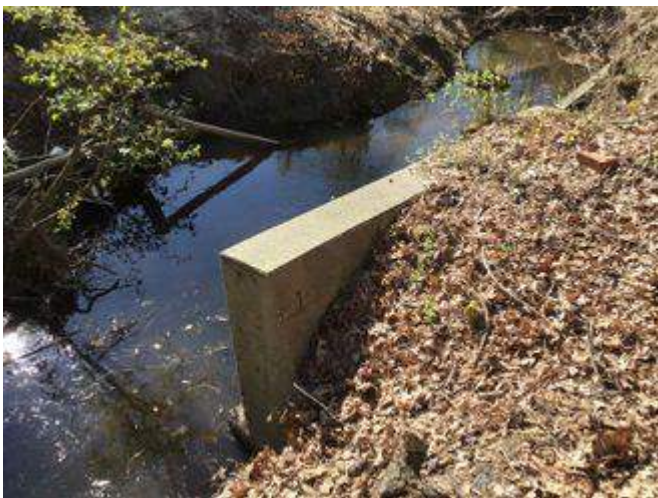
Outfall ID: 01	Date: 04/03/2020	Time: 10:00	Inspector: MSW
----------------	------------------	-------------	----------------

Indicator	Present?	Description	Relative Severity Index (1-3)
Odor	No	NA	NA
Turbidity	No	See Severity Index	NA
Floatables	No	NA	NA
Deposits/Stains	No	NA	NA
Poor Pool Quality		NA	NA
Pipe Benthic Growth	No	NA	NA

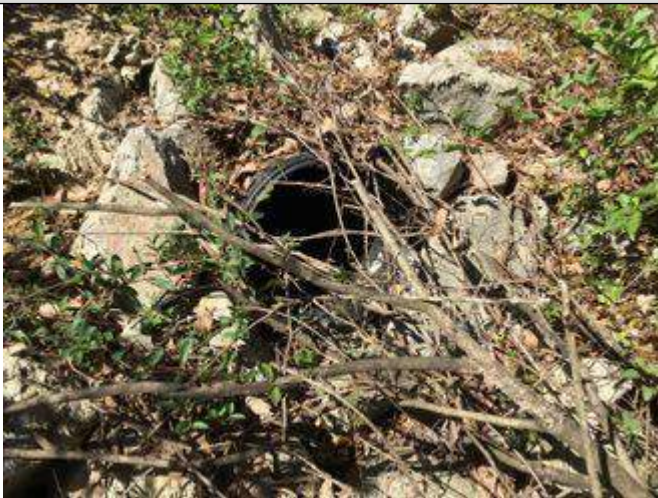
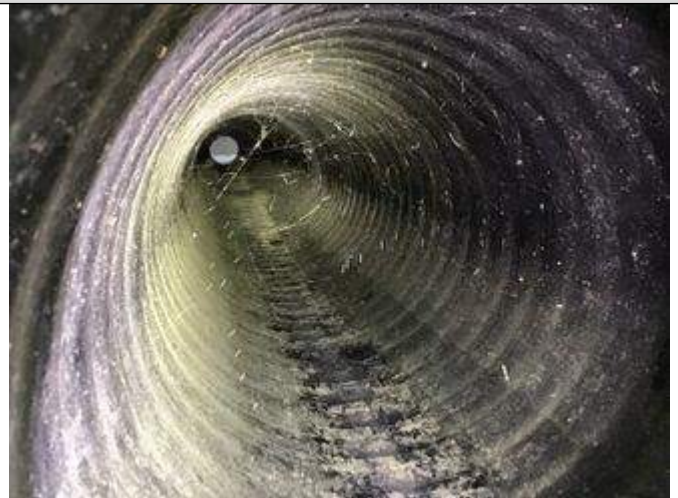
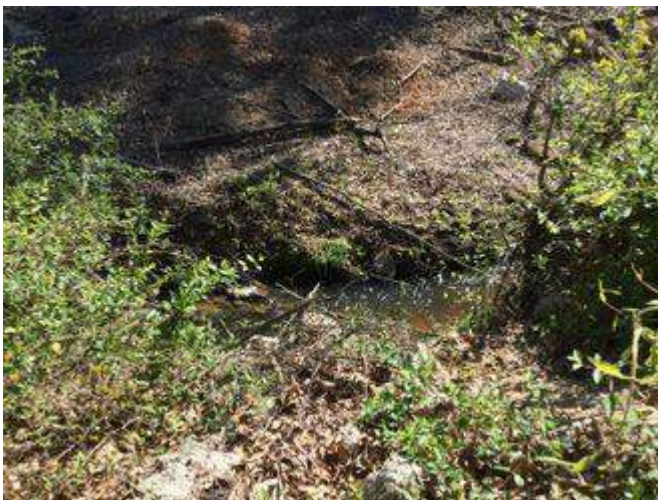
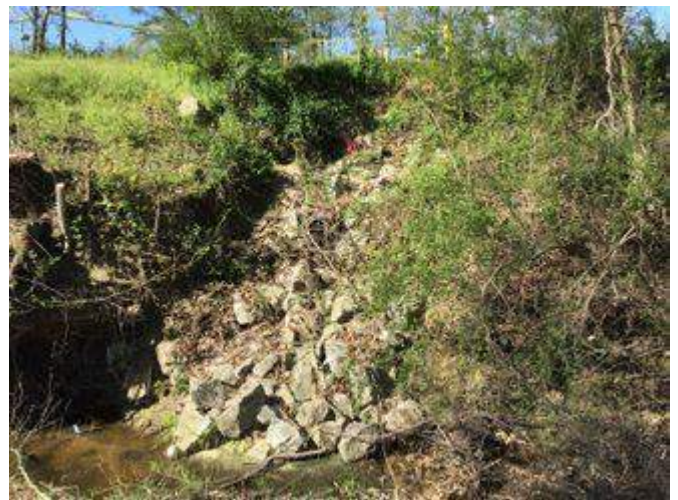
Outfall ID: 02	Date: 04/03/2020	Time: 10:06	Inspector: MSW
----------------	------------------	-------------	----------------

Indicator	Present?	Description	Relative Severity Index (1-3)
Odor	No	NA	NA
Turbidity	No	See Severity Index	NA
Floatables	No	NA	NA
Deposits/Stains	No	NA	NA
Poor Pool Quality	No	NA	NA
Pipe Benthic Growth	No	NA	NA

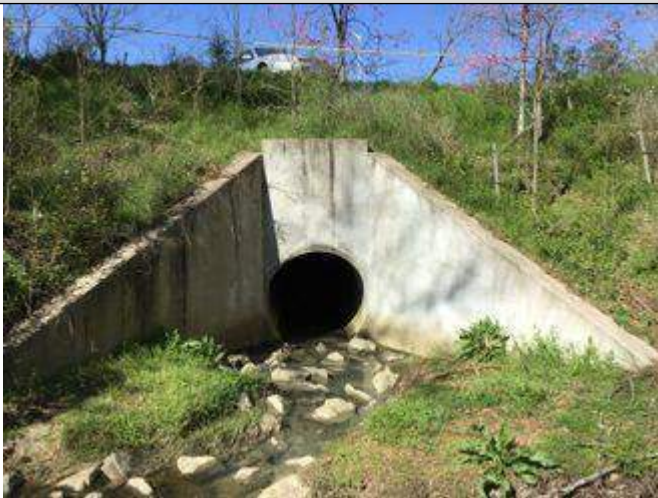
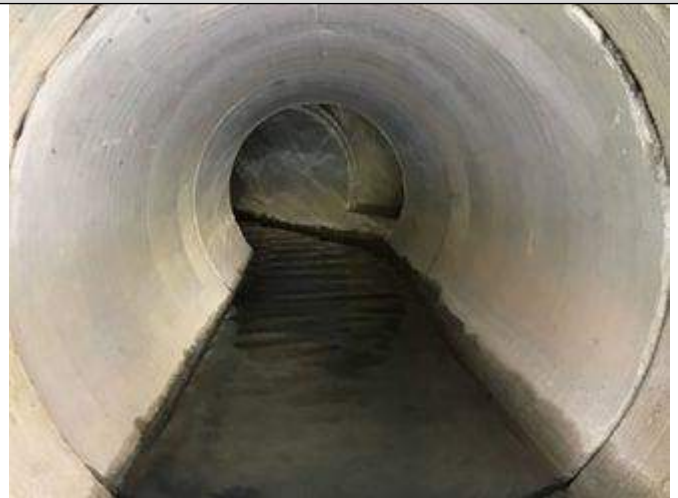
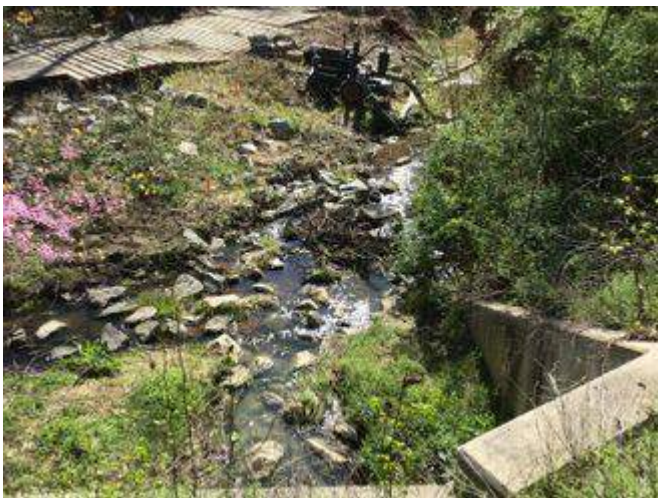
Indicator	Present?	Description	Relative Severity Index (1-3)
Odor	No	NA	NA
Turbidity	No	See Severity Index	NA
Floatables	No	NA	NA
Deposits/Stains	No	NA	NA
Poor Pool Quality	Yes	Colors, Excessive Algae, Floatables	2
Pipe Benthic Growth	Yes	Green	2

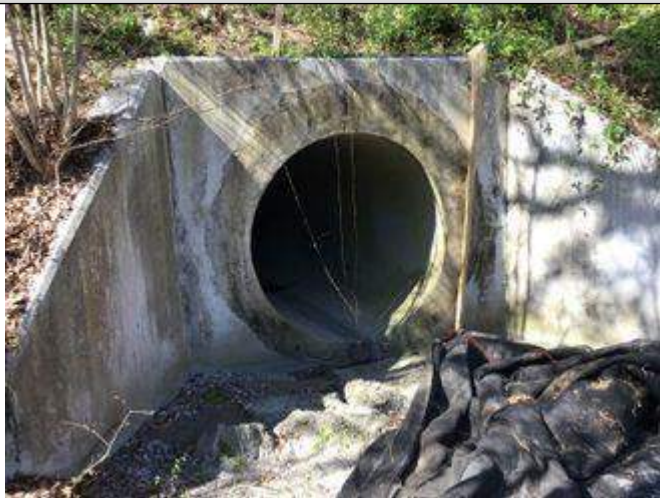
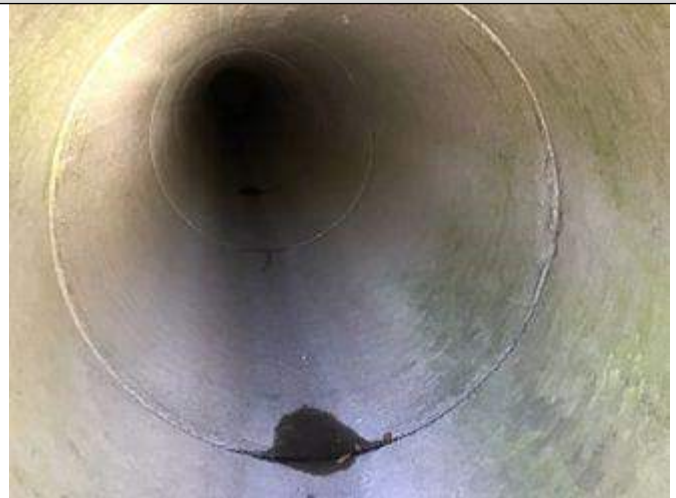
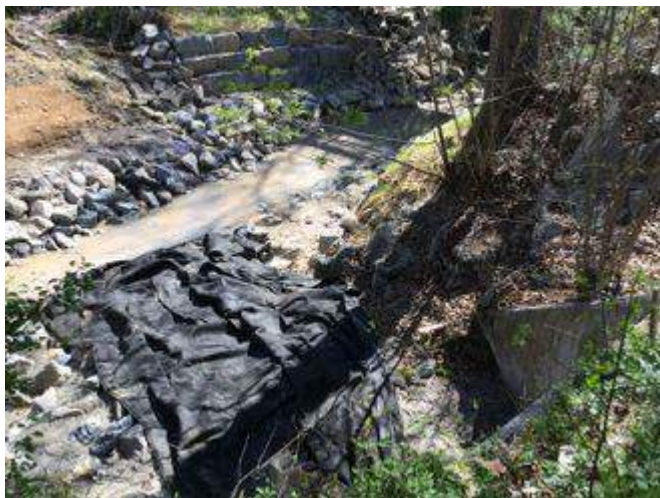
Outfall ID: 04	Date: 04/03/2020	Time: 10:44	Inspector: MSW
----------------	------------------	-------------	----------------

Indicator	Present?	Description	Relative Severity Index (1-3)
Odor	No	NA	NA
Turbidity	No	See Severity Index	NA
Floatables	Yes	Other: Pollen	2
Deposits/Stains	No	NA	NA
Poor Pool Quality	Yes	Excessive Algae, Floatables, Other: Trash	2
Pipe Benthic Growth	Yes	Brown	1

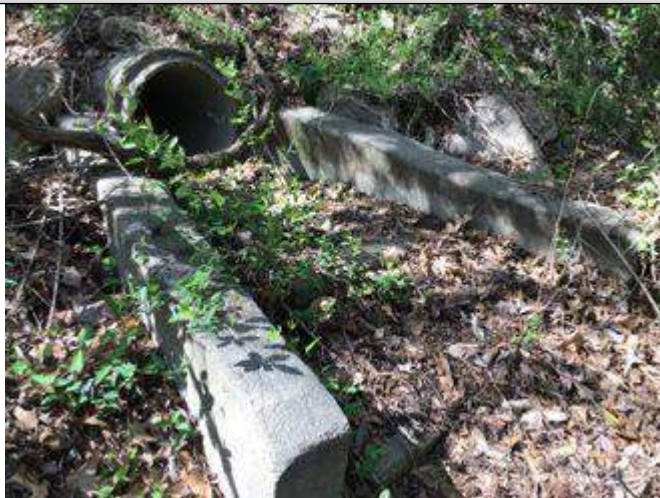
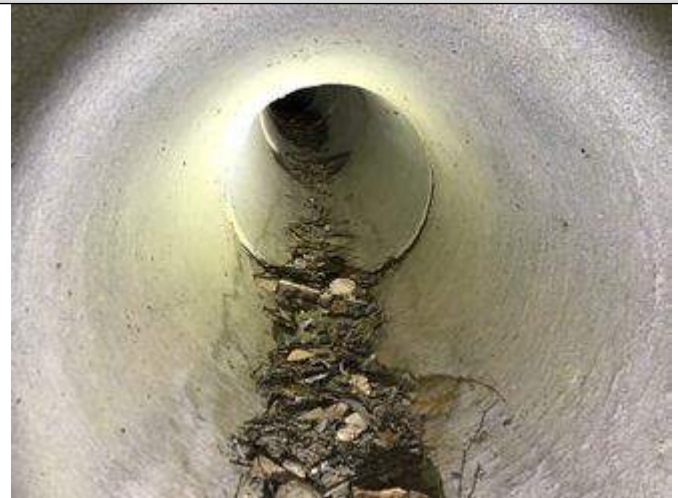
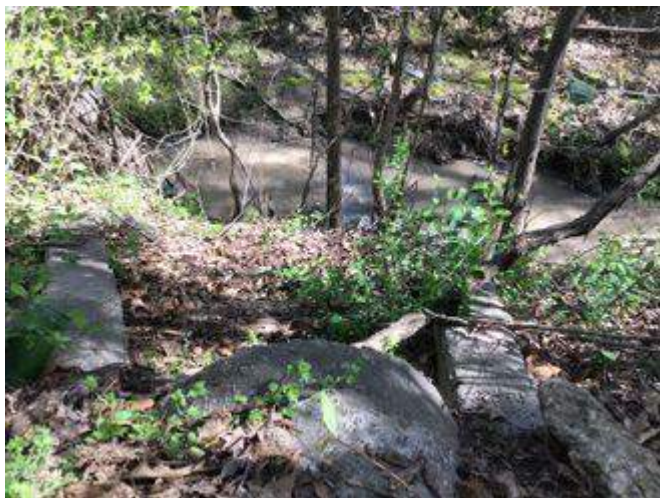
Outfall ID: 06	Date: 04/03/2020	Time: 11:02	Inspector: MSW
----------------	------------------	-------------	----------------

Indicator	Present?	Description	Relative Severity Index (1-3)
Odor	No	NA	NA
Turbidity	No	See Severity Index	NA
Floatables	No	NA	NA
Deposits/Stains	No	NA	NA
Poor Pool Quality	No	NA	NA
Pipe Benthic Growth	Yes	Green	1

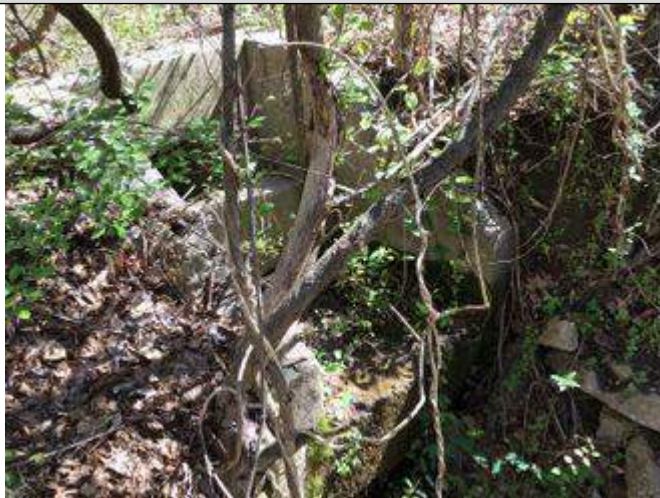
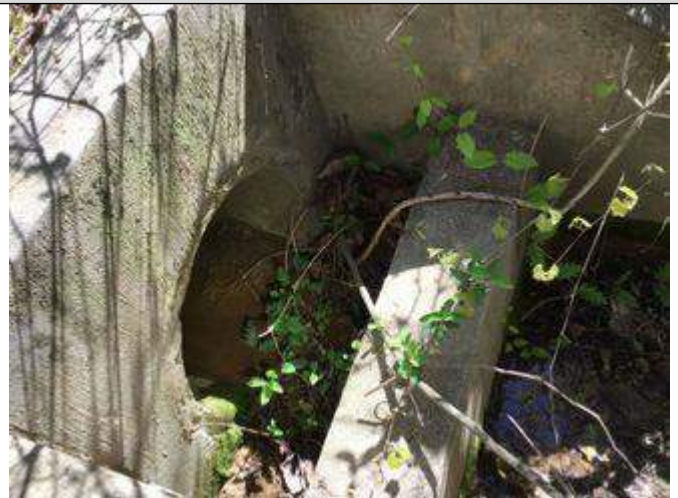
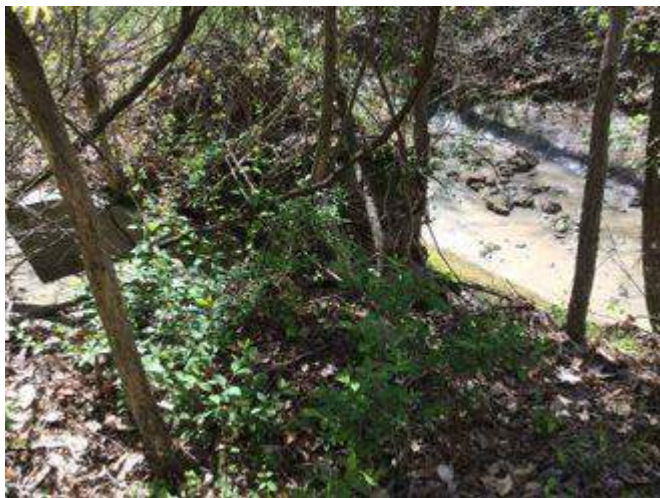
Outfall ID: 08	Date: 04/03/2020	Time: 11:09	Inspector: MSW
----------------	------------------	-------------	----------------

Indicator	Present?	Description	Relative Severity Index (1-3)
Odor	No	NA	NA
Turbidity	No	See Severity Index	NA
Floatables	No	NA	NA
Deposits/Stains	No	NA	NA
Poor Pool Quality	Yes	Other: Trash	3
Pipe Benthic Growth	Yes	Green	2

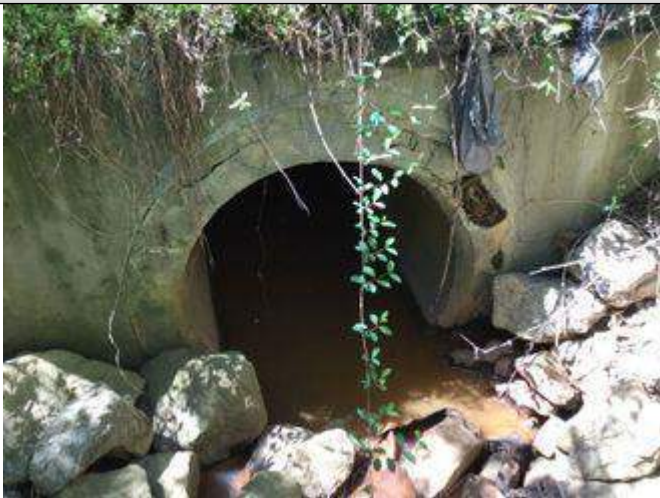
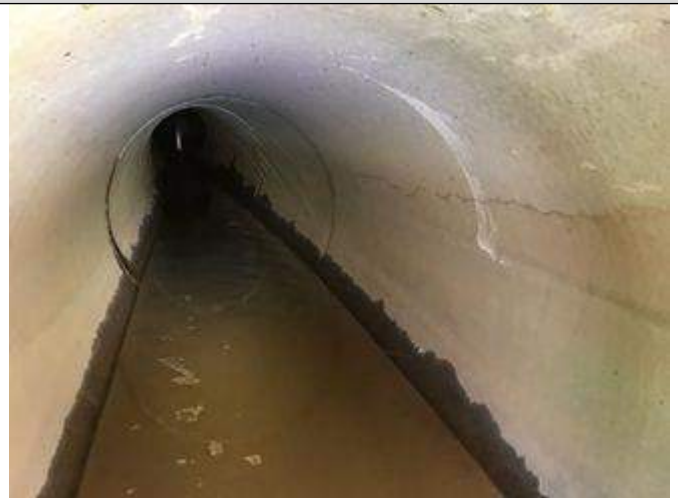
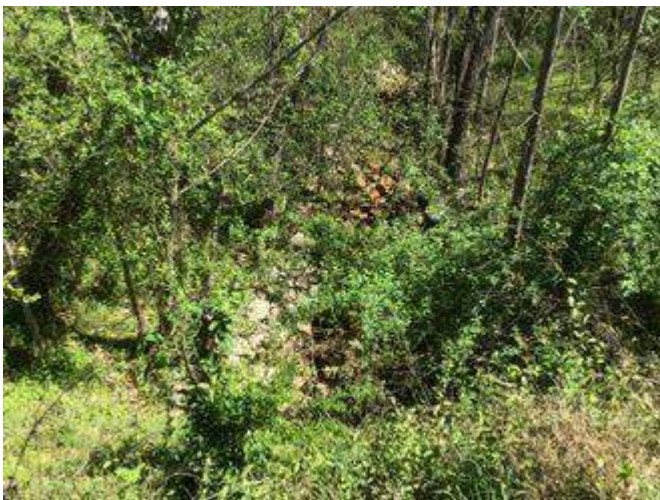
Outfall ID: 11	Date: 04/03/2020	Time: 12:45	Inspector: MSW
----------------	------------------	-------------	----------------

Indicator	Present?	Description	Relative Severity Index (1-3)
Odor	No	NA	NA
Turbidity	No	See Severity Index	NA
Floatables	Yes	Other: Orange algae	2
Deposits/Stains	No	NA	NA
Poor Pool Quality	Yes	ExcessiveAlgae	3
Pipe Benthic Growth	Yes	Orange	2

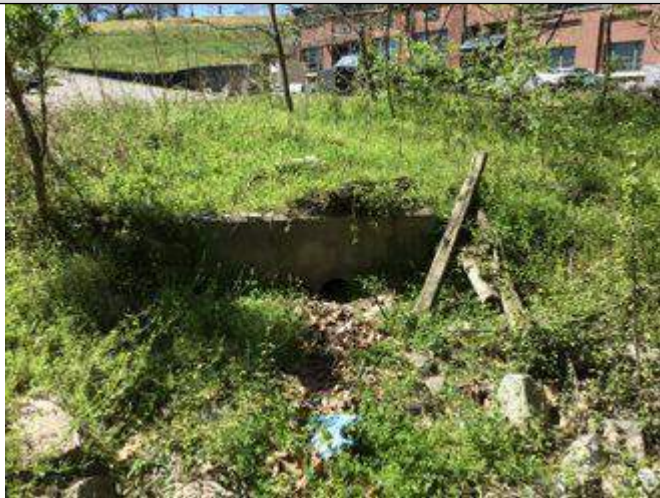
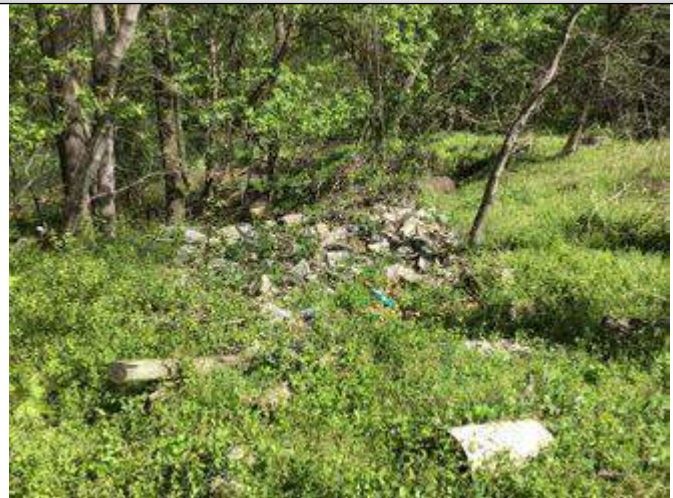
Outfall ID: 17	Date: 04/03/2020	Time: 14:48	Inspector: MSW
----------------	------------------	-------------	----------------

Indicator	Present?	Description	Relative Severity Index (1-3)
Odor	No	NA	NA
Turbidity	No	See Severity Index	NA
Floatables	No	NA	NA
Deposits/Stains	No	NA	NA
Poor Pool Quality	Yes	ExcessiveAlgae	2
Pipe Benthic Growth	Yes	Orange	2

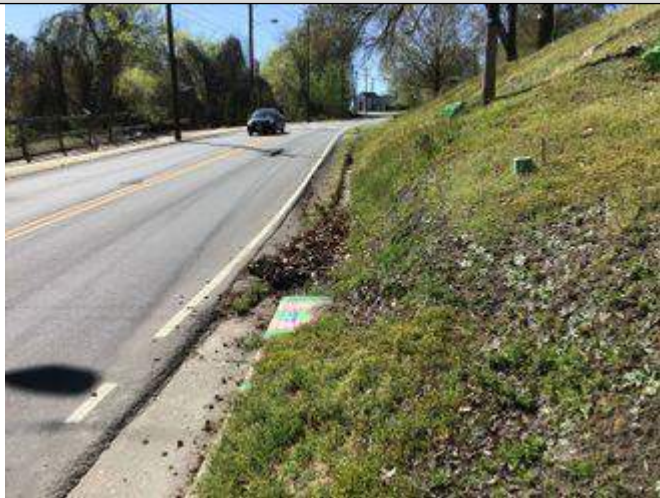
Outfall ID: 21	Date: 04/03/2020	Time: 15:28	Inspector: MSW
----------------	------------------	-------------	----------------

Indicator	Present?	Description	Relative Severity Index (1-3)
Odor	No	NA	NA
Turbidity	No	See Severity Index	NA
Floatables	No	NA	NA
Deposits/Stains	No	NA	NA
Poor Pool Quality	No	NA	NA
Pipe Benthic Growth	Yes	Green	1

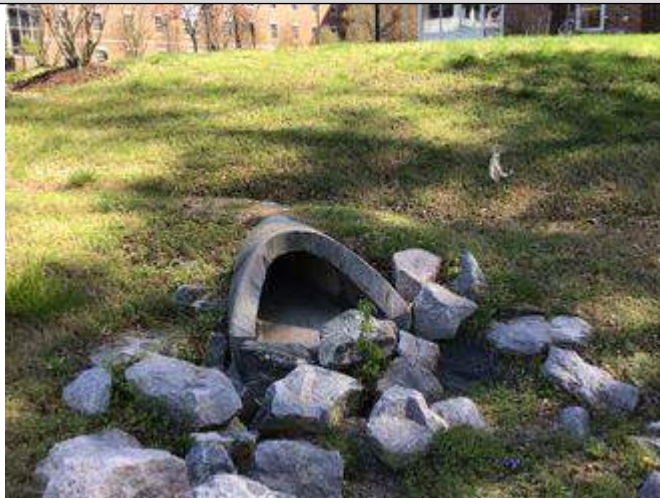
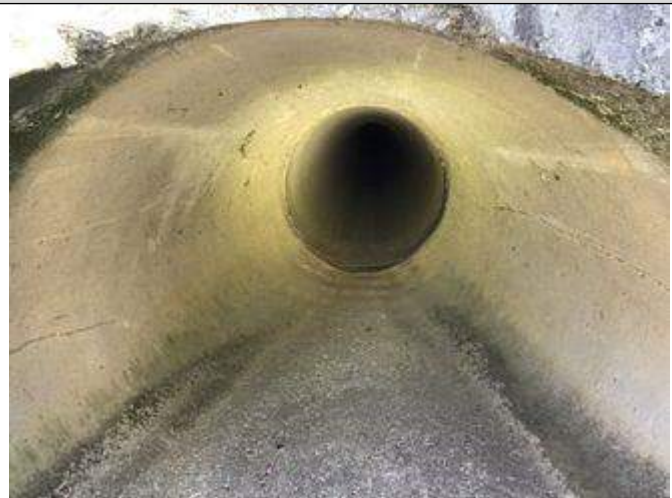
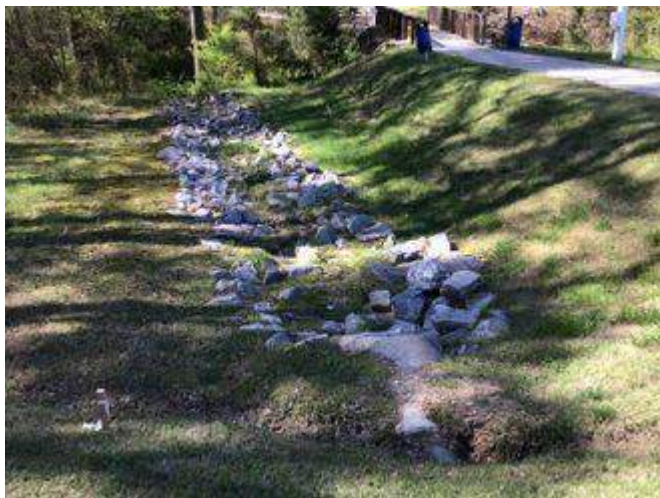
Outfall ID: 24	Date: 04/03/2020	Time: 10:58	Inspector: MSW
----------------	------------------	-------------	----------------

Indicator	Present?	Description	Relative Severity Index (1-3)
Odor	No	NA	NA
Turbidity	No	See Severity Index	NA
Floatables	No	NA	NA
Deposits/Stains	No	NA	NA
Poor Pool Quality	No	NA	NA
Pipe Benthic Growth	Yes	Other: Black	1

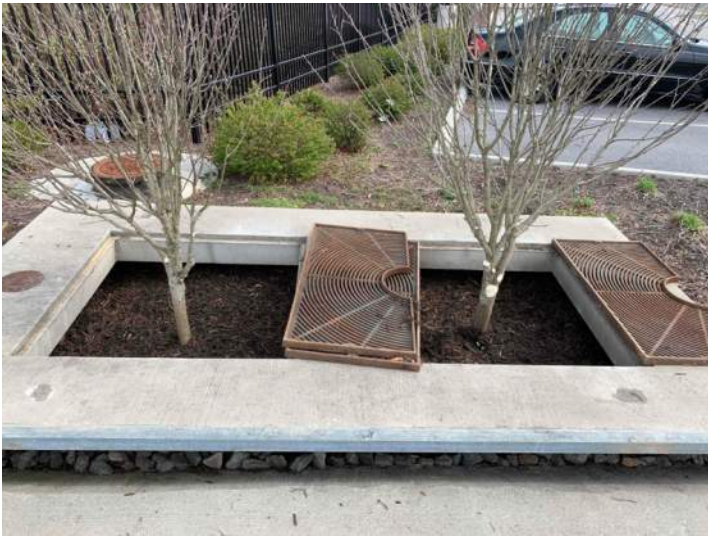
Unit 42 after - one side of grate is missing and has a board as a temporary replacement

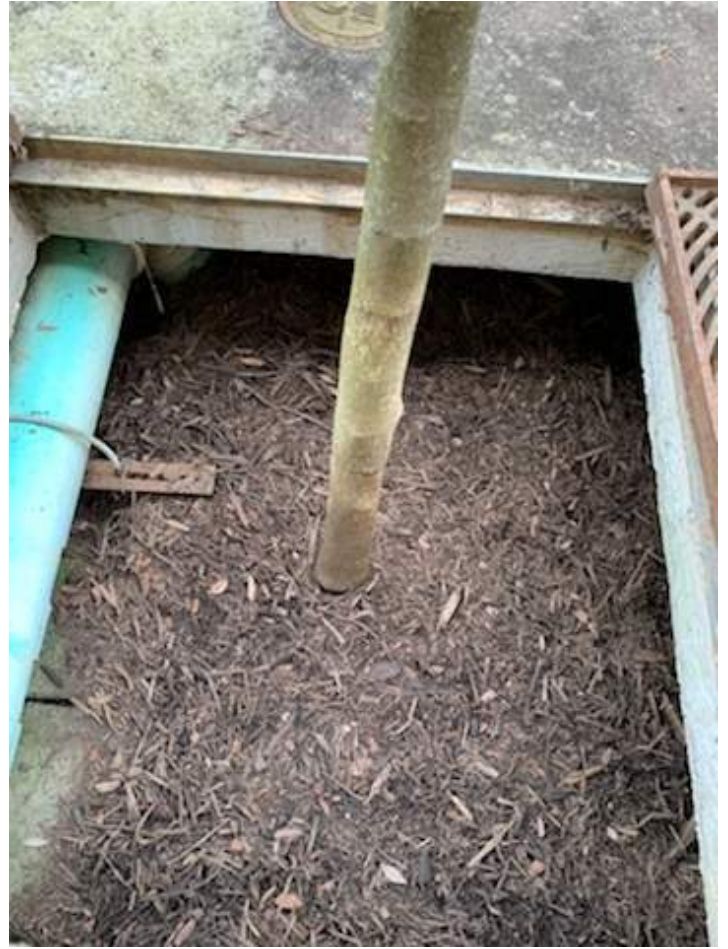
Unit 1 after

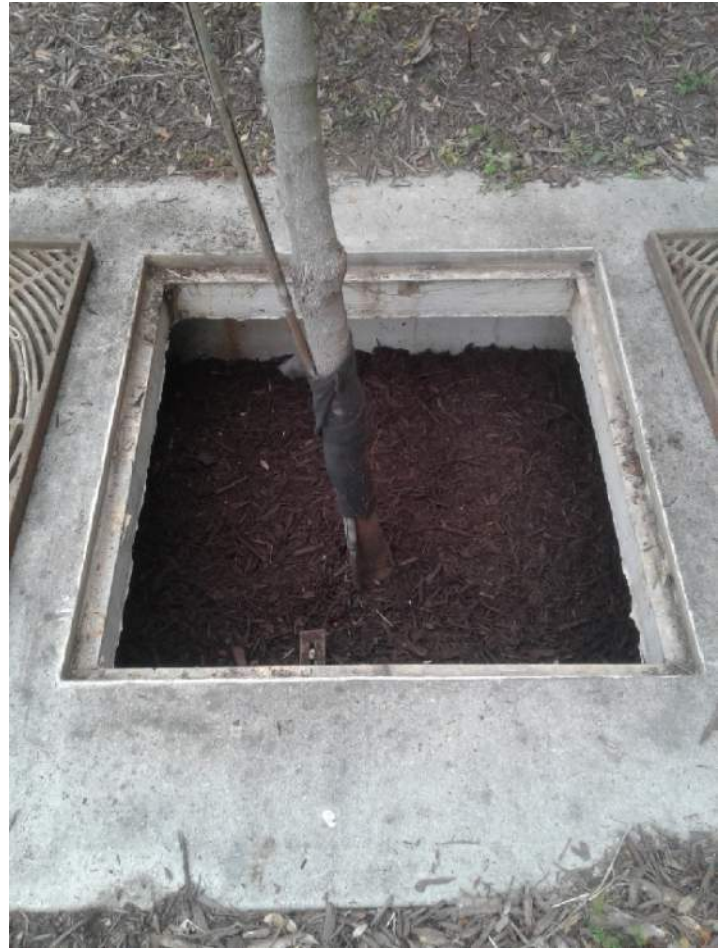
Unit 17 after

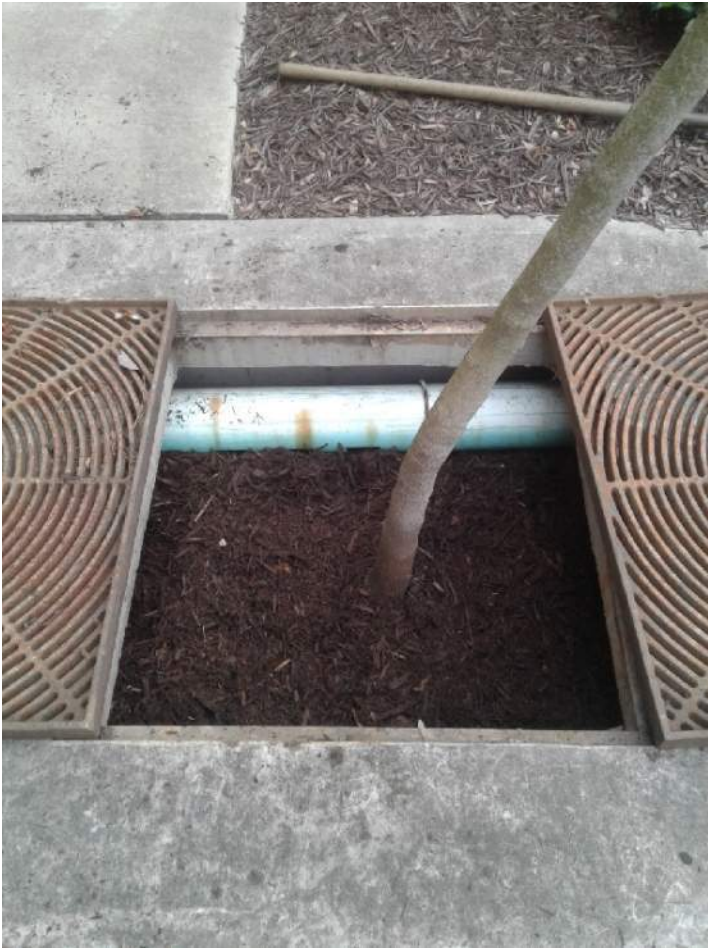
Unit 19 tree replaced and unit maintenance complete. Added media to replace lost during tree replacement.

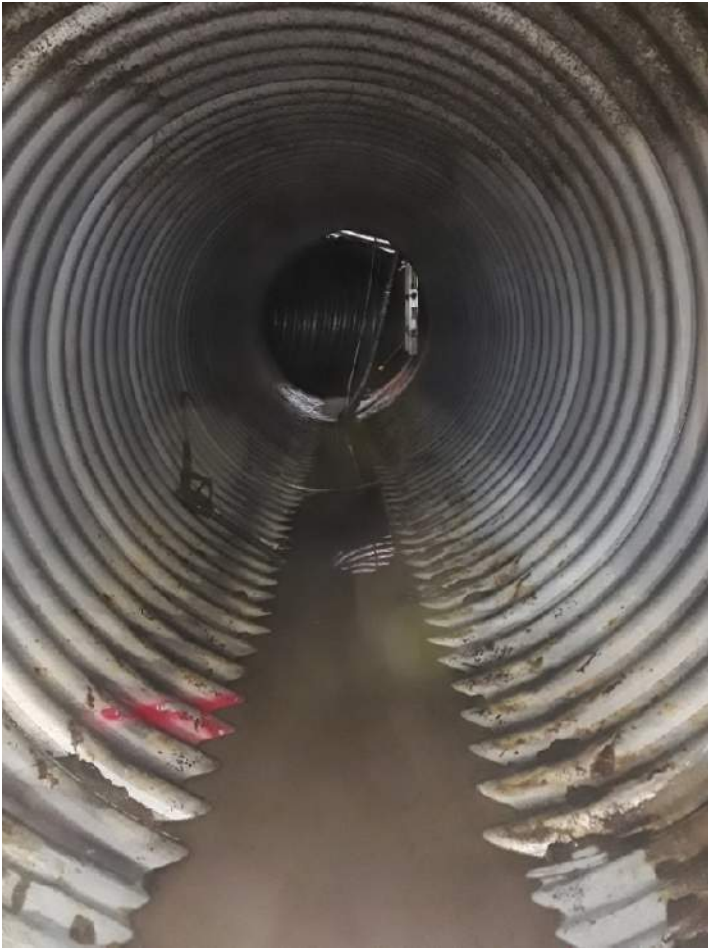
CMP 15 low flow is clear.

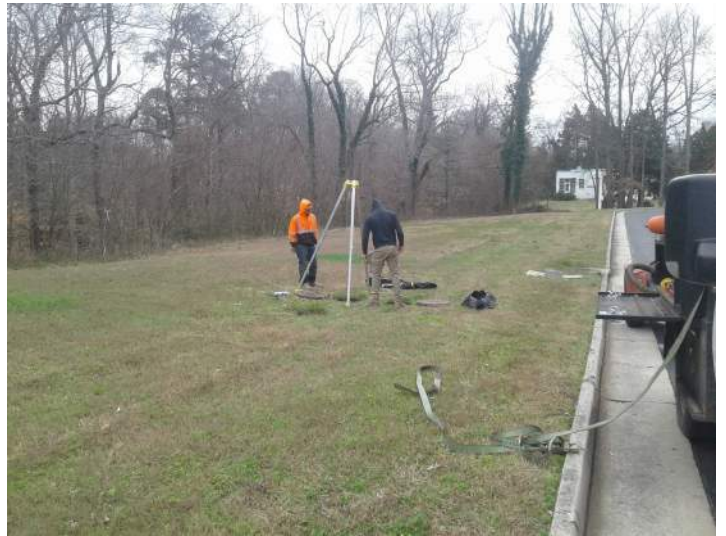
Unit 31 chamber 3. No debris to remove.

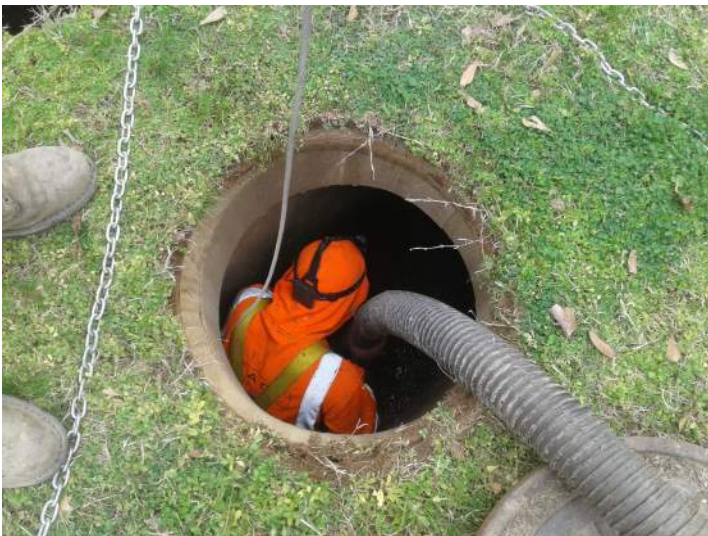
Making entry into unit 31

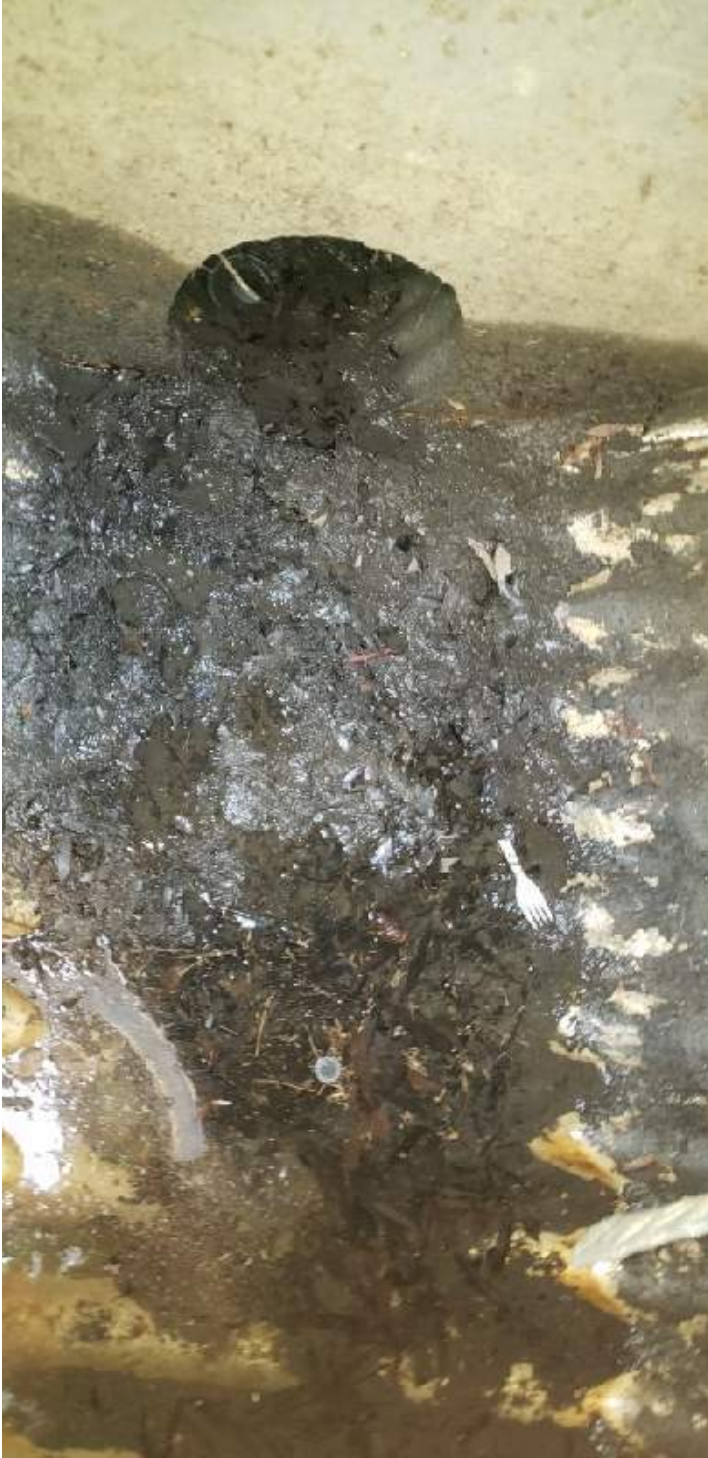
25 before.

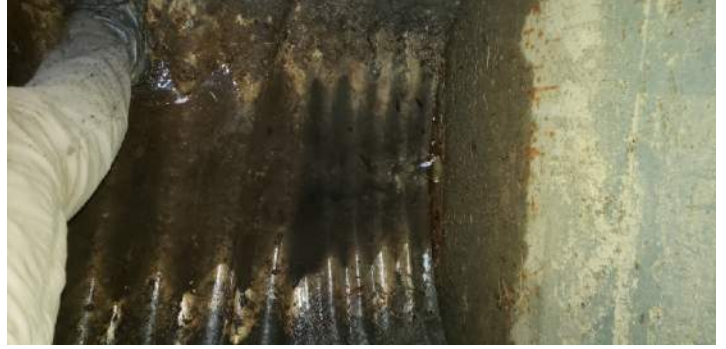
25 after.

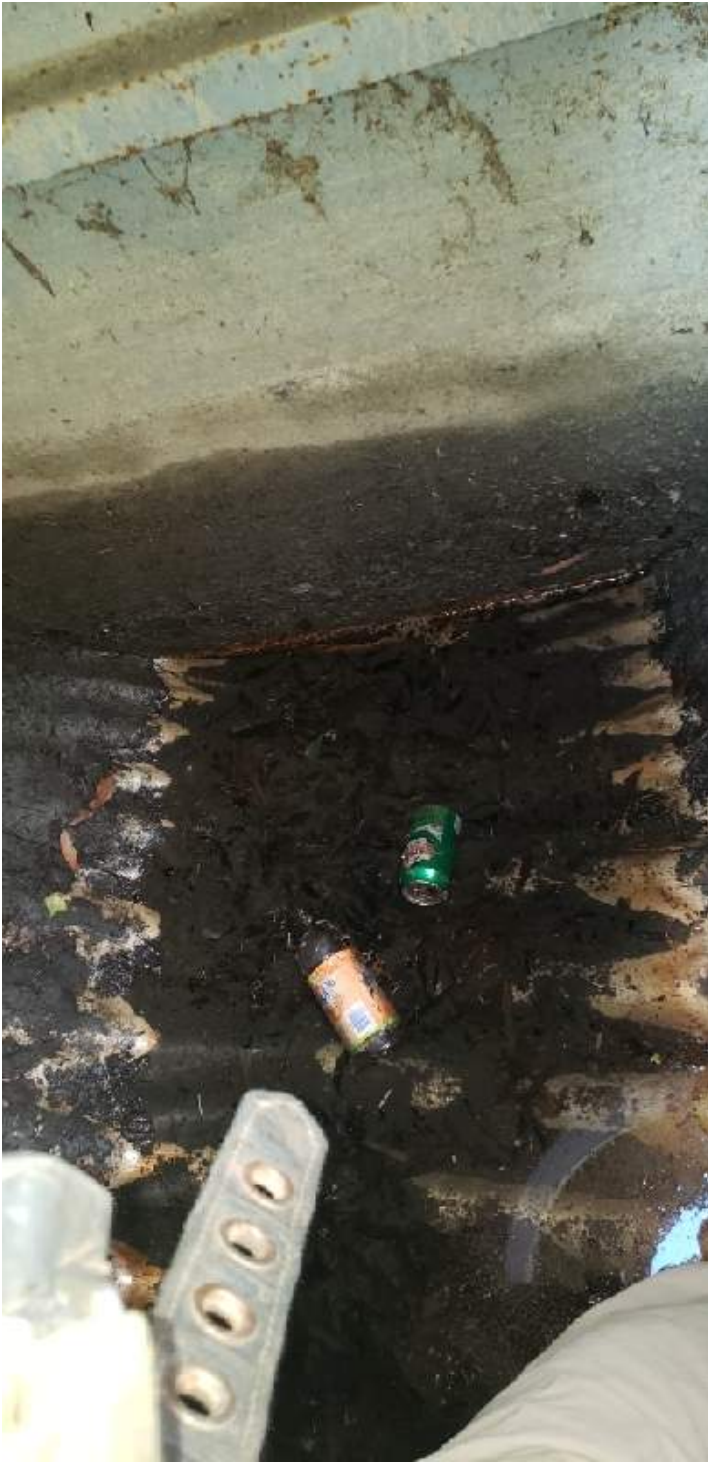
25 before.

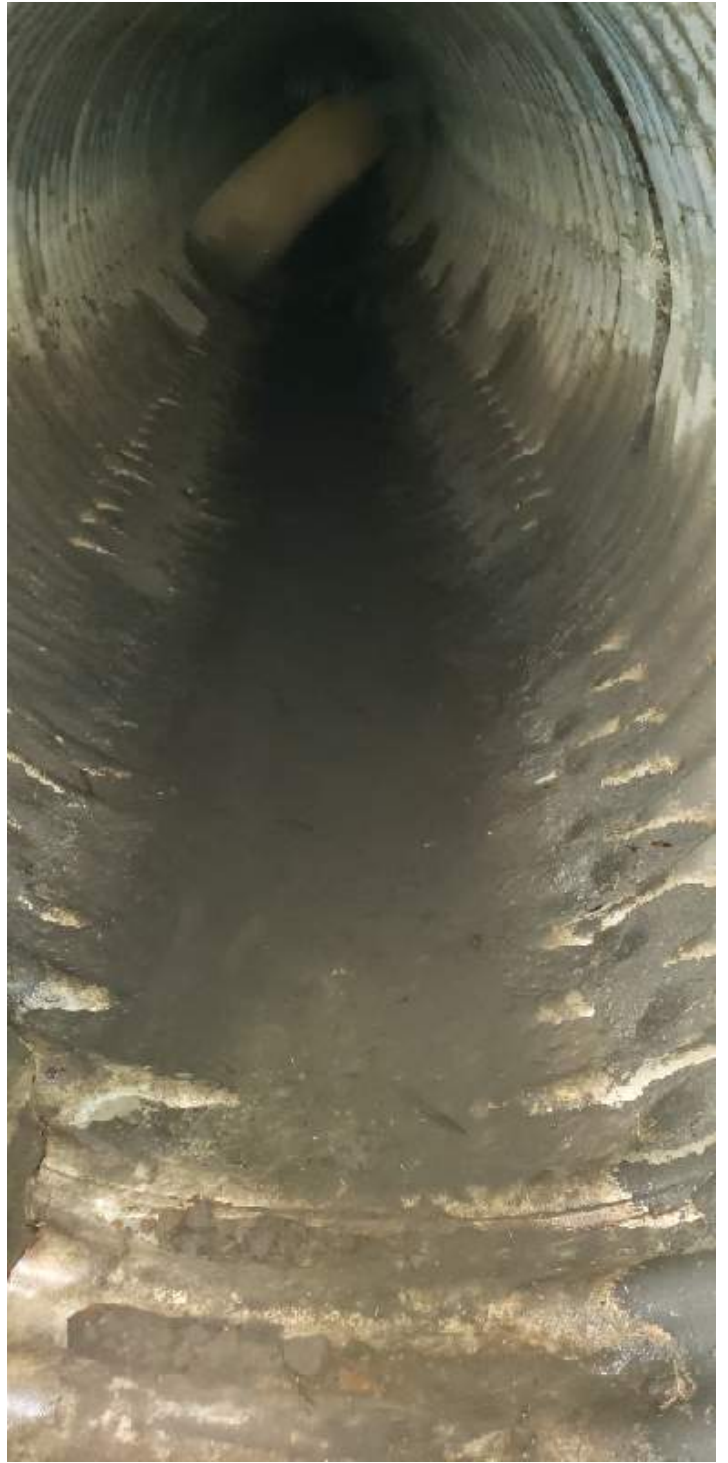
25 after.

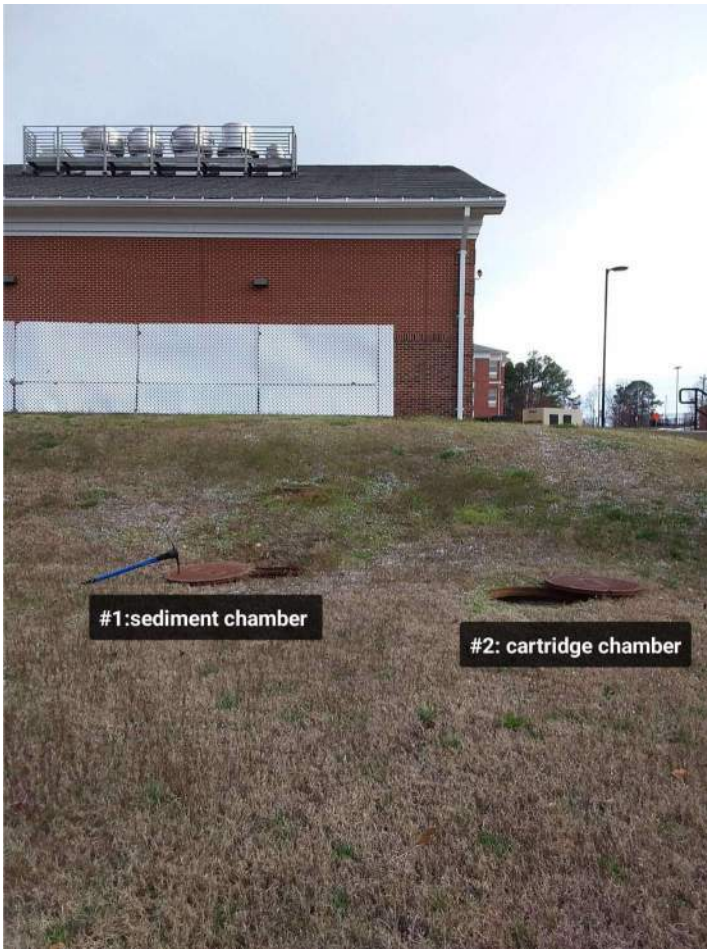
BMP 48

Vault structure includes cracks in wall or bottom; damage to the frame and/or top slab		✓	Cracks wider than 1/2 inch or evidence of soil particles entering the structure through cracks; determination that the vault is not structurally sound		✓	
			Cracks wider than 1/2 inch at the joint of any inlet/outlet pipe or evidence of soil particles entering through the cracks		✓	
Baffles		✓	Baffles corroding, cracking, warping, and/or showing signs of failure		✓	
Access ladder damaged		✓	Ladder is corroded or deteriorated, not functioning properly, not securely secured to the structure wall and/or missing rungs; cracks; misalignment		✓

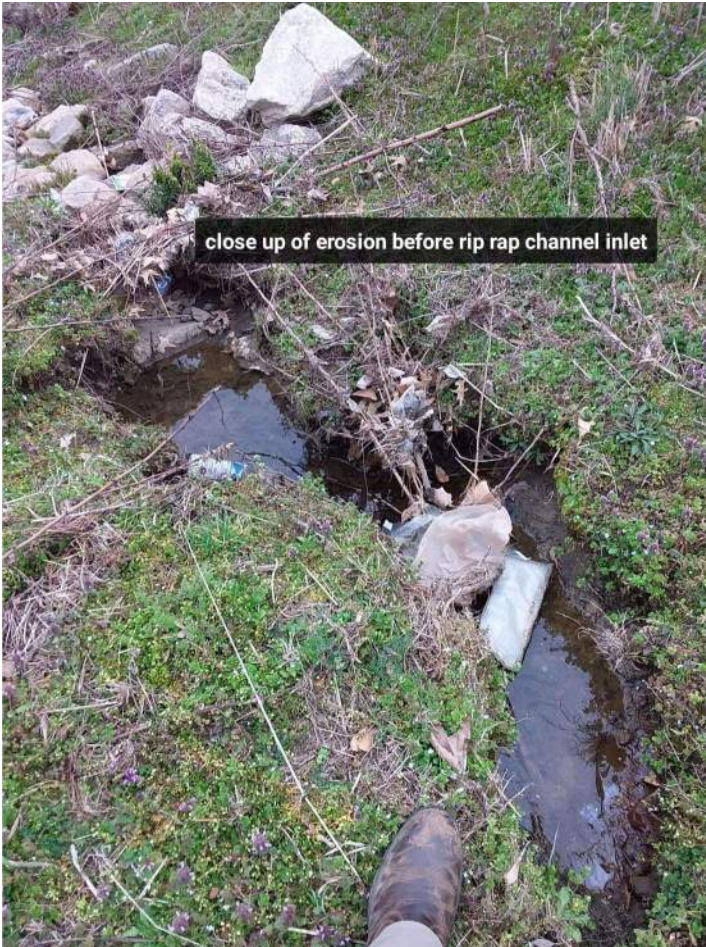
BMP 30

close up of erosion before rip rap channel inlet

sediment, vegetation and trash in rip rap must be removed

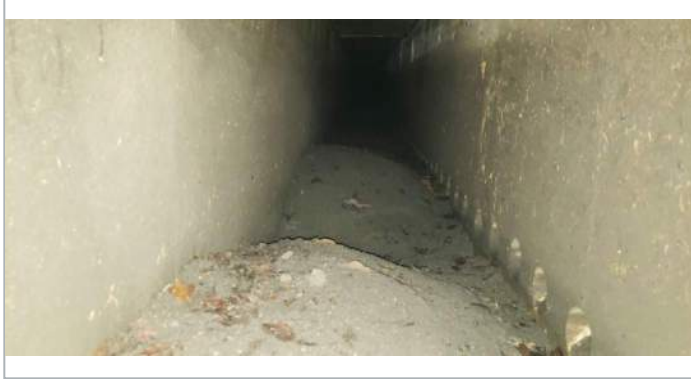
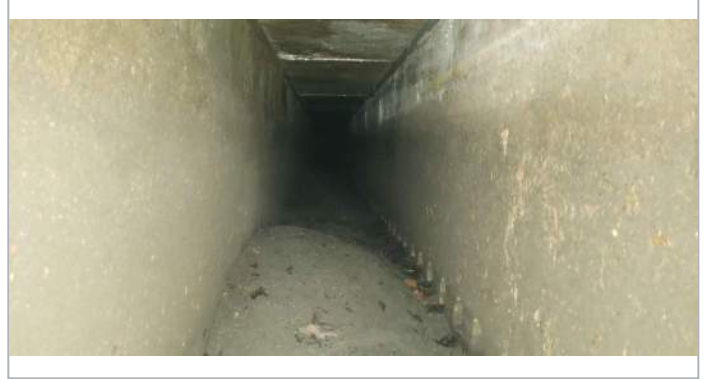
BMP 31 4" drain holes allow water to flow into the sand filter, but it appears disproportionate water dispersion is occurring. This could be the reason for having sediment clumps or piles

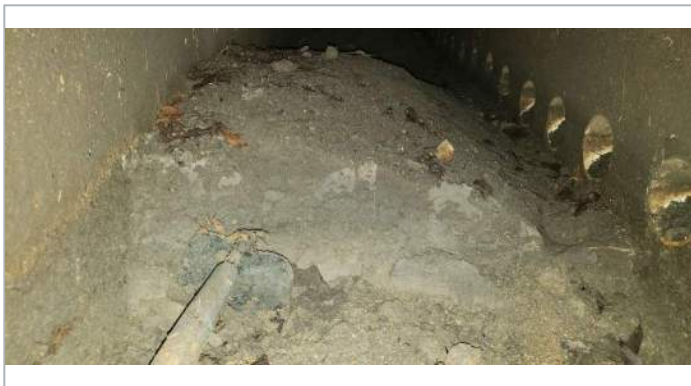
BMP 31 Almost all the way to the end of the underground sand filter, sediment accumulation throughout. Although the first section of sand filter was cleaned out. The further the sand filter goes the more accumulation there is.
